MATHER HOMESTEAD DARIEN, CT

CONDITIONS ASSESSMENT REPORT

P22-028

JULY 6, 2022

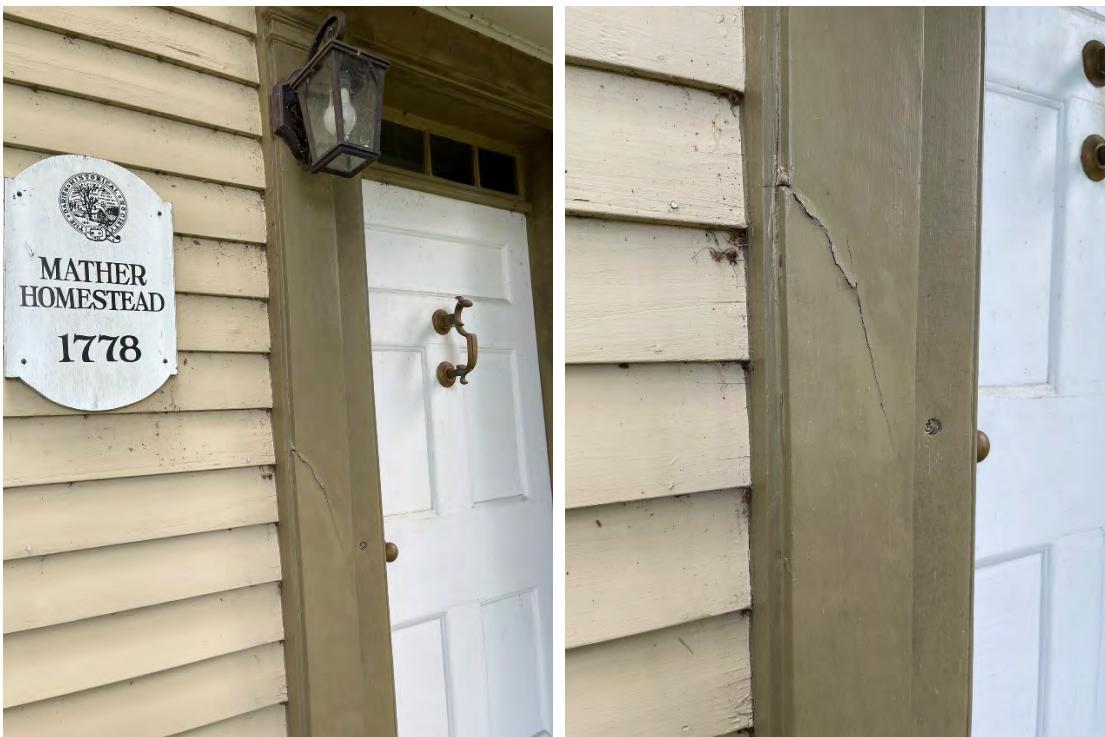
Mather Homestead – Mather Home - Exterior Details
North Elevation – Entrance Doorway
Cracked, Damaged Trim

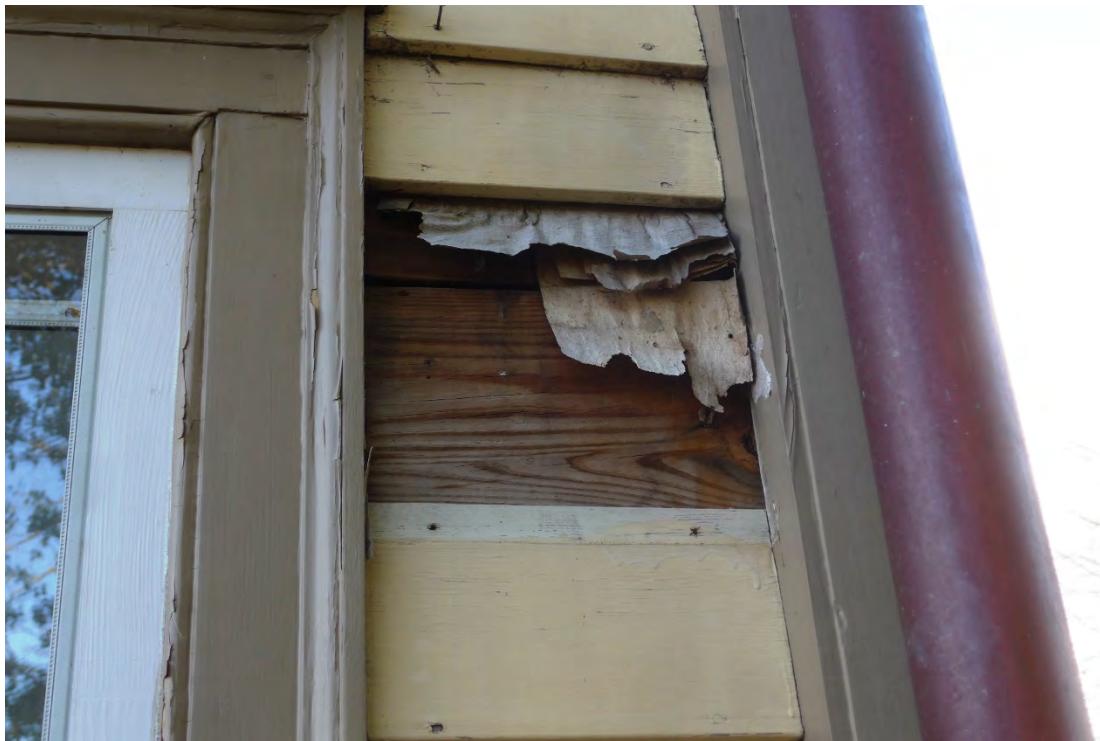
Mather Homestead – Mather Home - Exterior Details

East Elevation – Rear, Porch Wall at Northeast Corner – Missing Siding

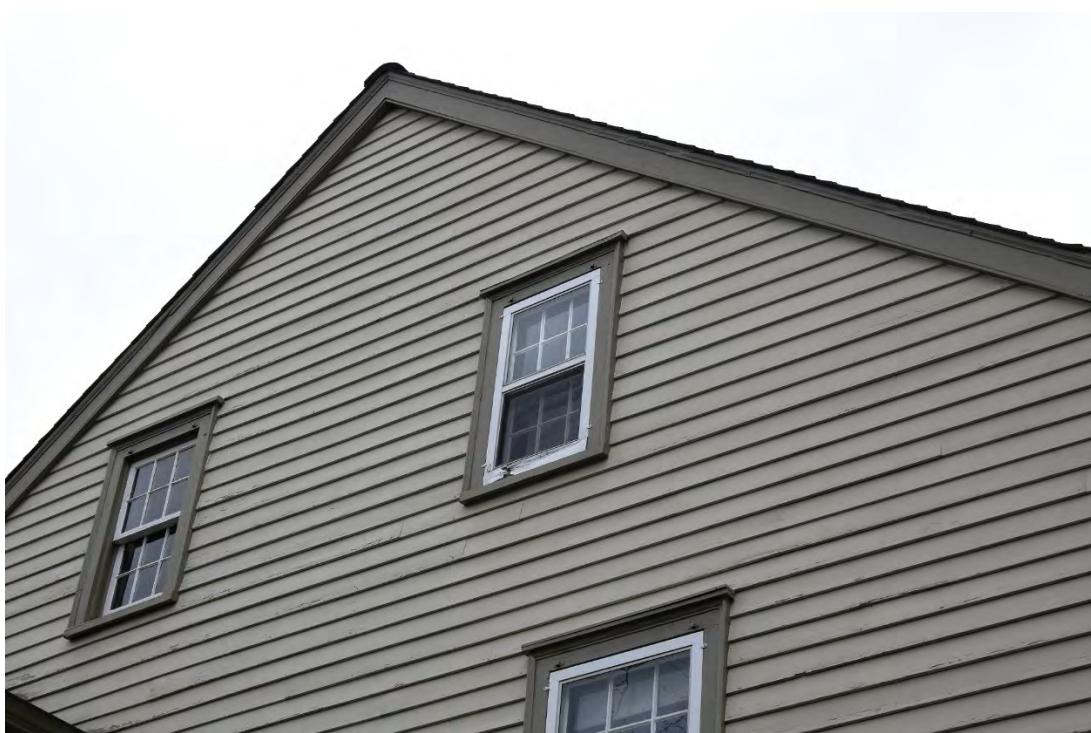
Mather Homestead – Mather Home - Exterior Details
West Elevation
Peeling Paint on Siding, and Peeling Paint and Rotting Wood at Storm Window

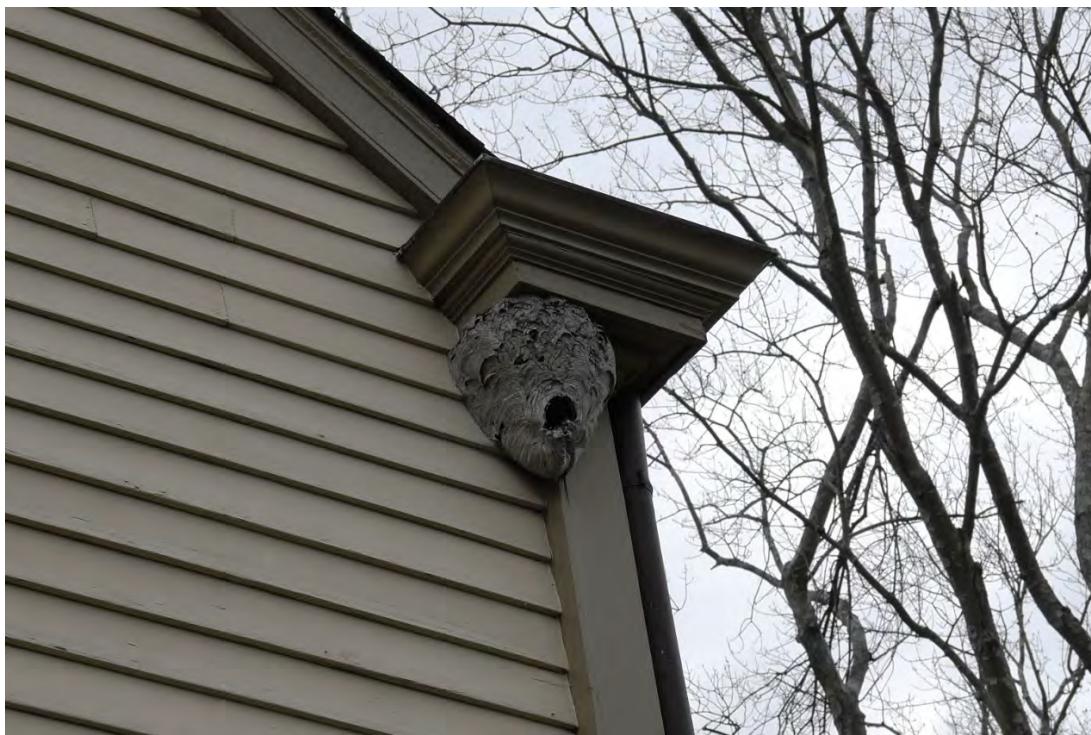
Mather Homestead – Mather Home - Exterior Details
West Elevation – Northwest Corner
Hornets' Nest at Overhang

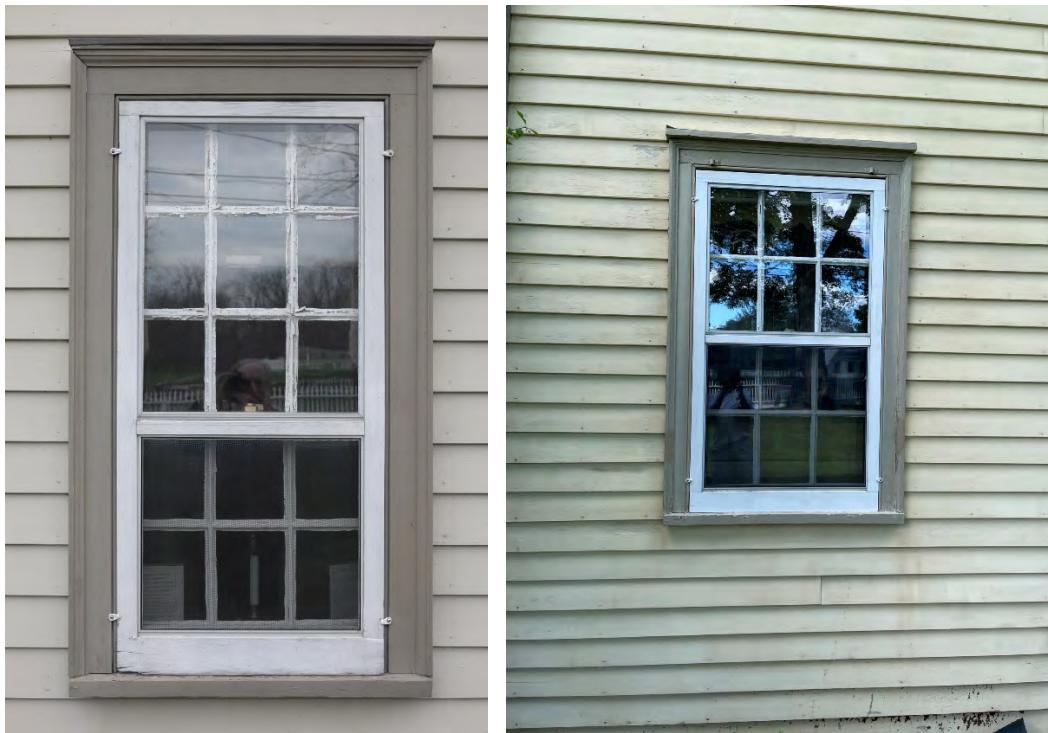
Mather Homestead – Mather Home - Exterior Details
Left: West Elevation - Peeling Paint at Window Sash, Some Deterioration of Wood Storm Window
Right: East Elevation – Worn and Peeling Paint

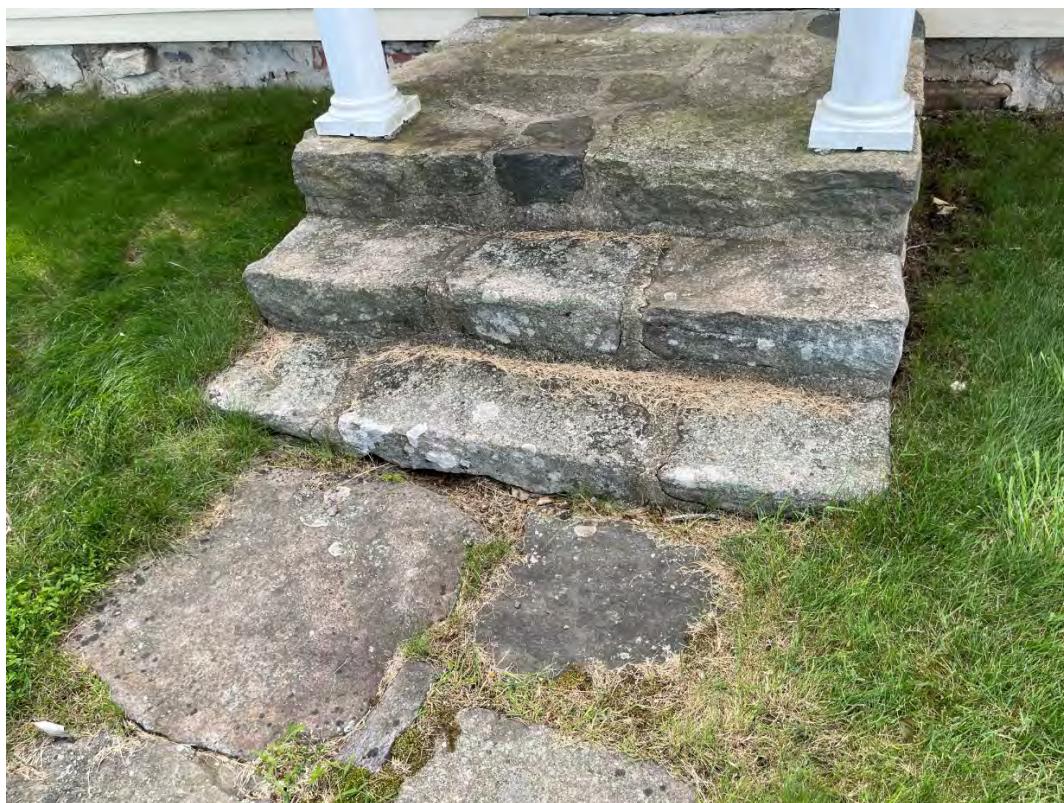
Mather Homestead – Mather Home - Exterior Details
North Elevation – Entrance Doorway
Erosion under Stone Step

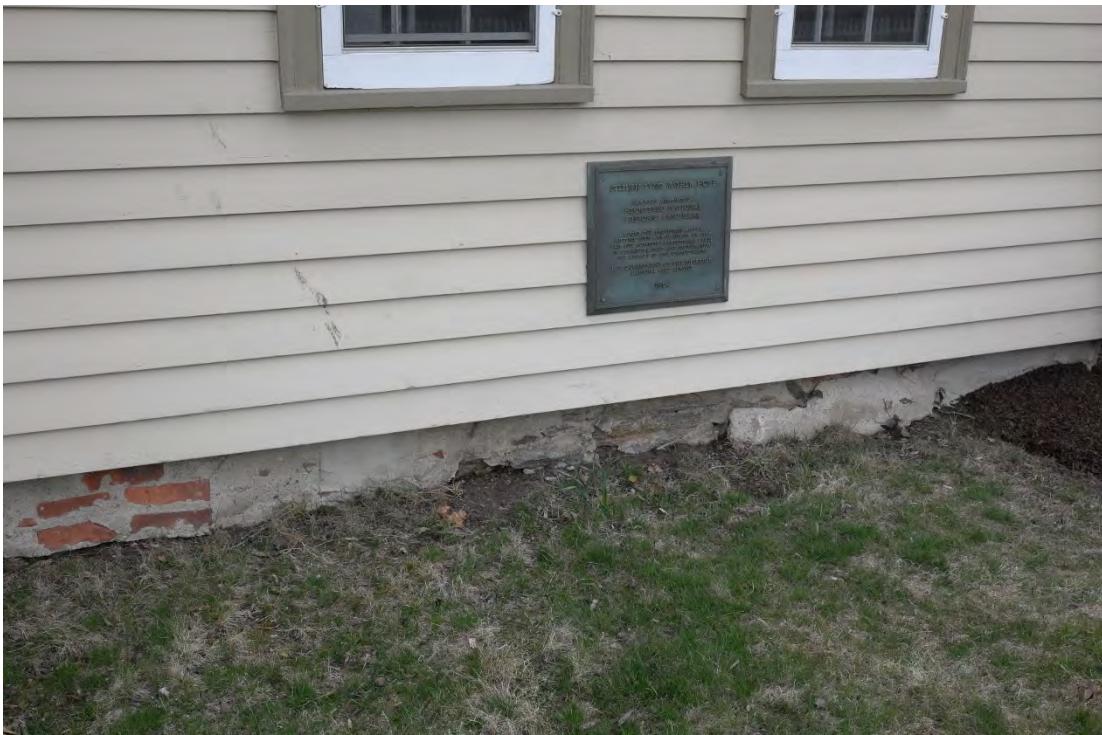
Mather Homestead – Mather Home - Exterior Details

Spalling Masonry Coating

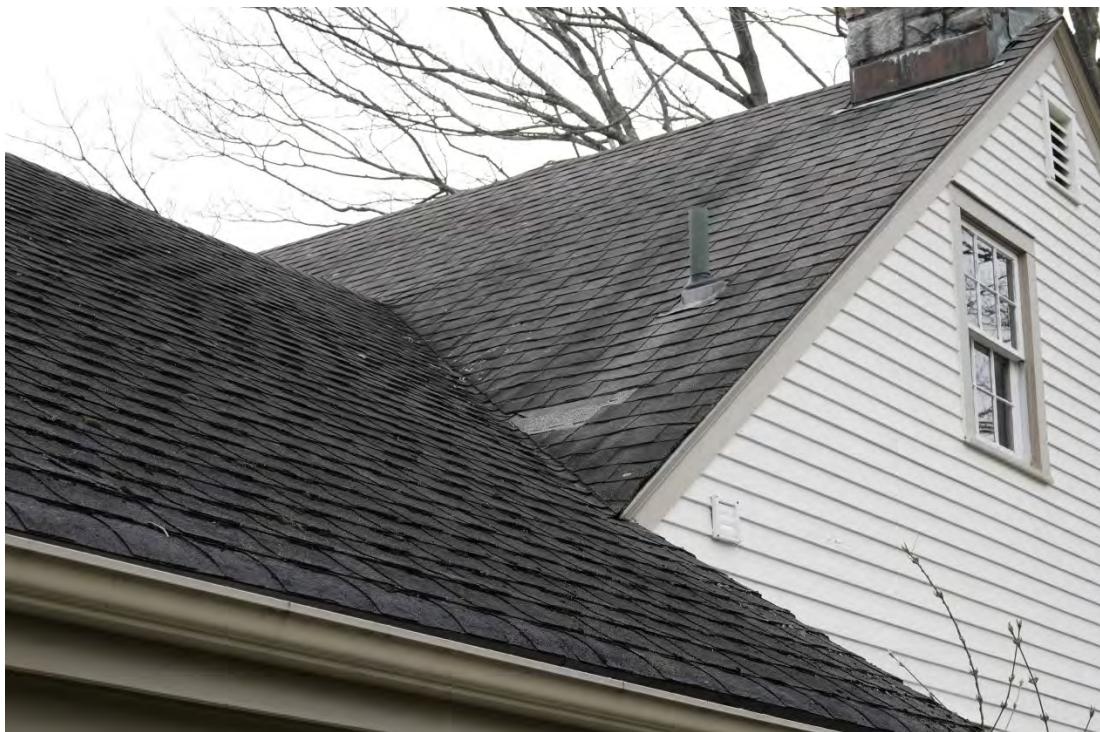
Mather Homestead – Caretaker's Cottage – Exterior Details
Missing Shingles; Peeling Paint

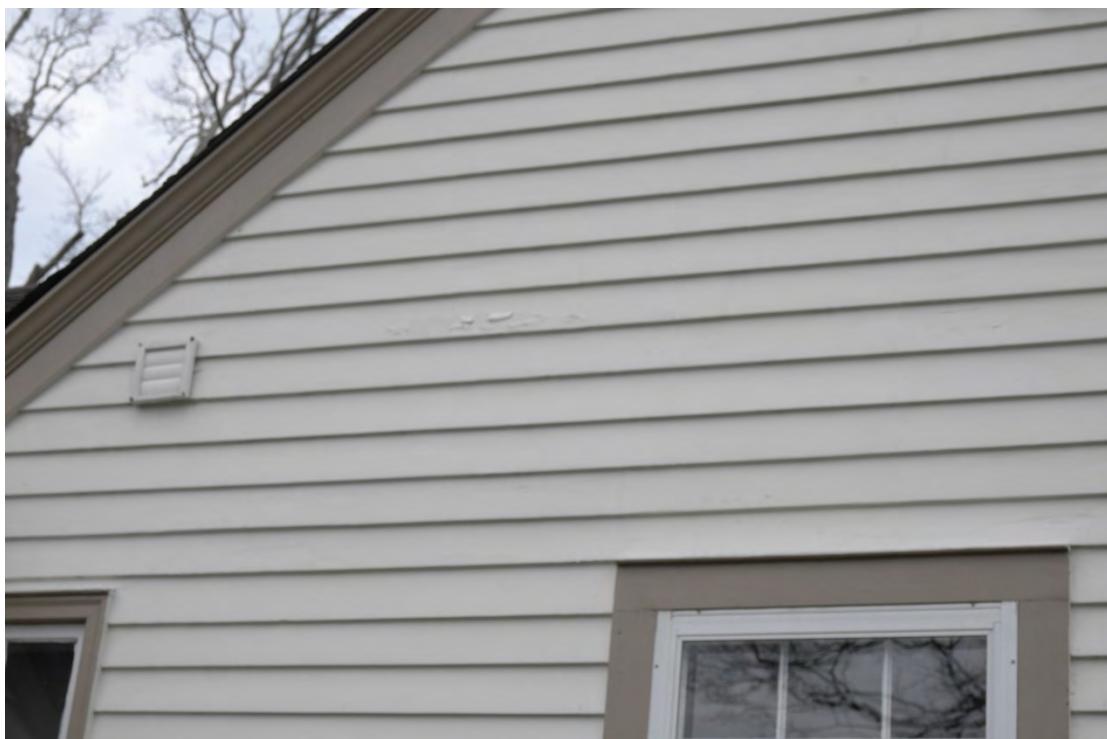
Mather Homestead - Caretaker's Cottage – Exterior Details
North Elevation – Peeling Paint

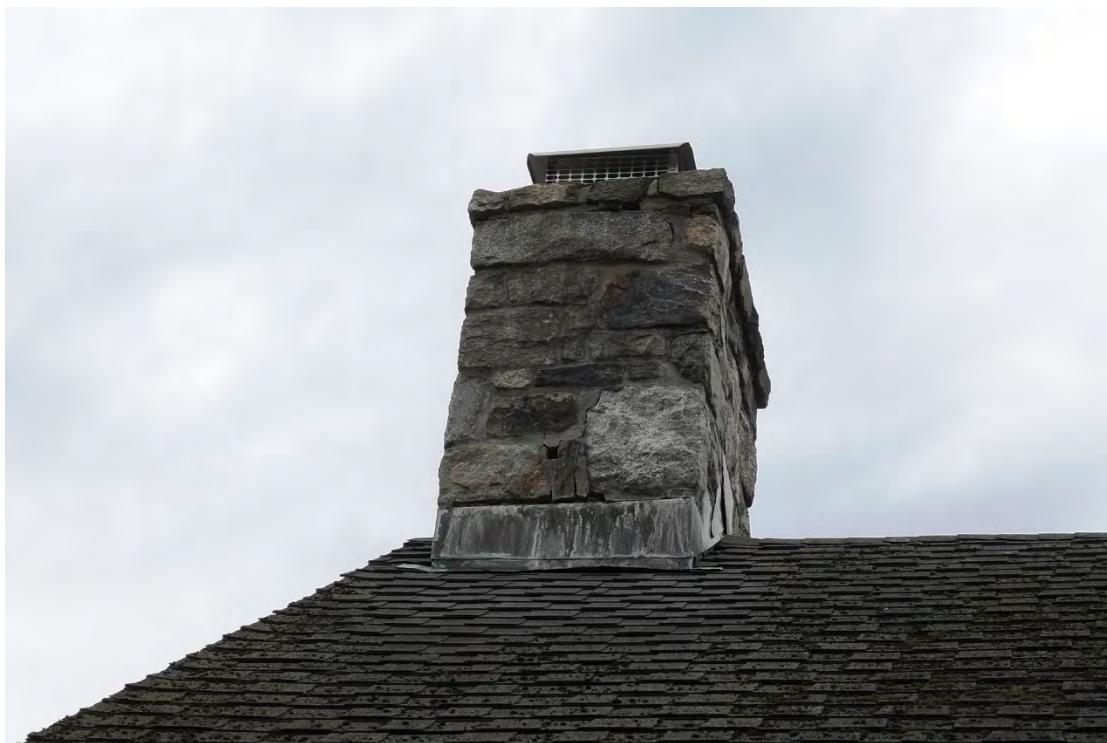
Mather Homestead - Caretaker's Cottage - Exterior Details
Chimney – Open Mortar Joints; Some Staining

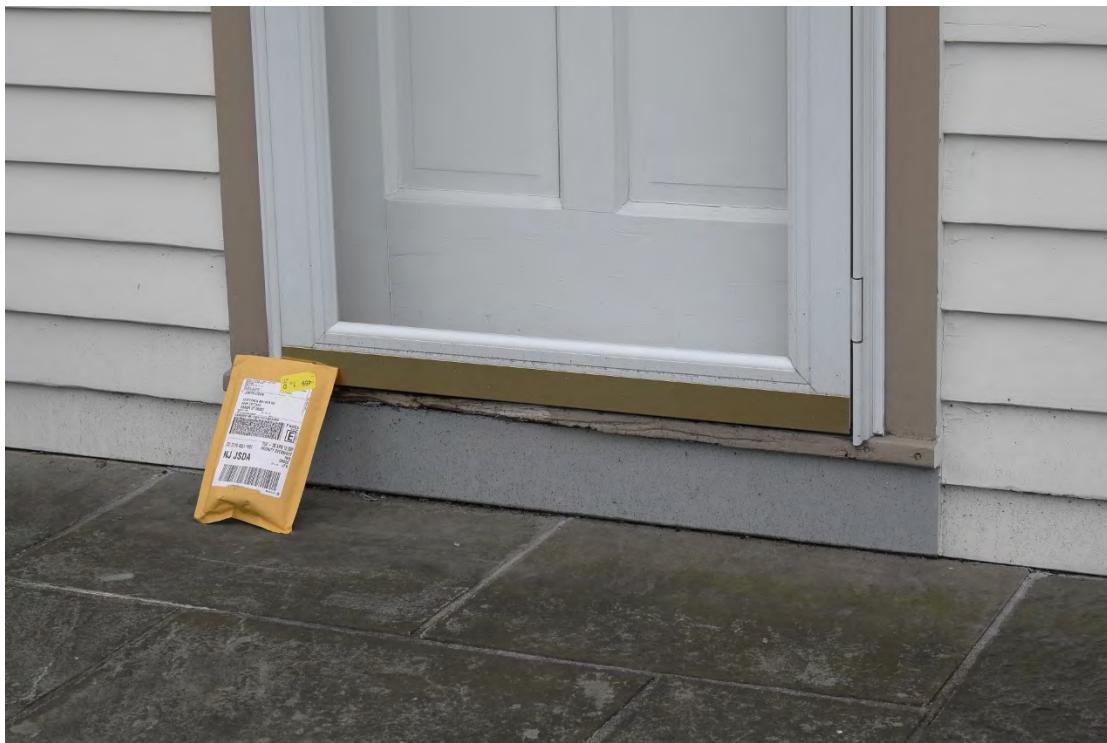
Mather Homestead – Caretaker's Cottage - Exterior Details
West Elevation – Entrance - Damaged Threshold

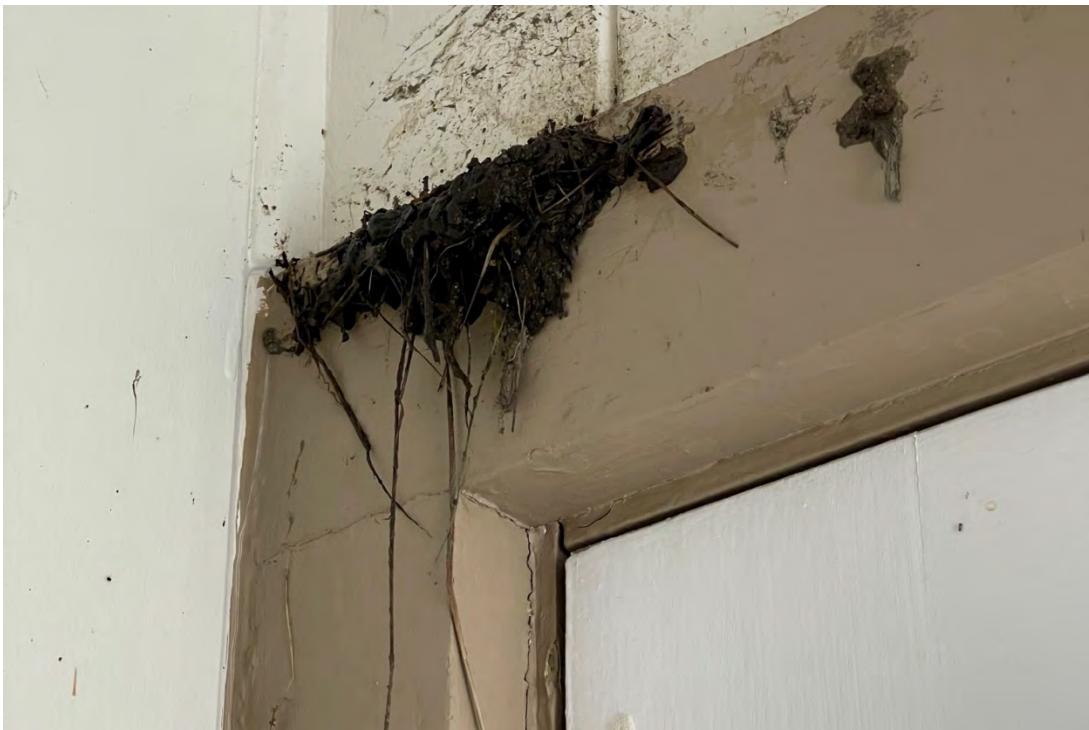
Mather Homestead - Caretaker's Cottage – Exterior Details
Exterior Entrance Vestibule – Debris and Staining from Nesting

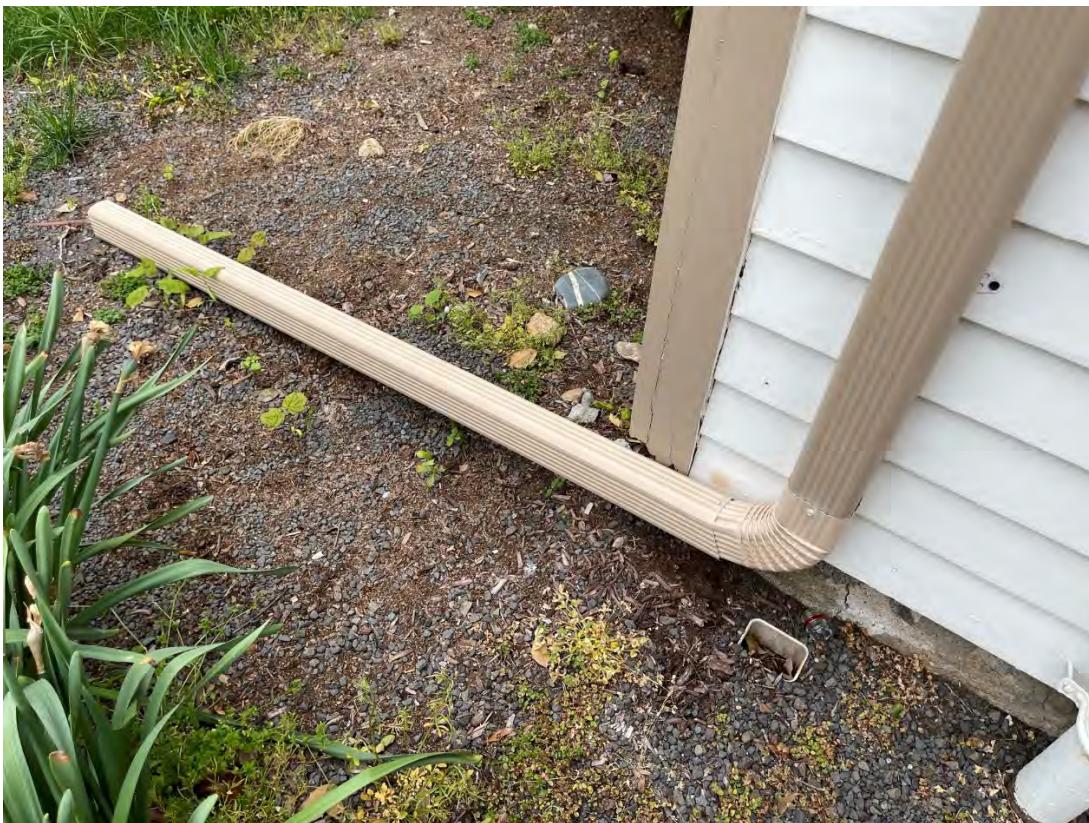
Mather Homestead - Caretaker's Cottage – Exterior Details
Southeast Corner of Living Space – Storm Drain Circumvented

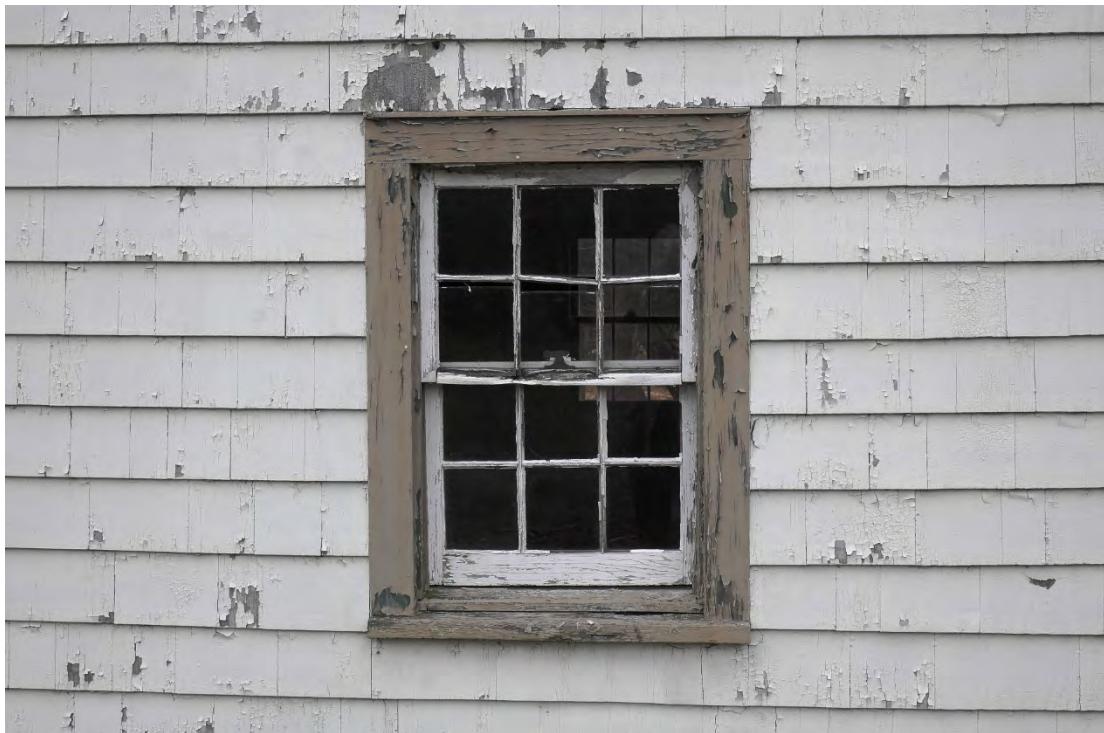
Mather Homestead – Playhouse - Exterior Details

Peeling Paint on Siding and Trim; Deteriorated Wood on Window Sash and Trim

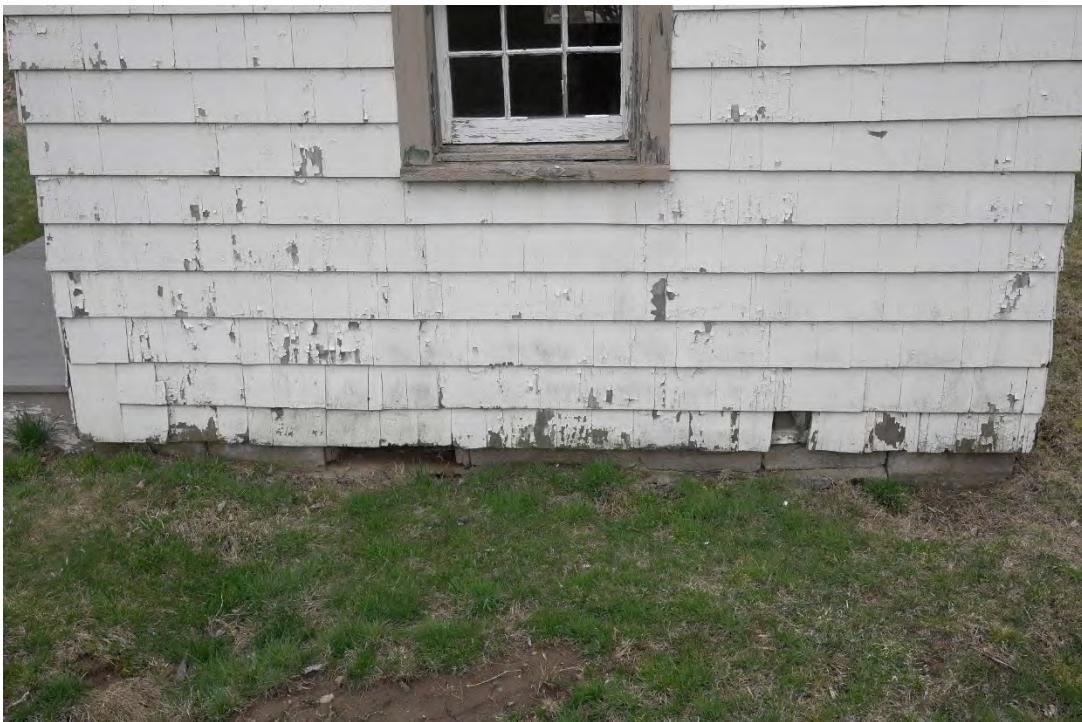
Mather Homestead – Playhouse - Exterior Details

Peeling Paint on Siding and Trim; Deteriorated Wood on Window Sash and Trim; Missing Shingle at Base of Wall

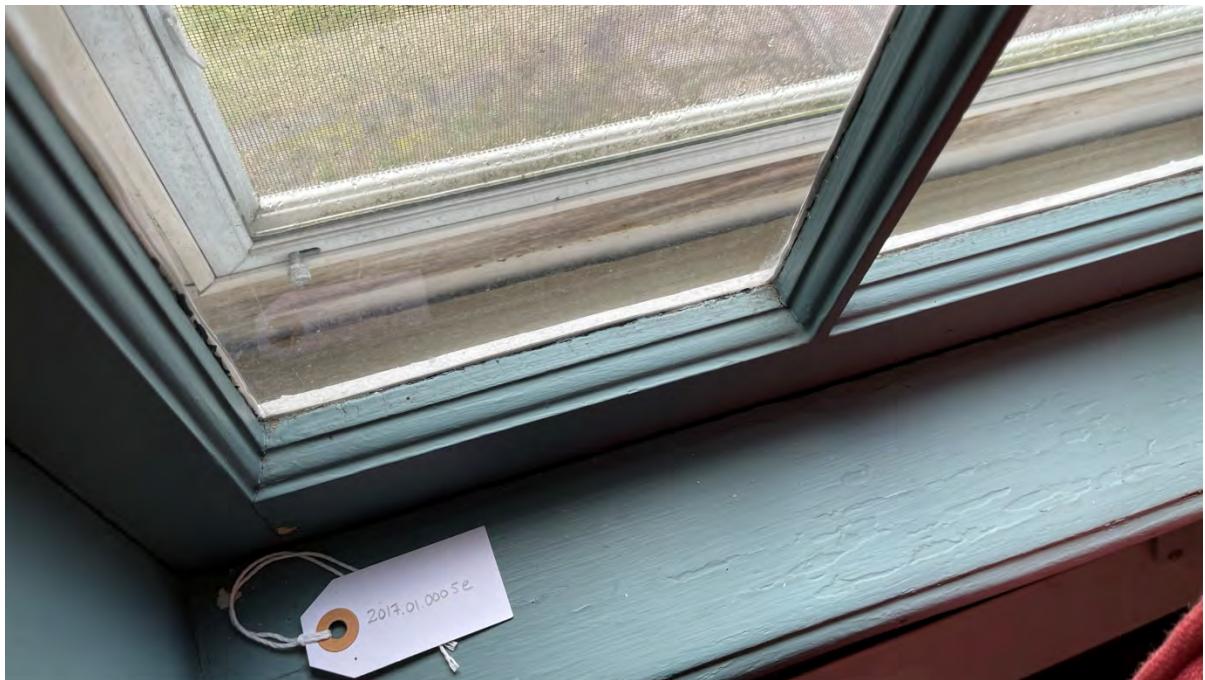
Mather Homestead – Mather House – Original Block - Interior Details

Damaged Storm Window

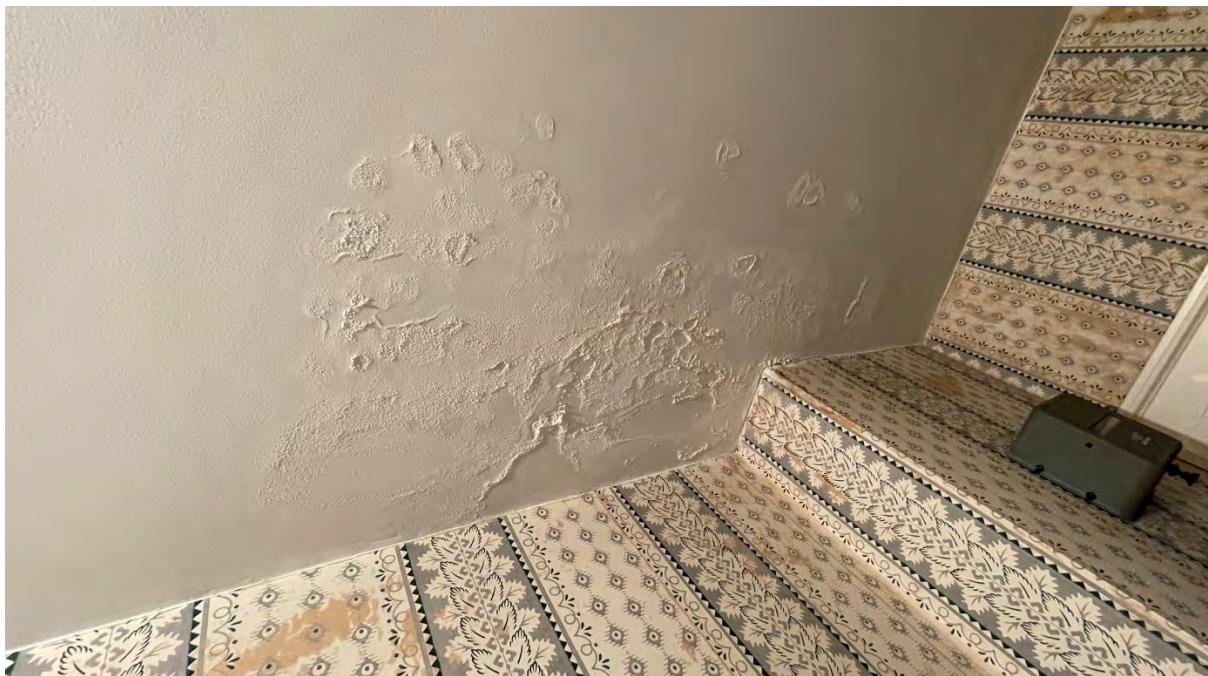
Mather Homestead – Mather House – Original Block - Interior Details
Second Floor – North Hall
Damage from Previous Leak

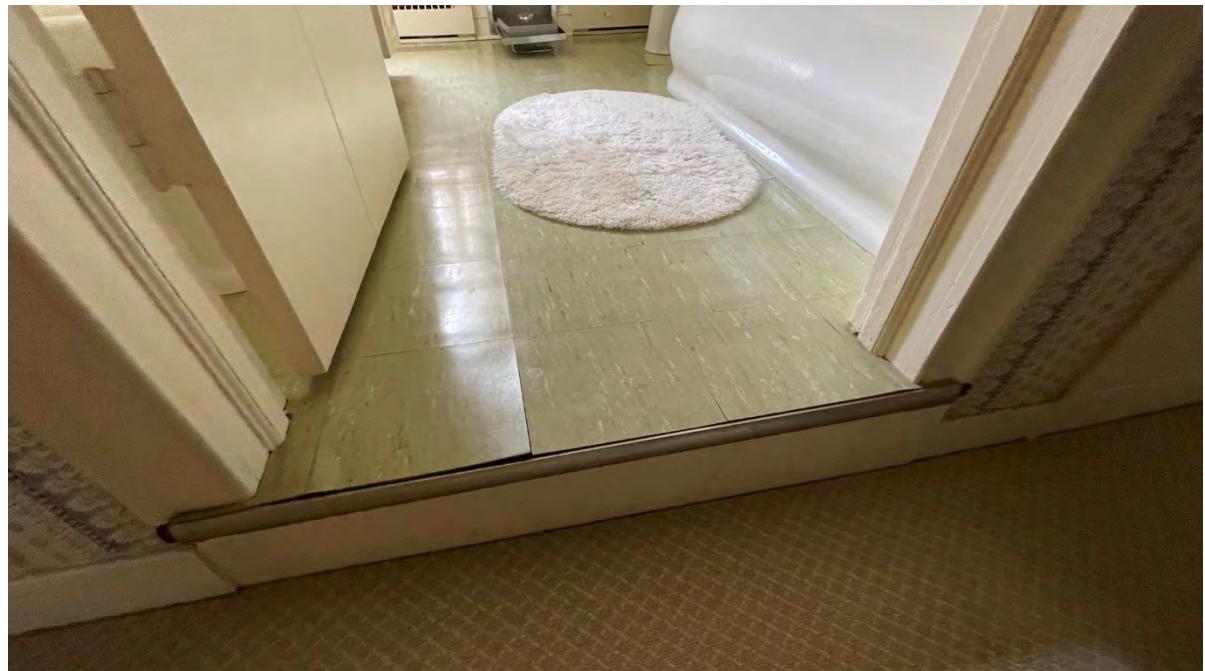
Mather Homestead – Mather House – Original Block - Interior Details
Second Floor – Bathroom
Step Up, Lifting Resilient Flooring

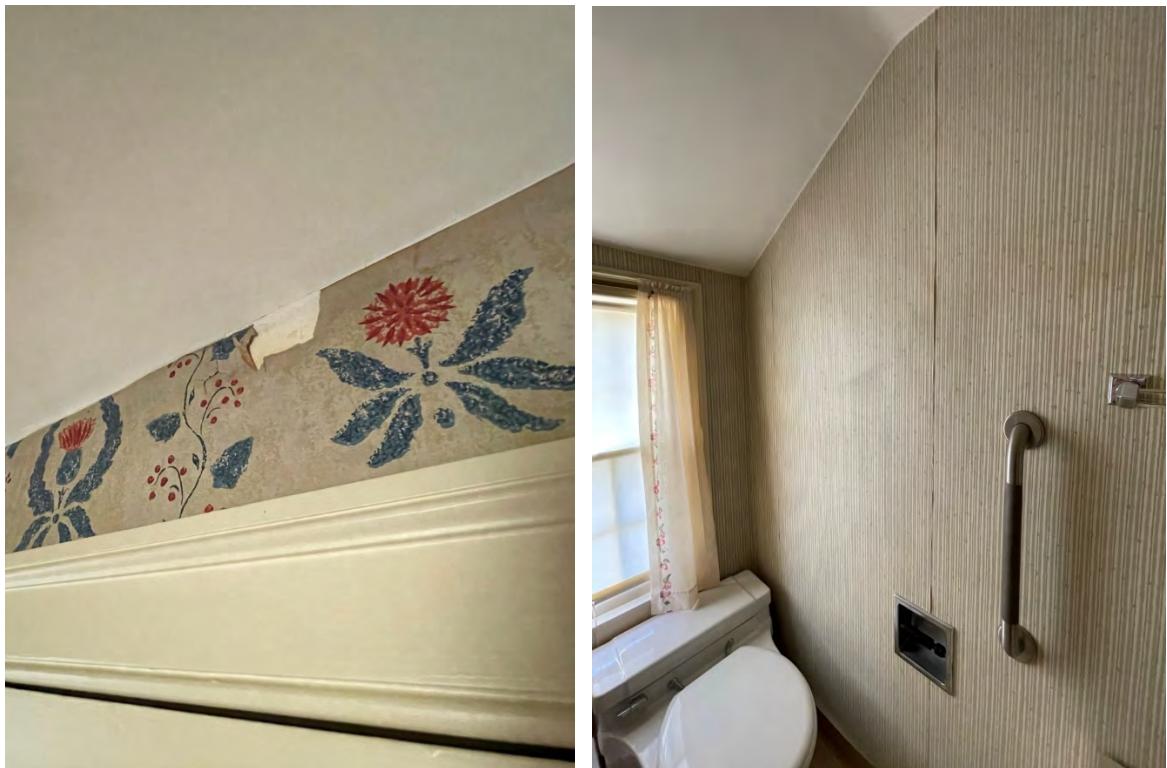
Mather Homestead – Mather House – West Porch Addition - Interior Details
Second Floor – Left: Hall Leading to Archive Room - Right: Bathroom
Damaged Wall Covering

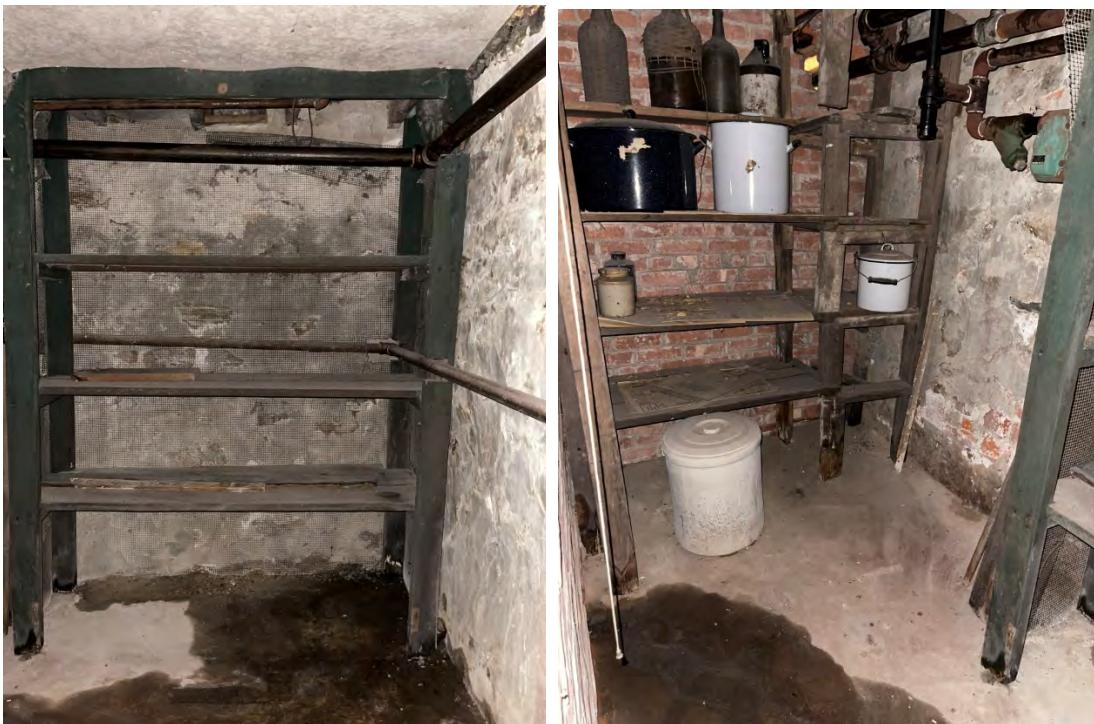
Mather Homestead – Mather House – Original Block - Interior Overalls
Basement – East Side of Chimney – Brick-Enclosed Room
Moisture on Floor Slab

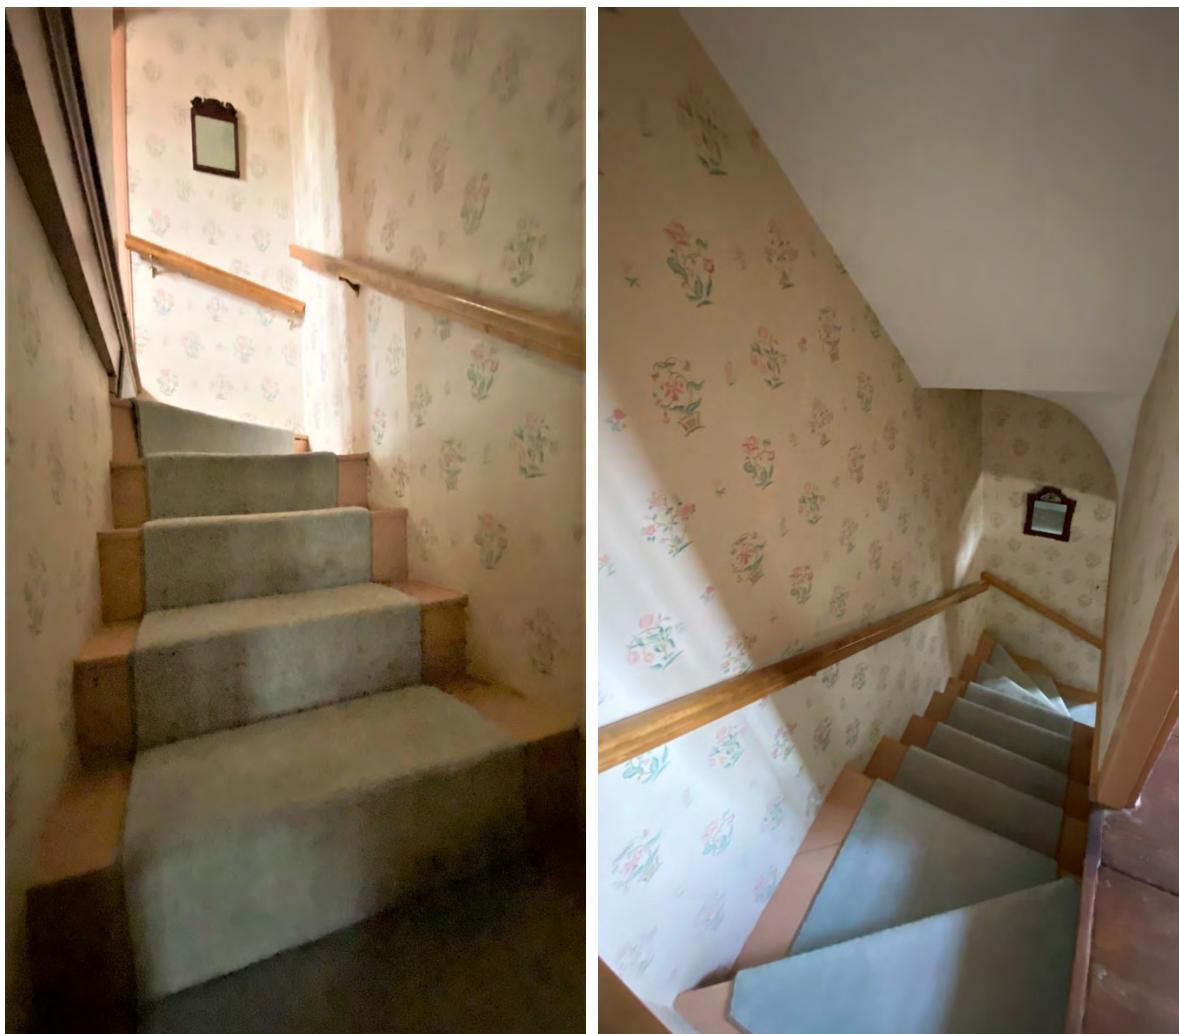
Mather Homestead – Mather House – ADA and General Access Review
First Floor – Stairs to Second Floor – Left: Looking Up; Right: Looking Down
Dark and Challenging for Some – Non-ADA-Compliant
