MATHER HOMESTEAD CULTURAL LANDSCAPE REPORT

Mather Homestead Foundation
Draft for Review
January 2024

Heritage Landscapes LLC
Preservation Landscape Architects & Planners
Charlotte, Vermont & Norwalk, Connecticut

In 2023, the Mather Homestead Foundation commissioned Heritage Landscapes to prepare a thorough Mather Homestead Cultural Landscape Report (CLR) for this historically significant site. The CLR research findings indicate that originating as a productive, subsistence-based landscape, the Mather Homestead steadily evolved from its conception in 1778 to the present day. The property was designated as a National Historic Landmark in 1963 and inscribed on the National Register of Historic Places in 1966, with a boundary amendment in 1978.¹ The 1963 nomination notes its significance for its association

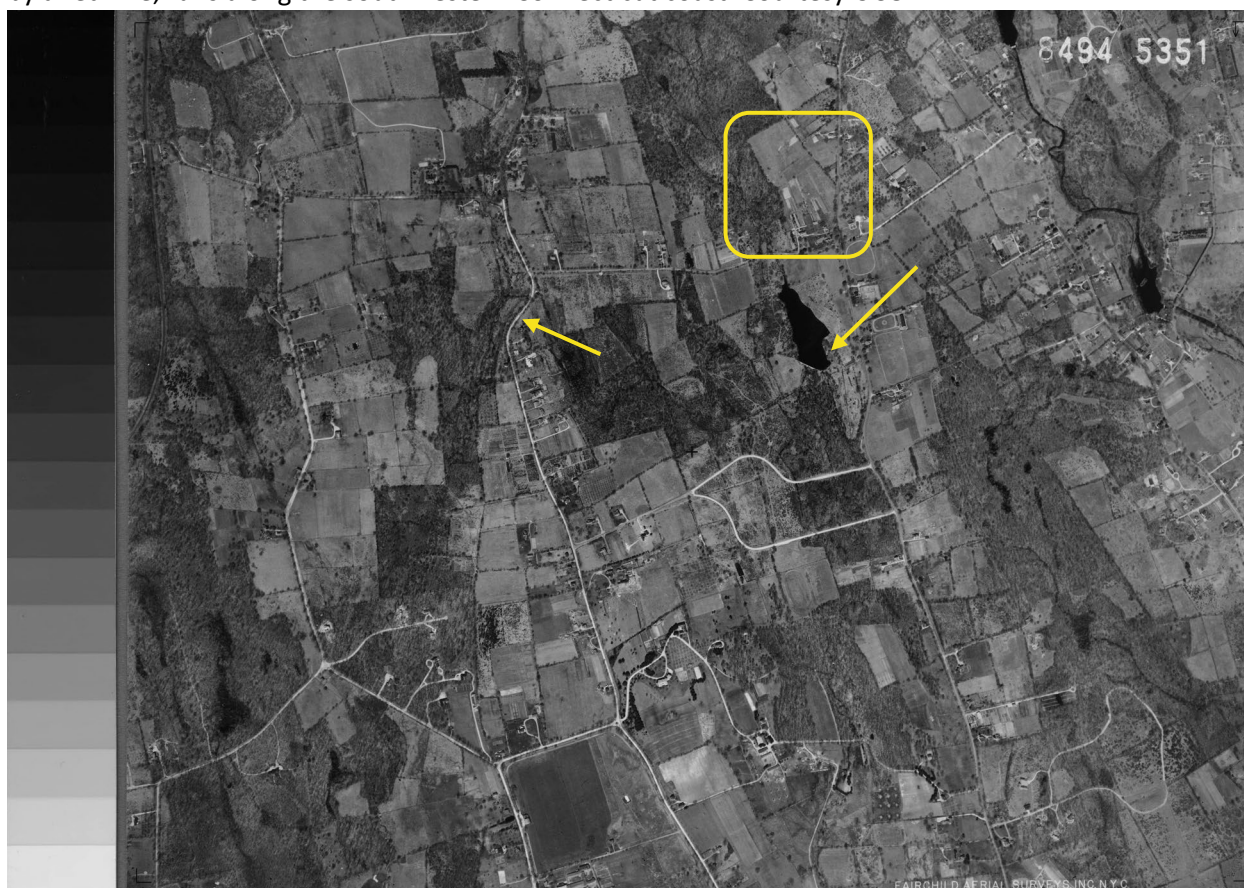
Figure 2.7 This overall 1934 aerial shows the development of Darien in the early to mid-twentieth century. The Mather Homestead is highlighted in a yellow square. To the south, Mathers Pond is visible as a dark oblong shape. To the west, the north-south spine of Mansfield Avenue (Route 124) appears. The landscape of this northeastern corner of Darien is a patchwork of residential properties, fields, and woodlands, woven together by networks of streams and roads. Courtesy CT State Library.

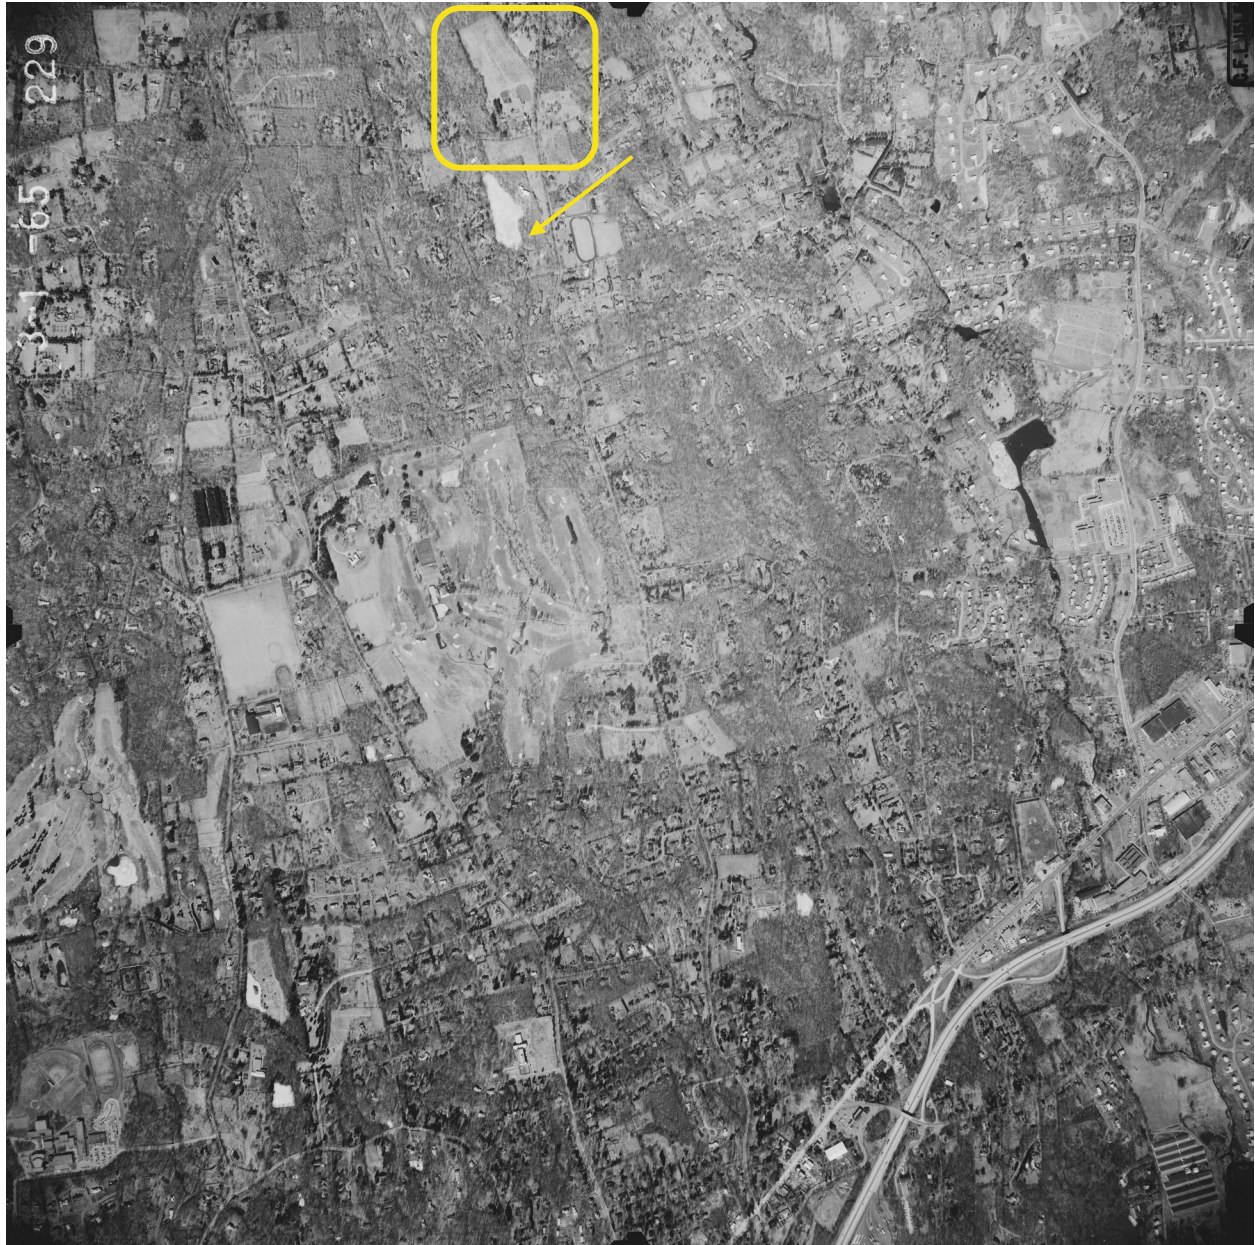
Figure 2.8 This 1965 aerial photograph of Darien captures the addition of the Country Club of Darien, located southwest of the Mather Homestead, signifying the rising socioeconomic status of the town. The Homestead is highlighted in a yellow square. To the southeast, the wide corridor of I-95 appears, with the narrow Old Post Road running nearly parallel to the north. Courtesy CT State Library.

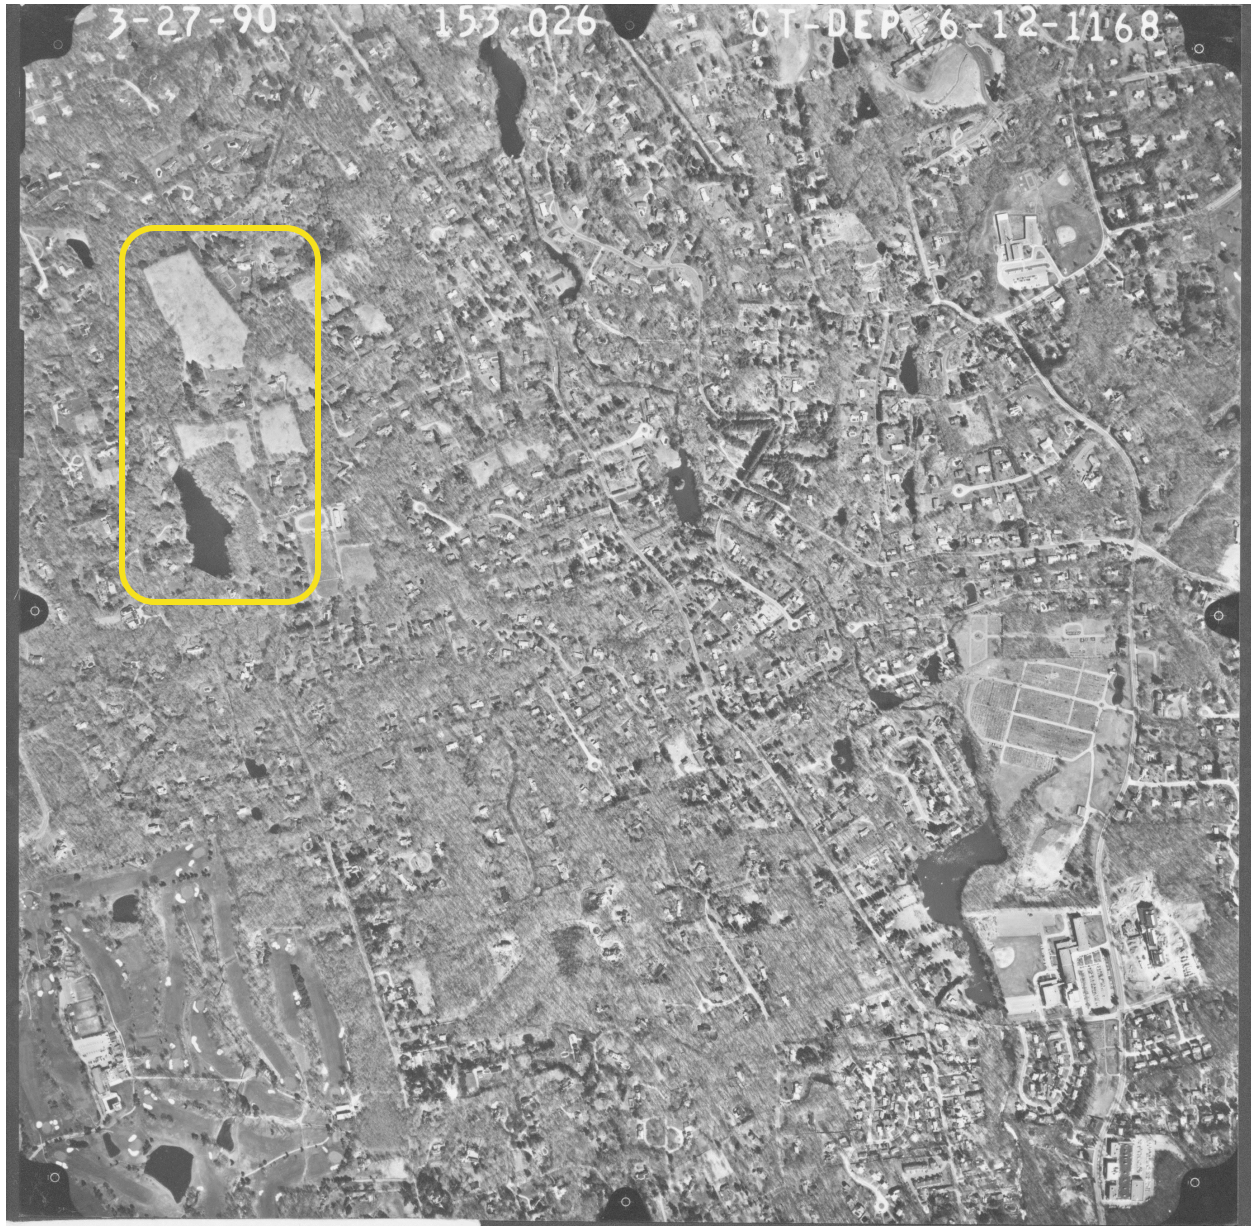
Figure 2.9 1990 aerial of Darien. The Mather Homestead and pond are highlighted in a yellow rectangle. Like in the 1965 photograph, the fields to the north of the Main House and across Stephen Mather Road to the south remain undeveloped. Courtesy UCONN.

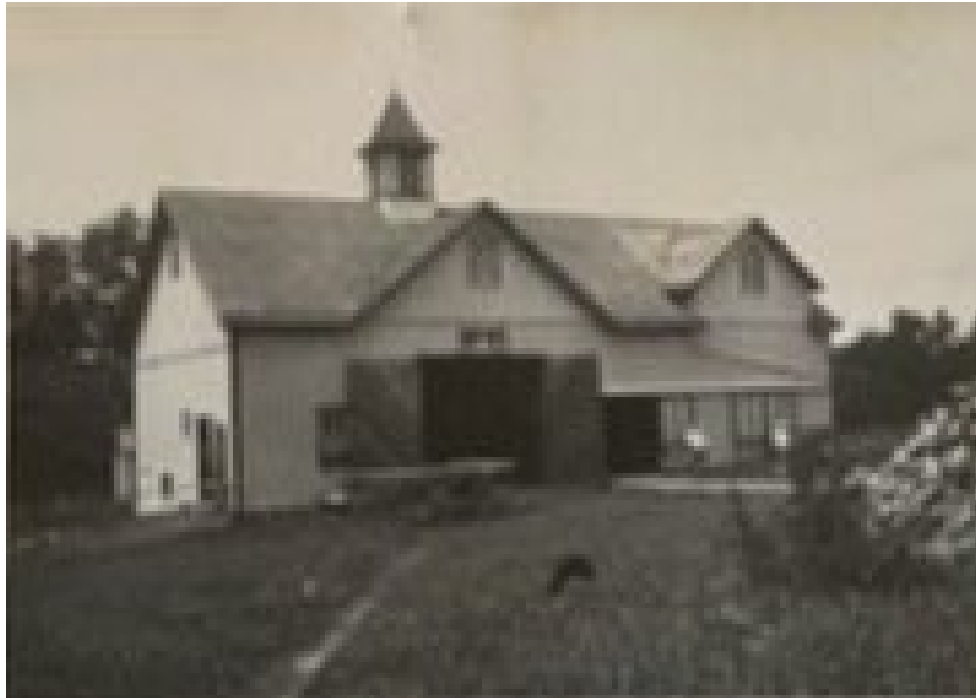
Figure 2.16 Circa 1900 photograph of the barn built by Joseph Wakeman Mather and William F. Mather. This original barn was located 120 feet west of the Main House. Courtesy MHF.

In 1891, Joseph Wakeman Mather and his brother, William F. Mather, built a new barn to replace the existing structure, which dated to Deacon Joseph Mather's late 1770s or subsequent decades in the early construction of the Homestead. This new barn was sited approximately 120 feet west of the Main House (**Figures 2.16 and 2.17**).⁴³

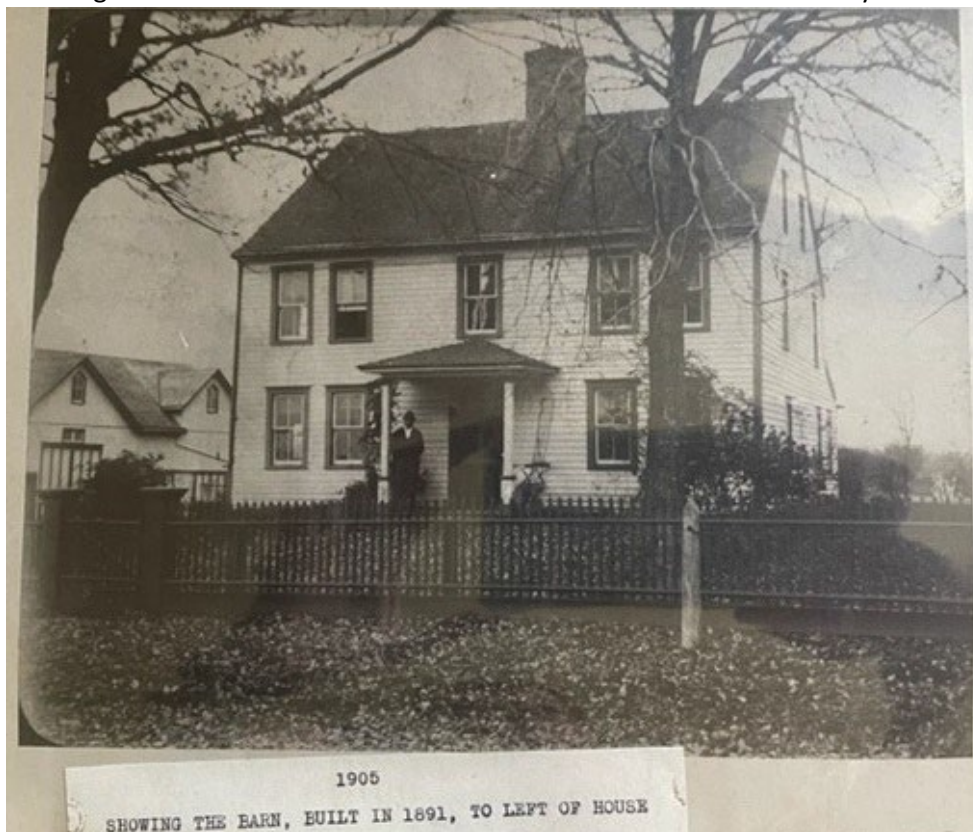
Figure 2.17 Circa 1905 photograph of house. Joseph Wakeman Mather's 1891 barn is present to the west (left). Fallen leaves cover the ground plane and several shrubs appear around the house. A vine climbs the west side of the portico. Courtesy MHF.

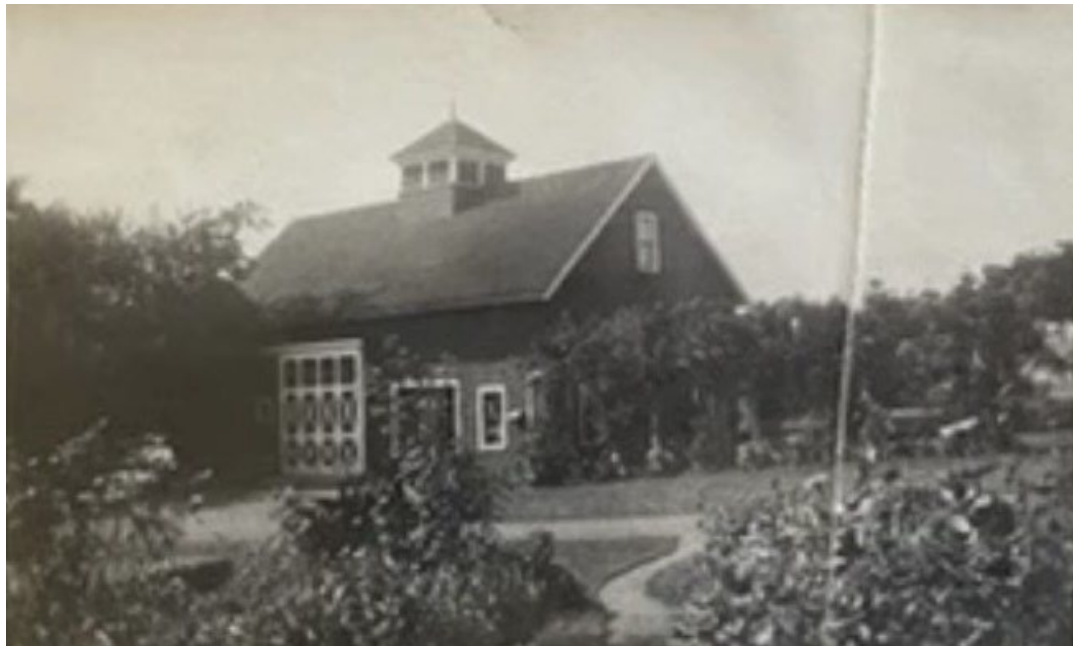
Figure 2.21 Circa 1910 photograph of the barn built by Stephen Tyng Mather in 1906, viewed from the southeast. Courtesy MHF.

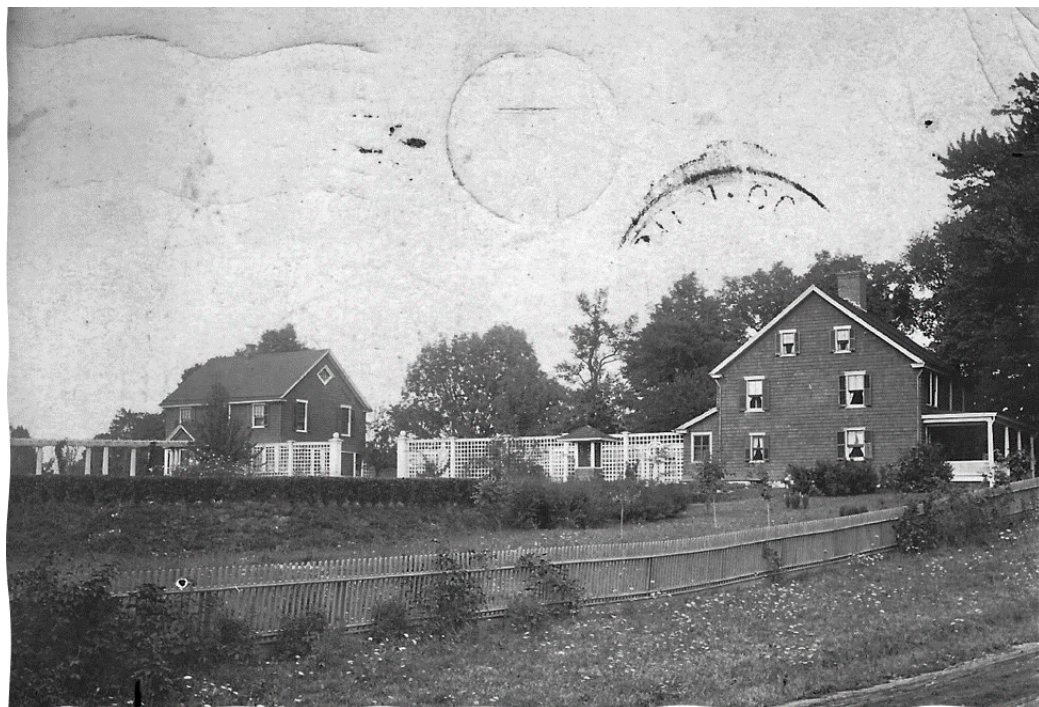
Figure 2.26 Circa 1912 photograph capturing the west façade of the house, viewed from the road. A low hedge and other plantings on a west axis with the house are likely part of Walter Burley Griffin's Sunken Garden design. Vining plants climb the picket fence in the foreground. Courtesy MHF.

Most of the alterations to the Homestead made by Stephen Mather in 1906 are documented in subsequent photographs. A circa 1912 photograph shows the west house façade and the adjacent lawn and garden as seen from Stephen Mather Road (**Figure 2.26**). A white latticework trellis extends north from the Main House and the guest house, with a wide opening where the gravel entry drive passes through. A wooden pergola extends west from the guest house, visually enclosing the garden from the rest of the property. The tall canopy heads of deciduous trees along Stephen Mather and Brookside Roads are seen behind the Main House. A second ca. 1912 photograph captures the Sunken Garden, where Jane and Bertha Mather are pictured with another woman and young boy (**Figure 2.27**). A circa 1910-15 photograph of Bertha Mather and a friend with her pony captures in the background the pergola extending from east to west between the barn and the caretaker's cottage (**Figure 2.28**).

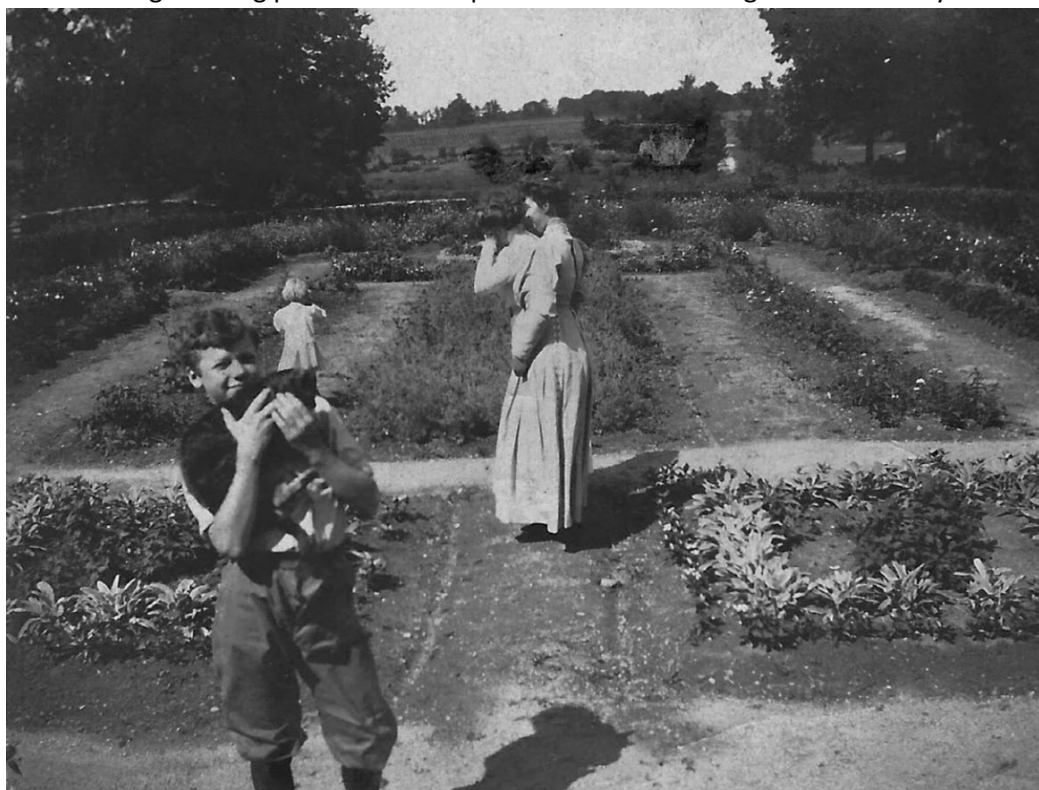
Figure 2.27 1912 photograph of Jane F. Mather and Bertha Mather (child), with another woman and young boy, in the Sunken Garden designed by Walter Burley Griffin. Square and rectangular beds occupy the center of the garden. Courtesy MHF.

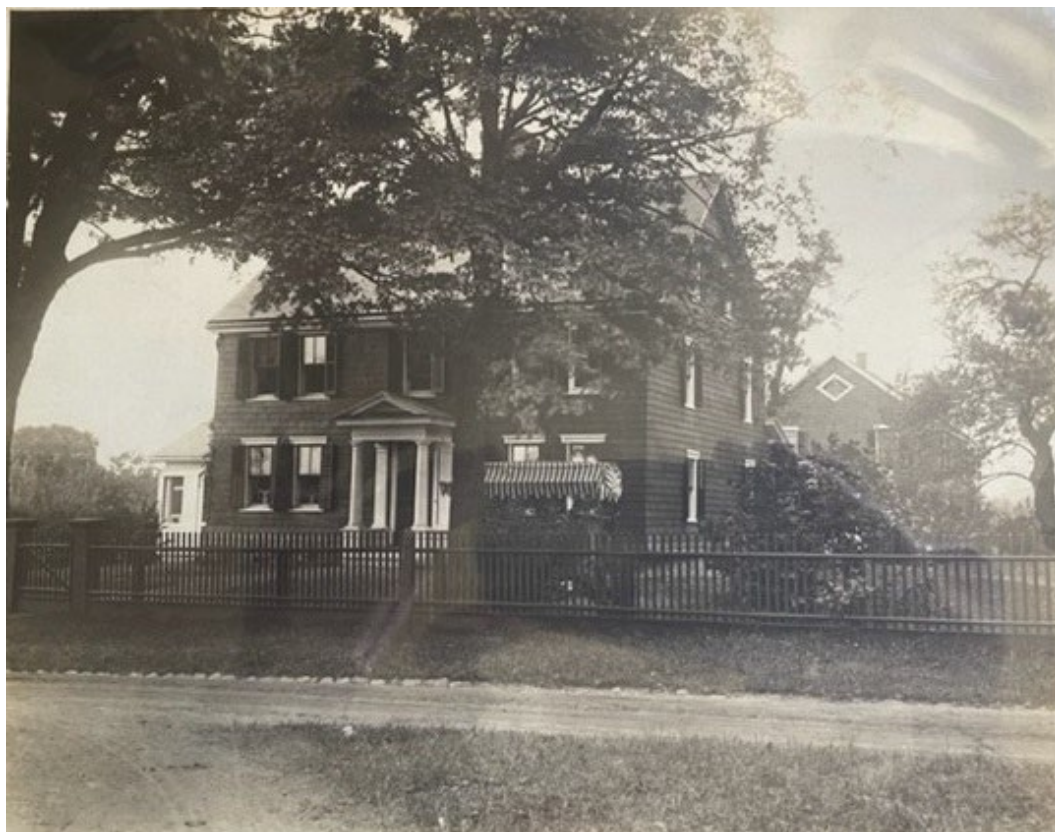
Figure 2.29 A circa 1915 photograph captures the landscape setting of tilled turf, deciduous trees and gravel drive as well as recent alterations to the house with a redesigned front entry portico and a one-story porch on the west side of the house. Note the cobble stone lined road edge. Courtesy MHF.

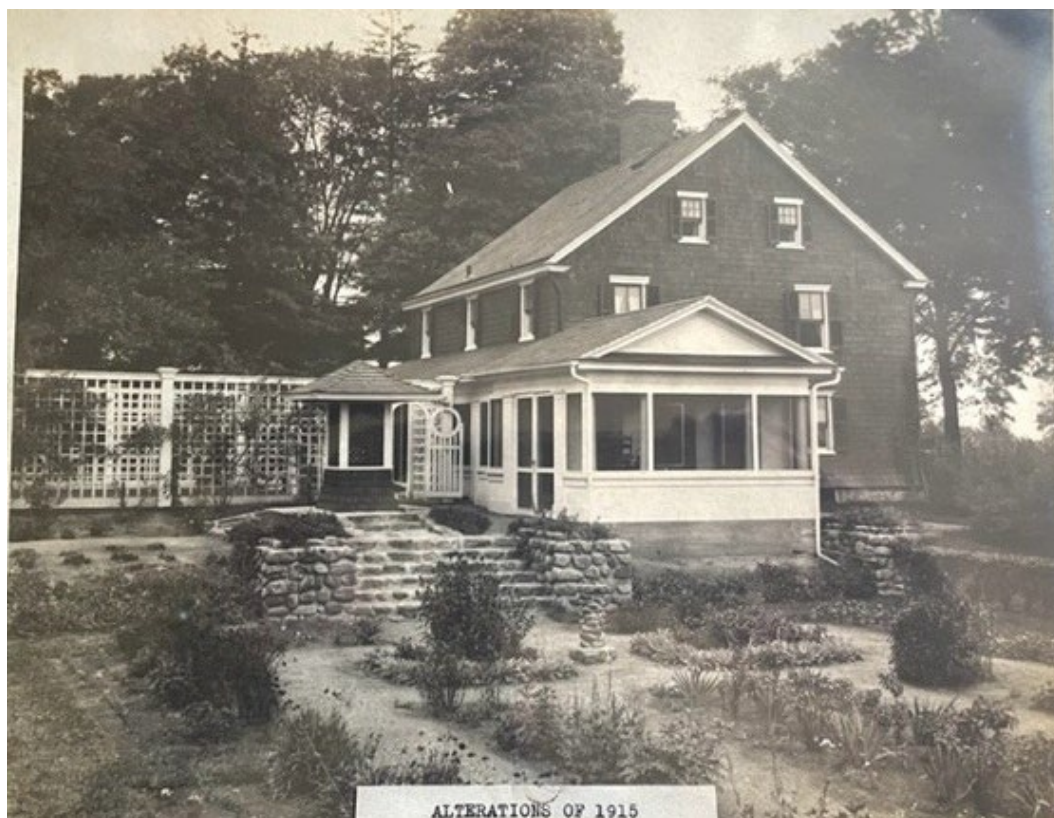
Figure 2.30 Circa 1915 photograph of the west side of the house shows the newly constructed one-story screened porch and the as-constructed Walter Burley Griffin garden with geometric beds. Courtesy MHF.

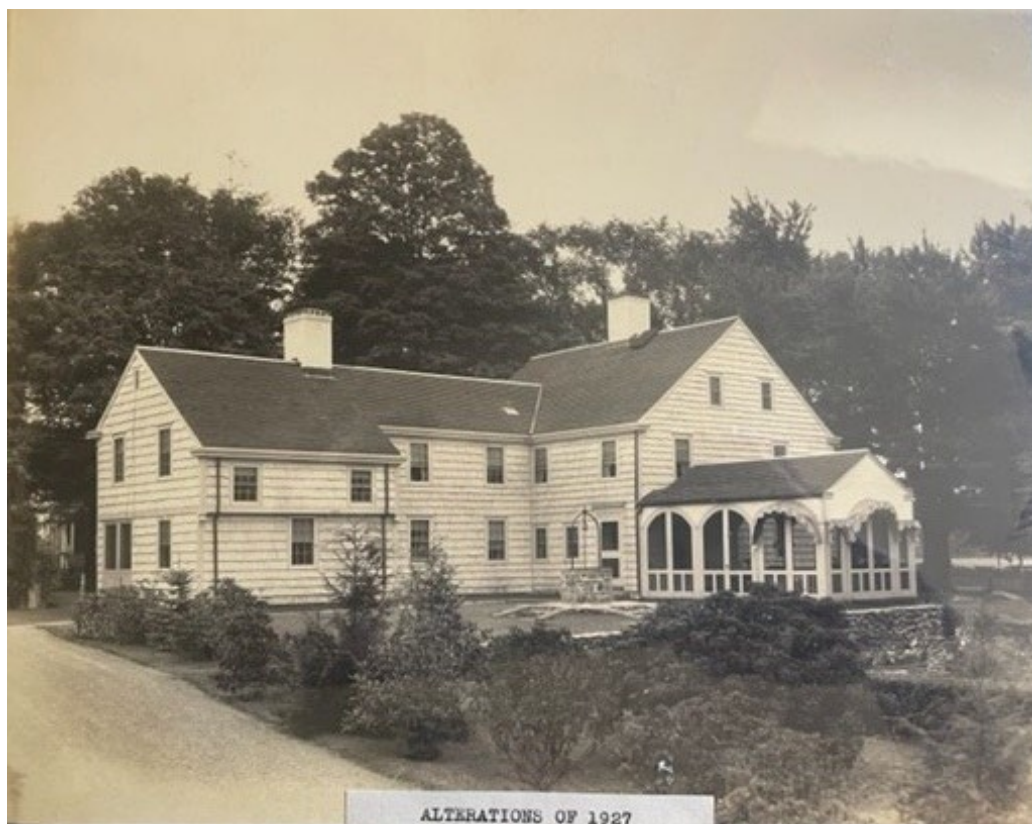
Figure 2.34 This ca. 1927-35 photograph of the house captures the new stone-and-iron wellhead, having replaced the 18th-century wooden wellhouse. The 1927 alterations completed by Stephen Tying Mather and architect Thomas Harlan Ellett are shown, including a two-story addition (left) and a redesigned side porch. A bed of small evergreen trees and shrubs lines the gravel driveway. Courtesy MHF.

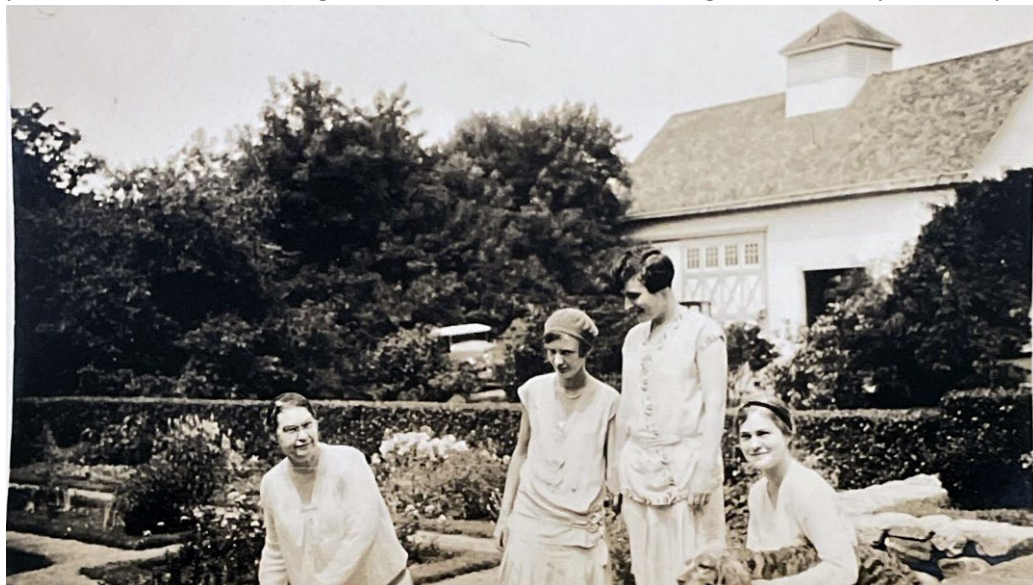
Figure 2.35 This 1927 photograph captures Jane F. Mather (left), Bertha Mather (right), and two other women in the Sunken Garden. The geometric beds are clearly defined by gravel paths running between them. The flat-topped hedge around the garden is relatively low, allowing clear views to the barn and a Ford Model T appear in the background. Courtesy MHF.

In Stephen Mather and T.H. Ellet's 1927 alterations, a two-story wing was added to the north side of the house, greatly expanding the overall building footprint. The addition of this north wing replaced the latticework trellis which had previously extended over the driveway to the caretaker's cottage. Other changes included a remodeled west porch and the replacement of the historic wooden wellhouse with a stone-and-iron wellhead, shown in a ca. 1927 photograph taken from the Sunken Garden (**Figure 2.34**). Another ca. 1927 image of the garden shows Jane Mather, Bertha Mather, and two other women in the garden; Stephen Mather's barn and a Ford Model-T appear in the background (**Figure 2.35**).

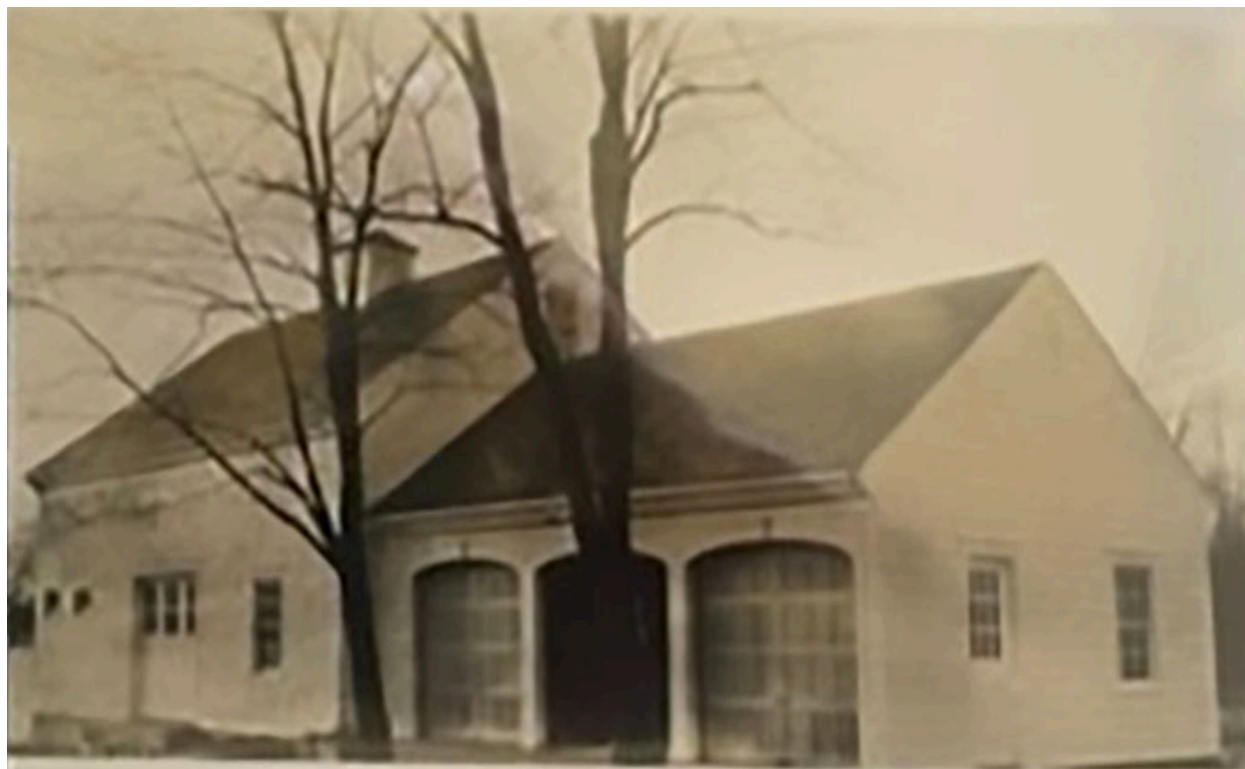
Figure 2.36 Barn built by Stephen Tyng Mather, circa 1929. Two existing deciduous trees appear in front of the south façade of the three-car attached garage. Courtesy MHF.

In 1929, Stephen Mather oversees the construction of a new barn further west.⁵⁶ The construction of this barn is captured in a circa 1929 Mather family video, which shows both Stephen and Bertha Mather on site during the process. The new barn had an attached three-car garage (**Figure 2.36**).

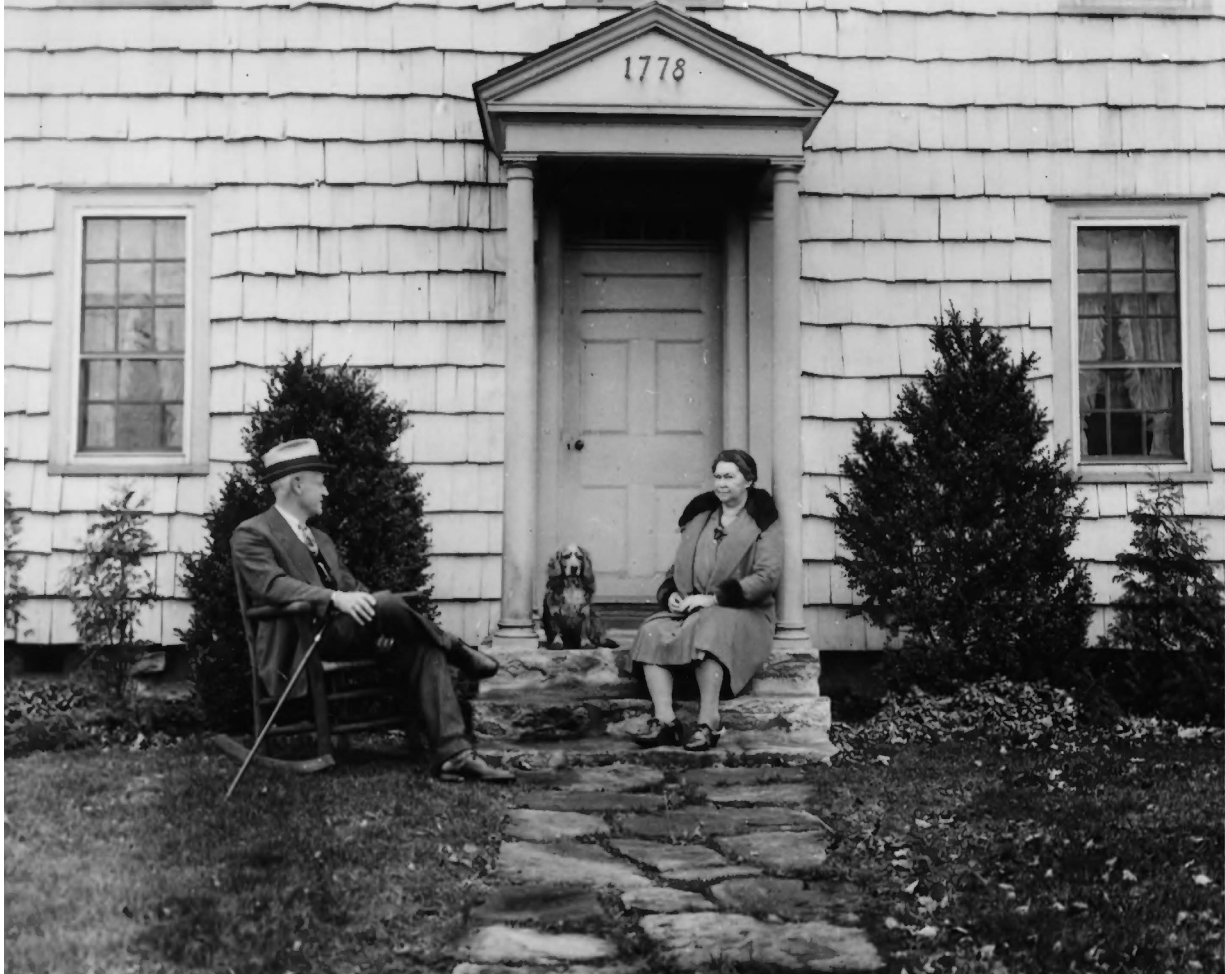
Figure 2.37 1929 photograph of Stephen Tying Mather and Jane Thacker Floy seated in front of the Mather Homestead. Evergreen shrubs of various sizes are planted along the foundation. A mosaic flagstone path leads from the gate and up two steps to the front door, surmounted by the 1916 redesigned portico. Courtesy MHF.

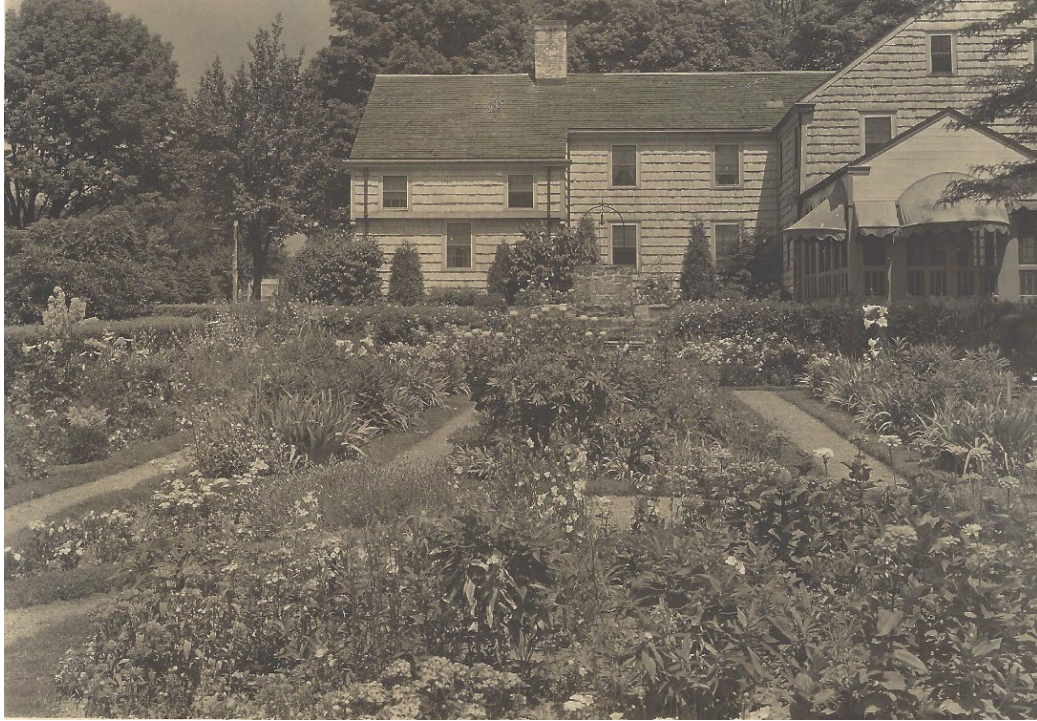
Figure 2.38 Circa 1929 photograph of the Walter Burley Griffin Sunken Garden, facing east toward the house. The two-story wing, added in 1927, blocks the view between the garden and Brookside Road. Courtesy MHF.

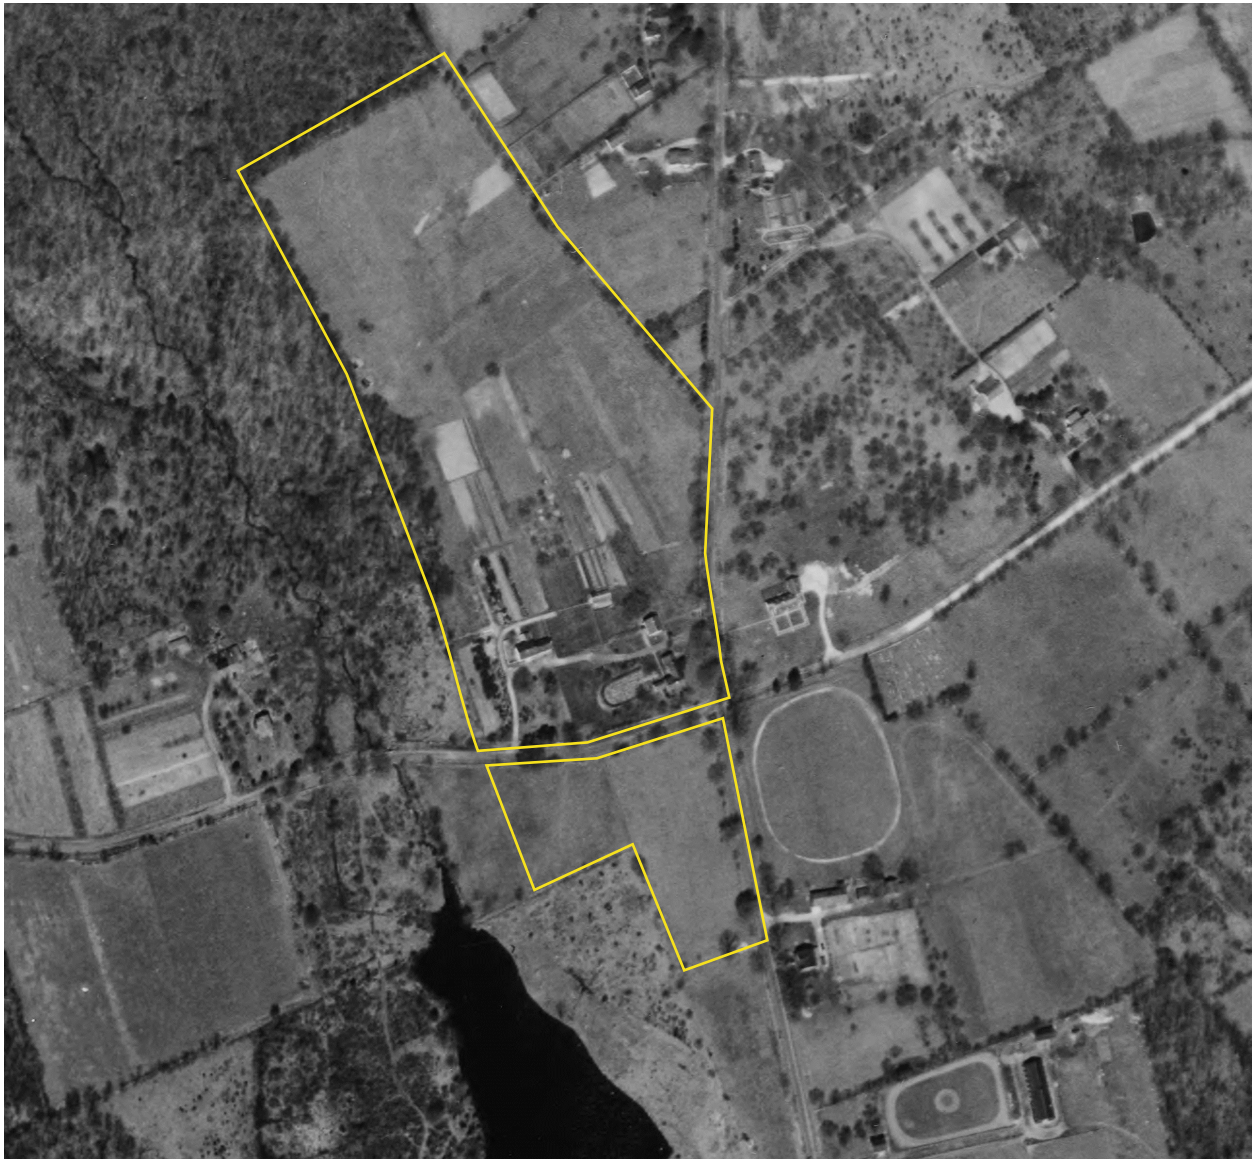
Figure 2.42a A detail of the 1934 aerial shows the Mather Homestead and adjacent properties. The outline shows the Homestead property according to the 1901 survey of Joseph W. Mather's property. Courtesy CT State Library.

An aerial photograph from 1934 captures the Mather Homestead landscape four years after Bertha Mather took ownership of the property (**Figure 2.42**). Structures on the property include the Main House, caretaker’s cottage, greenhouse, and barn. A patchwork of fields that extends north of the core property indicates ongoing productive land use. To the east along Stephen Mather Road, the house designed by Bertha Mather for Grace Floy is present. The McPherson family’s activities extended beyond the core Homestead property. Bertha was known to ride horses in the parcel to the southeast; a worn path around the perimeter of this parcel can be seen in the 1934 aerial photograph. Mathers Pond, south of Stephen Mather Road, was used by the children for swimming and ice skating.⁵⁹

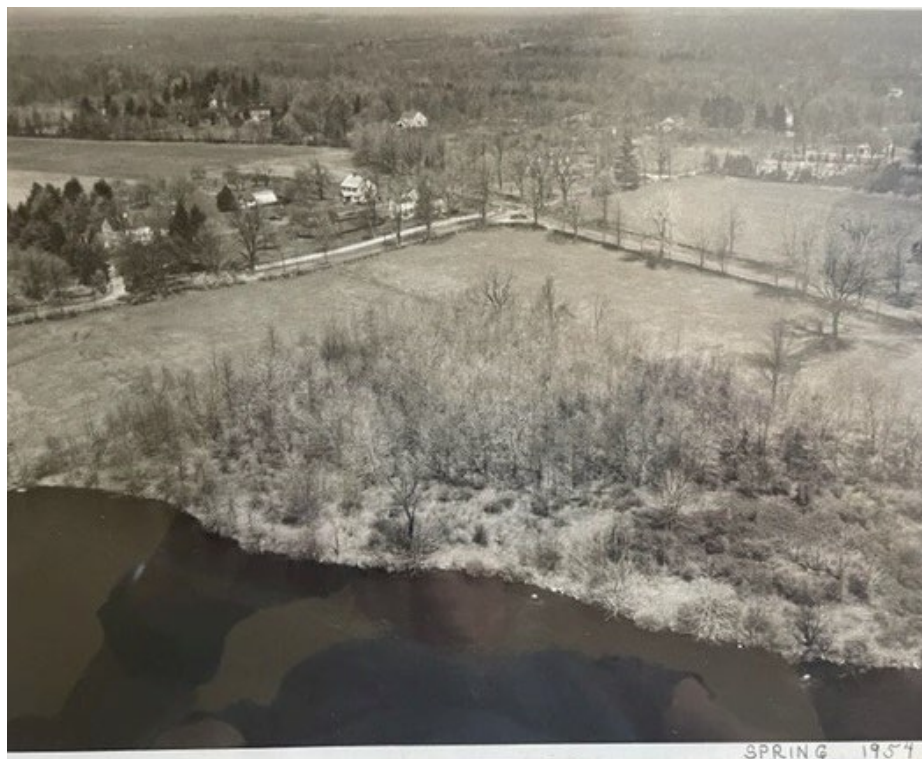
Figure 2.46 1954 oblique aerial photograph of the Mather Homestead in context. Mathers Pond is seen to the southwest, at the bottom of the image. Stephen Mather Road extends east from the left side of the image, and Brookside Road extends north from the right side. The Homestead is situated on the north side of Stephen Mather Road. Courtesy MHF.

Productive use of the Mather Homestead landscape continued into the 1940s. Anne Tracy, the oldest of Bertha McPherson's children, recalls the Homestead property as a farm having a horse, a cow, and a vegetable garden.⁶³ The primary vegetable garden was located north of the caretaker's cottage and extended north in a rectilinear bed. Apple orchards were also present north of the Main House.⁶⁴ A circa 1944-45 photograph shows Stephen Mather McPherson, son of Bertha and Edward McPherson, on a horse pulling a plow (**Figure 2.44**). A 1946 Sanborn fire insurance map shows the Main House, caretaker's cottage, greenhouse, and barn (**Figure 2.45**). An oblique 1954 aerial photograph captures landscape around these buildings and structures. Small trees are present north of the greenhouse. On the left side of the photograph, two linear stands of pines are present, one alongside the driveway and the other extending north of the barn (**Figure 2.46**). The greenhouse was razed in 1965, though the potting shed remained.⁶⁵

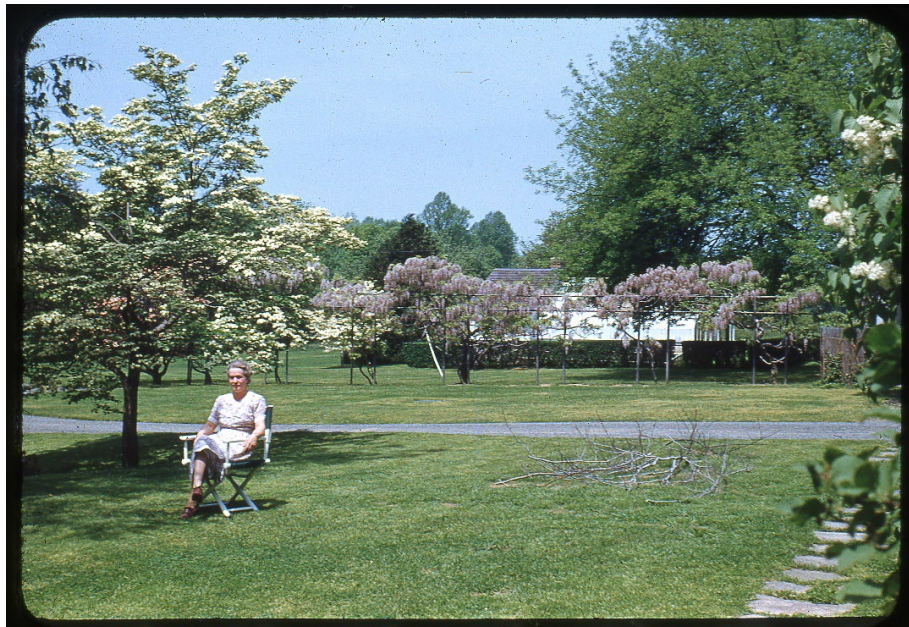
Figure 2.48 1951 photograph of the north view from the area between the Mather house and the Sunken Garden. A flagstone path leads to the gravel driveway. On the opposite side of the driveway, a pergola supports climbing wisteria. At the east end of the pergola is a wooden fence; a glimpse of the caretaker's cottage is visible. North of the pergola is a greenhouse and gable-roofed potting shed, flanked by a low hedge. A large canopy tree stands between the cottage and the greenhouse. Bertha Mather McPherson is seated in a lawn chair; a pile of branches likely indicates recent lawn seeding where a tree was removed. Courtesy MHF.

A series of photographs from 1951-56 capture Lilian Egleston's redesigned Sunken Garden as built, as well as some of Bertha Mather's alterations to the landscape. A 1951 photograph of Bertha seated in a lawn chair between the Sunken Garden and the Main House captures the wisteria pergola extending west from the guest house, a feature retained from Stephen Mather's era (**Figures 2.48 and 2.21**). A photograph from 1953 reveals more of the landscape north of the garden, with a mown lawn panel southwest of the children's playhouse. A linear bed of tulips bordered the west edge of the lawn north of the barn (**Figure 2.49**). A second 1953 photograph of the playhouse shows the difference between the maintained lawn in the play area and the rougher turf closer to the greenhouse; the latter structure is captured in a 1956 photograph (**Figure 2.50 and 2.51**). The Sunken Garden appears in another 1953 photograph with a central lawn panel and perimeter beds (**Figure 2.52**). The area between the Sunken Garden and Main House was surfaced with grass (**Figure 2.53**).

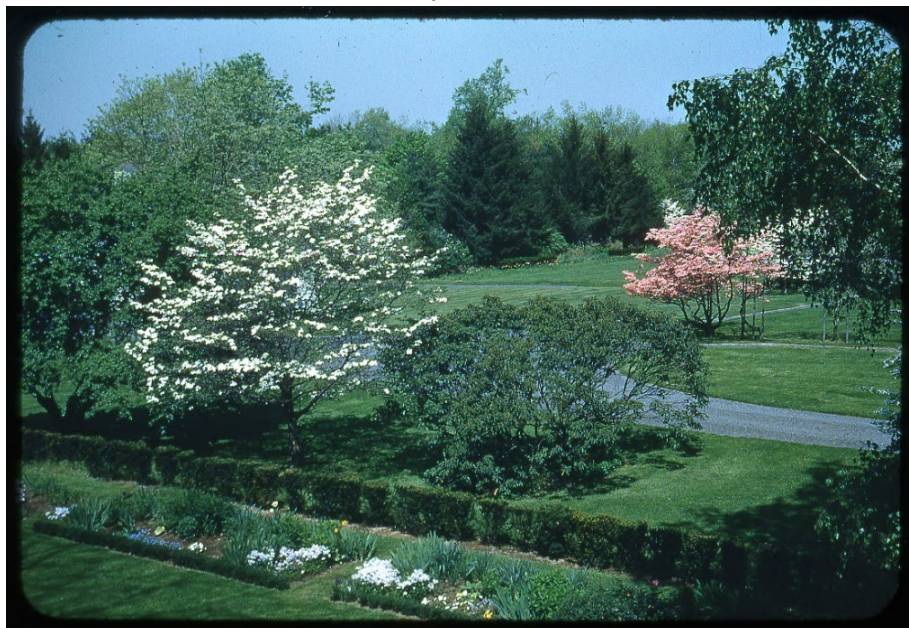
Figure 2.49 1953 photograph captures the northwest view from a window in the Main House, looking over the Sunken Garden. North of the driveway, an area of closely mown turf is bisected by a gravel path. This lawn may be associated with the playhouse, partially obscured by the pink flowering tree. At one point, a linear planting of tulips lined the lawn west edge adjacent to a row of evergreen trees. Birch tree branches near the Main House are visible on the right side of the image. Courtesy MHF.

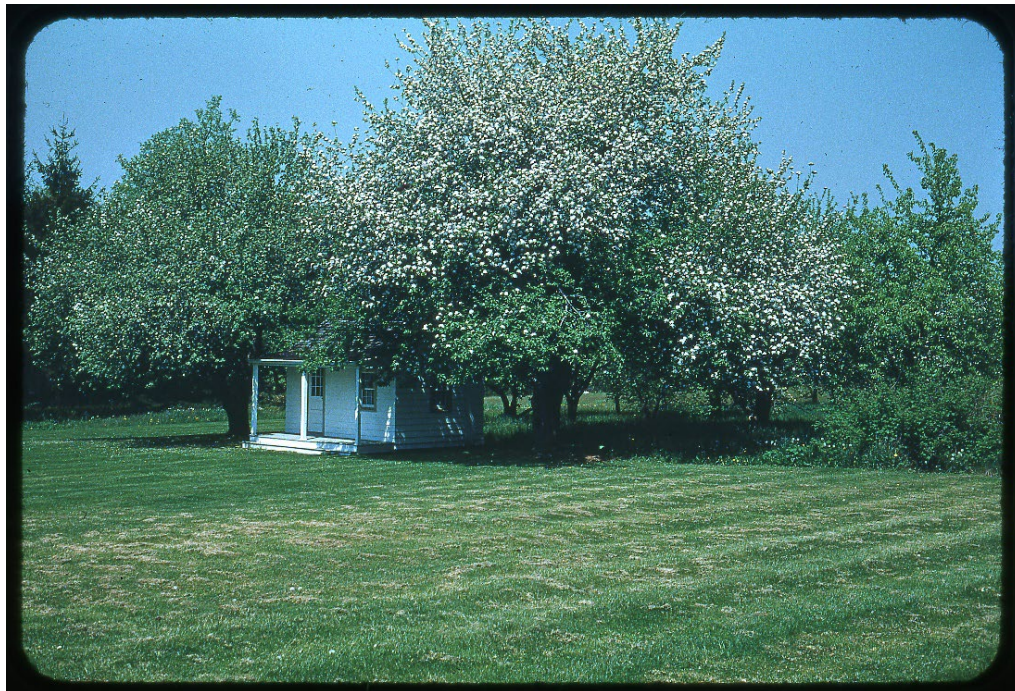
Figure 2.50 1953 photograph of the playhouse structure, located north of the barn. The playhouse was moved to this location in the late 1930s or early 1940s. Two flowering trees stand against the playhouse on either side. To the left, a strip of mown grass stretched north. An area of low shrubs is present to the right. Courtesy MHF.

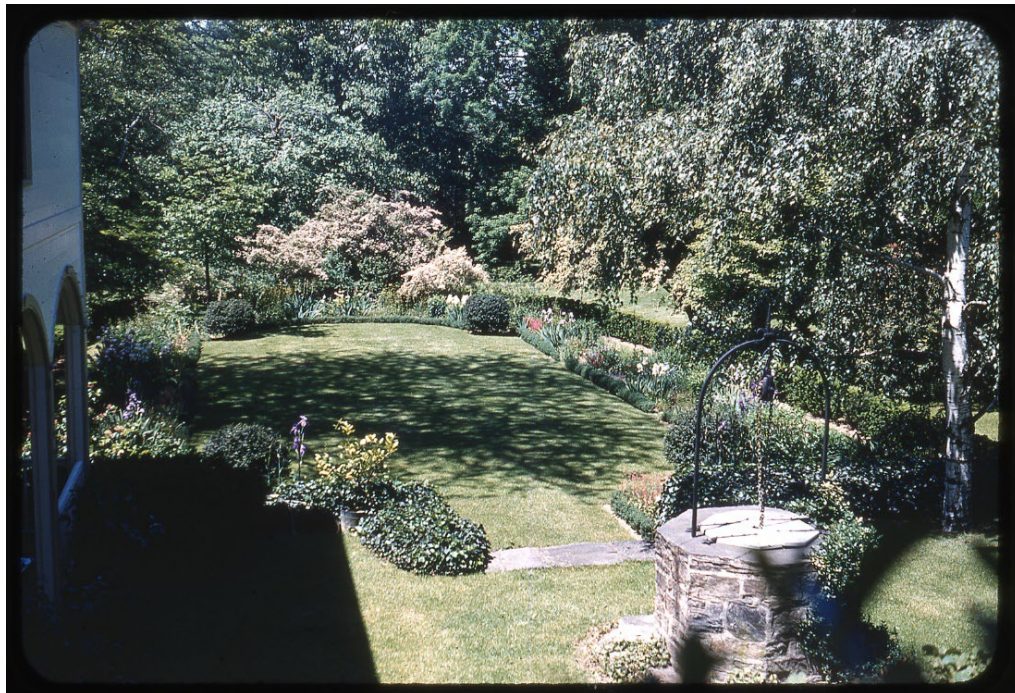
Figure 2.52 1953 photograph of the Sunken Garden with Lilian Egleston's design in place. The ground plane around the historic well is mown grass. A panel of mown grass occupies the center of the Sunken Garden, lined with planted beds of flowering perennials around the perimeter and enclosed by a low hedge. Courtesy MHF.
