MATHER HOMESTEAD CULTURAL LANDSCAPE REPORT

Mather Homestead Foundation
Draft for Review
January 2024

Heritage Landscapes LLC
Preservation Landscape Architects & Planners
Charlotte, Vermont & Norwalk, Connecticut

In 2023, the Mather Homestead Foundation commissioned Heritage Landscapes to prepare a thorough Mather Homestead Cultural Landscape Report (CLR) for this historically significant site. The CLR research findings indicate that originating as a productive, subsistence-based landscape, the Mather Homestead steadily evolved from its conception in 1778 to the present day. The property was designated as a National Historic Landmark in 1963 and inscribed on the National Register of Historic Places in 1966, with a boundary amendment in 1978.¹ The 1963 nomination notes its significance for its association

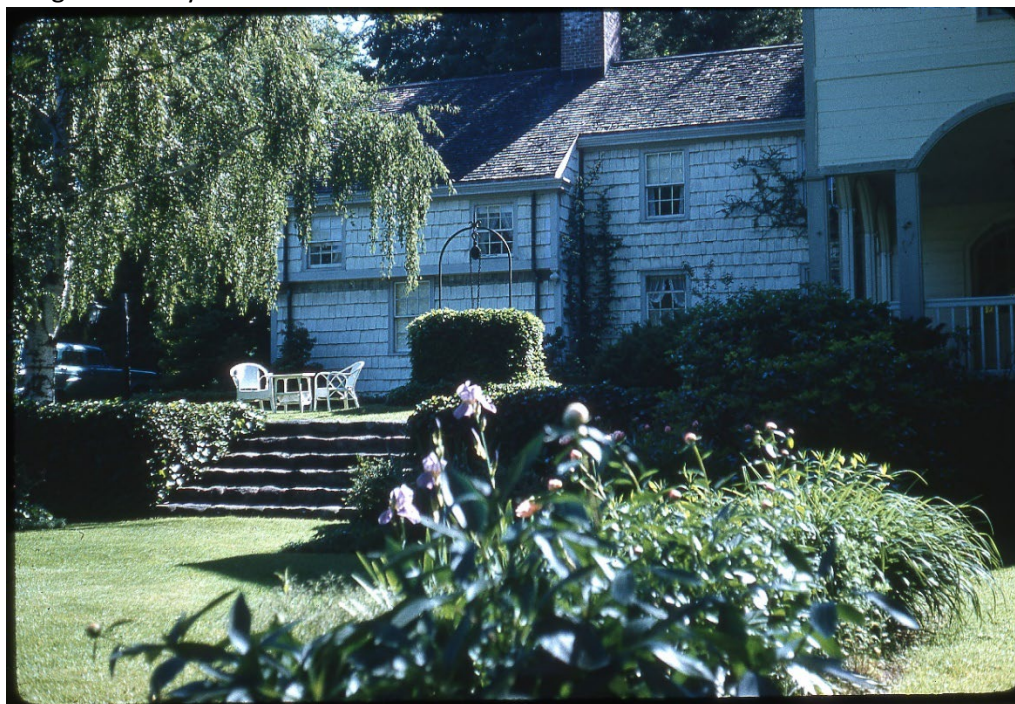
Figure 2.53 1960 photograph of the Main House, viewed from the Sunken Garden. The area between the garden and the house is surfaced with grass. Two white wicker chairs and a table are present beside the ivy-covered wellhead. Vines climb the house façade. A silver birch hangs over the north (left) side of the stone steps. In the foreground, one of the Sunken Garden beds is planted with iris. Courtesy MHF.

A series of photographs from 1951-56 capture Lilian Egleston's redesigned Sunken Garden as built, as well as some of Bertha Mather's alterations to the landscape. A 1951 photograph of Bertha seated in a lawn chair between the Sunken Garden and the Main House captures the wisteria pergola extending west from the guest house, a feature retained from Stephen Mather's era (**Figures 2.48 and 2.21**). A photograph from 1953 reveals more of the landscape north of the garden, with a mown lawn panel southwest of the children's playhouse. A linear bed of tulips bordered the west edge of the lawn north of the barn (**Figure 2.49**). A second 1953 photograph of the playhouse shows the difference between the maintained lawn in the play area and the rougher turf closer to the greenhouse; the latter structure is captured in a 1956 photograph (**Figure 2.50 and 2.51**). The Sunken Garden appears in another 1953 photograph with a central lawn panel and perimeter beds (**Figure 2.52**). The area between the Sunken Garden and Main House was surfaced with grass (**Figure 2.53**).

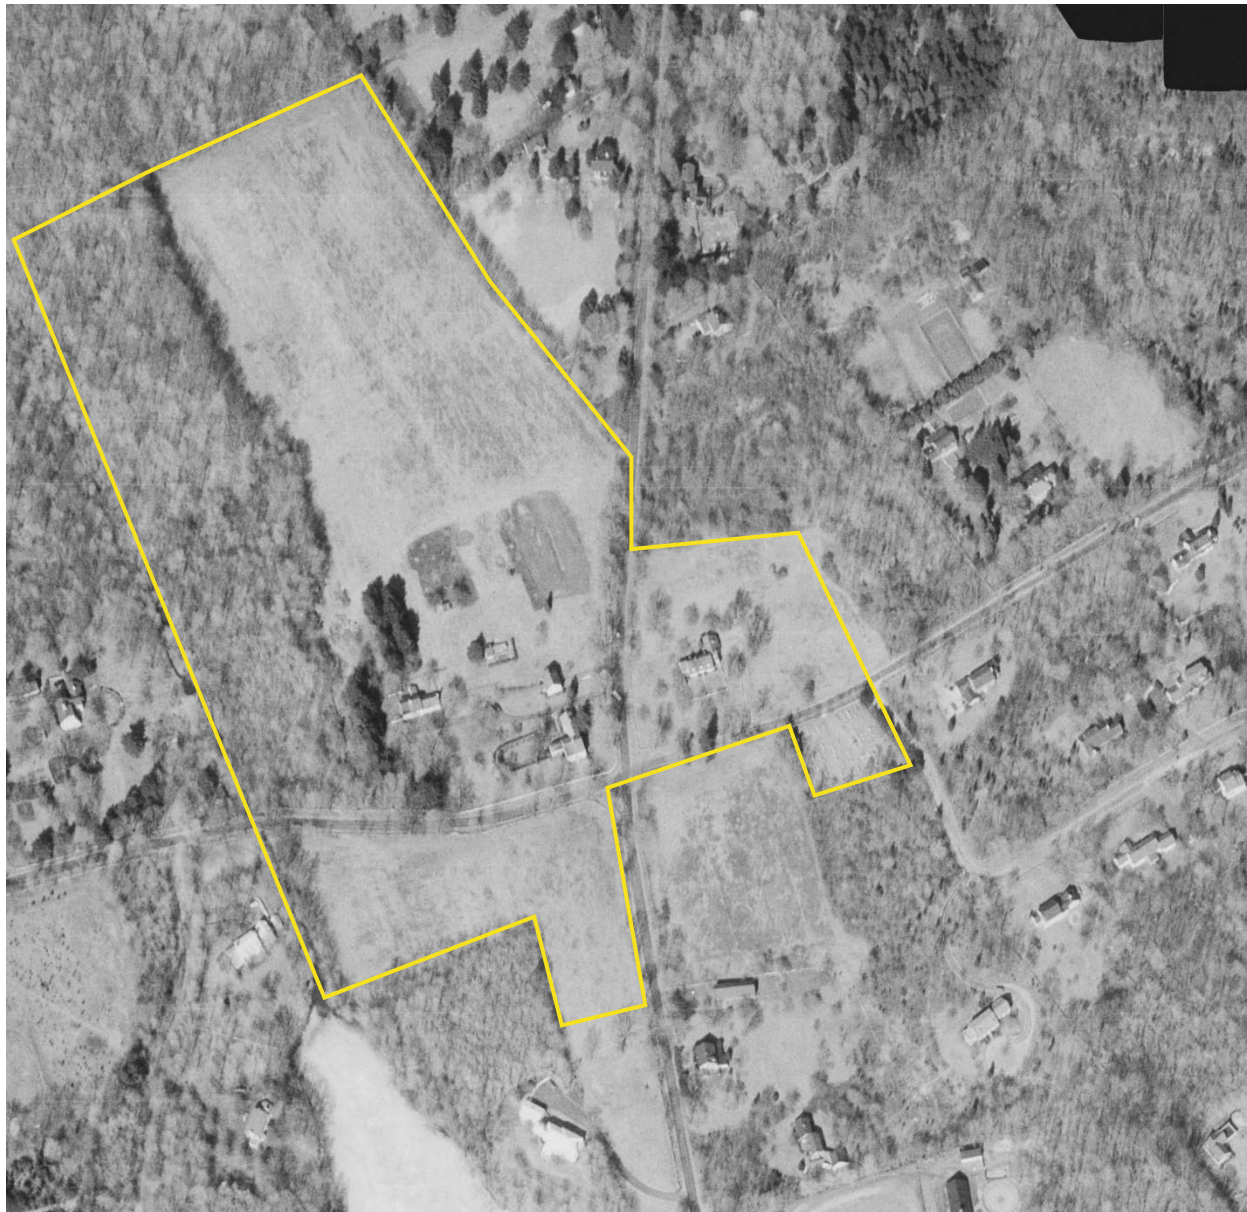
Figure 2.55a Detail of 1965 aerial showing the approximate Mather Homestead National Historic Landmark Boundary, as designated in the 1963 nomination form.⁷³ This leaf-off view clearly captures the linear plantings of evergreen trees along the west boundary of the core Homestead, as well as smaller evergreens near the Main House. Courtesy CT State Library.

A 1965 aerial photograph of the Homestead captures the diminishment of cultivated land in the north portion of the property. Of the formerly broad geometry of linear beds and orchards, only two quadrants remain: one directly north of the playhouse, and another directly north of the guest house (**Figure 2.55**). Photographs of the Mather Homestead from the late 1960s and 1970s show the Middleleer brick terrace as built, as well as other alterations to the house surrounds and broader landscape. A 1963 photograph shows the slate walk from the driveway to the terrace; a lamppost stands on the left side of the path. Within the terrace, a young tree is present, presumably the honey locust proposed in Middleleer's plans (**Figure 2.56**). Two photographs from 1969 show the completed brickwork, border plantings, and the maturing honey locust (**Figures 2.57 and 2.58**).

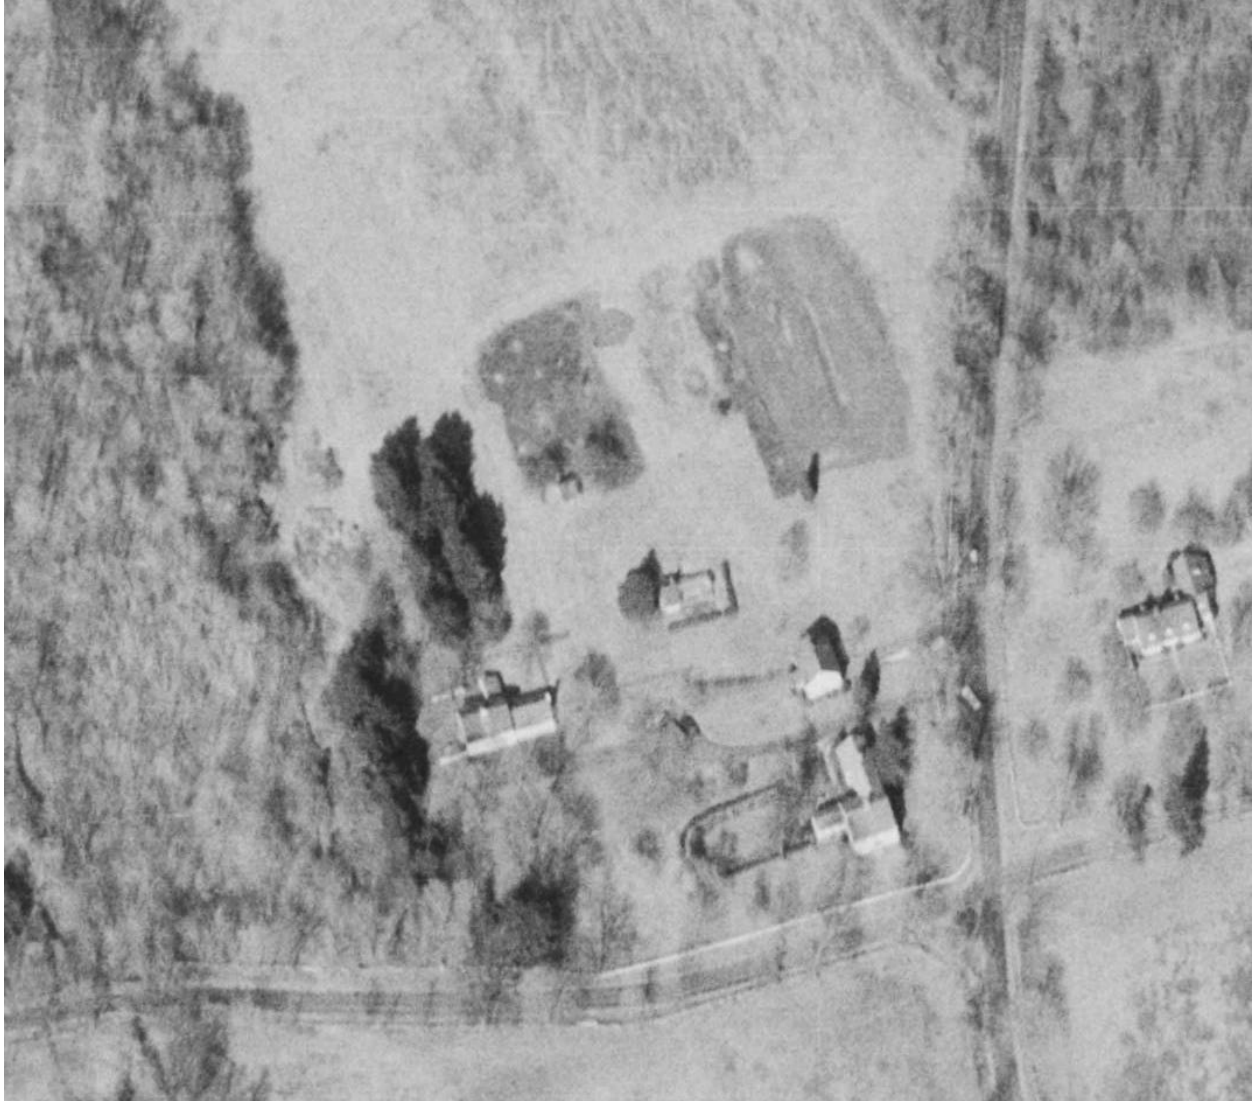
Figure 2.55b A close detail of the 1965 Mather Homestead depicts a landscape with trees, lawns, garden and cultivated plots to the north. Courtesy CT State Library.

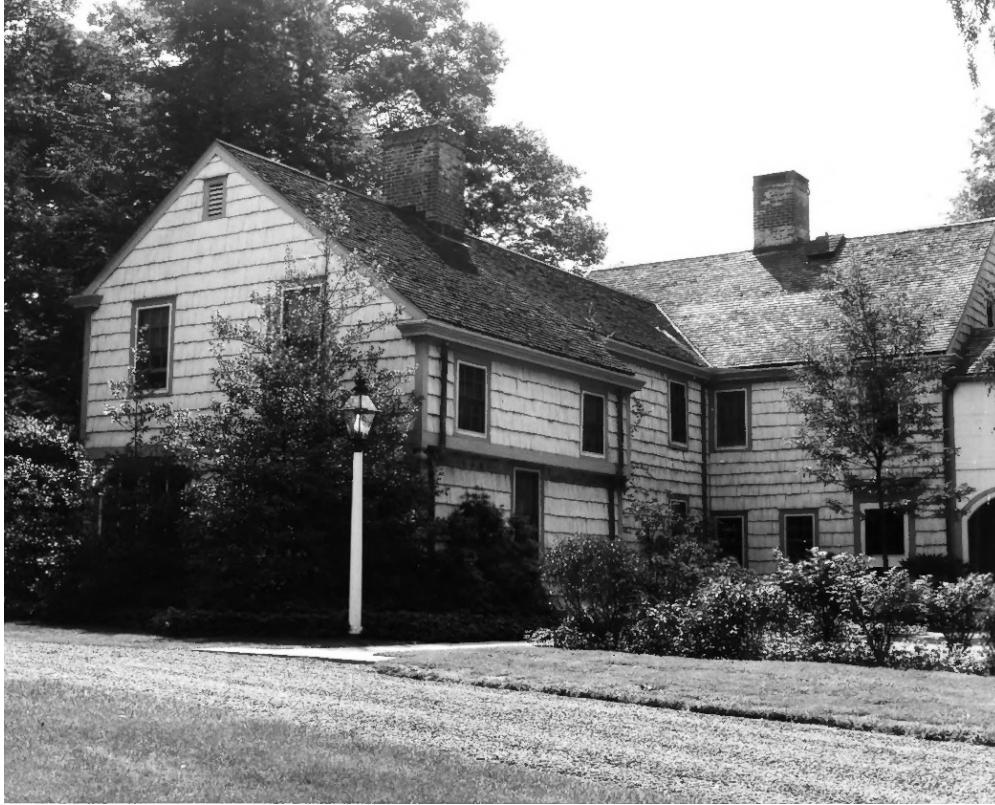
Figure 2.56 1963 NPS photograph of the Mather Homestead, taken from the northwest. A slate walk extends from the gravel drive toward the terrace. A young tree, presumably the honey locust proposed and planted by Middleleer, is present within the terrace. Courtesy MHF.

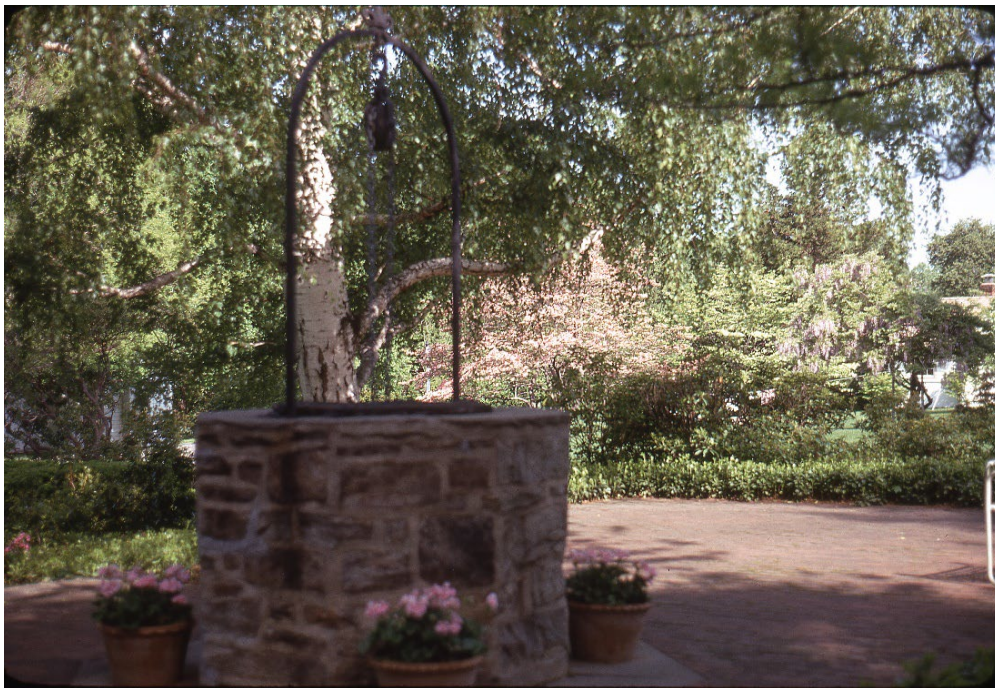
Figure 2.57 This 1969 photograph captures the brick terrace in place, as designed by Charles Middleleer in 1962. In the background, the guest house and wisteria pergola are visible. Small terracotta pots of pink geraniums are arranged around the well. Courtesy MHF.

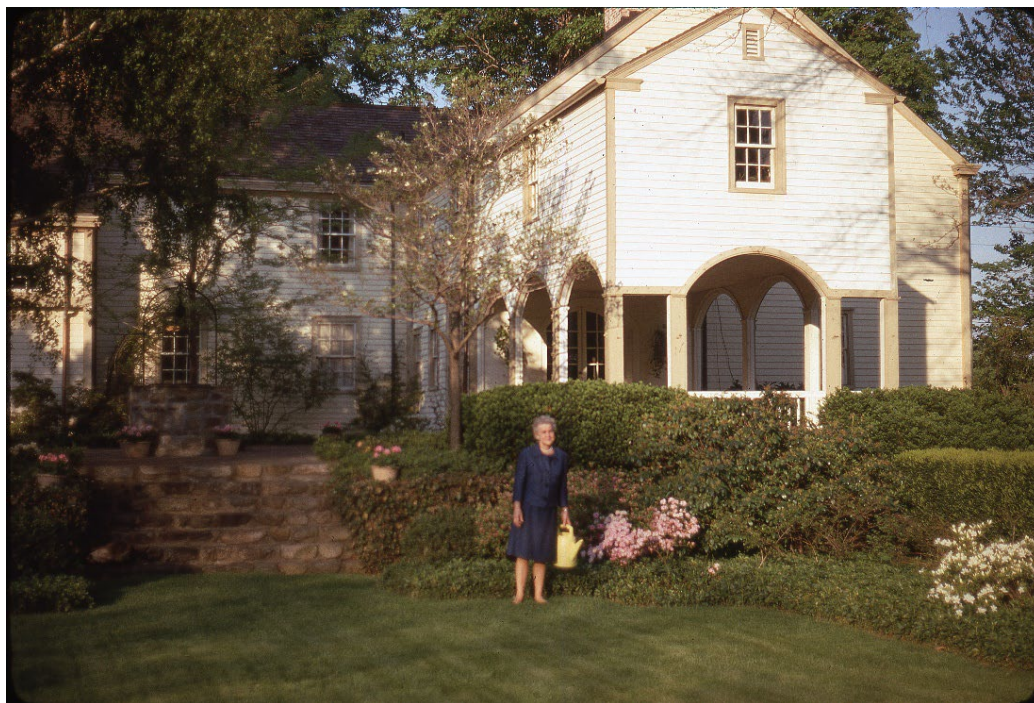
Figure 2.58 Another 1969 photograph of the brick terrace viewed from the Sunken Garden. Bertha Mather McPherson is pictured holding a watering can. Behind the historic well, a young honey locust is present. Two pots of pink geraniums on the stone walls frame the steps to the terrace. Courtesy MHF.

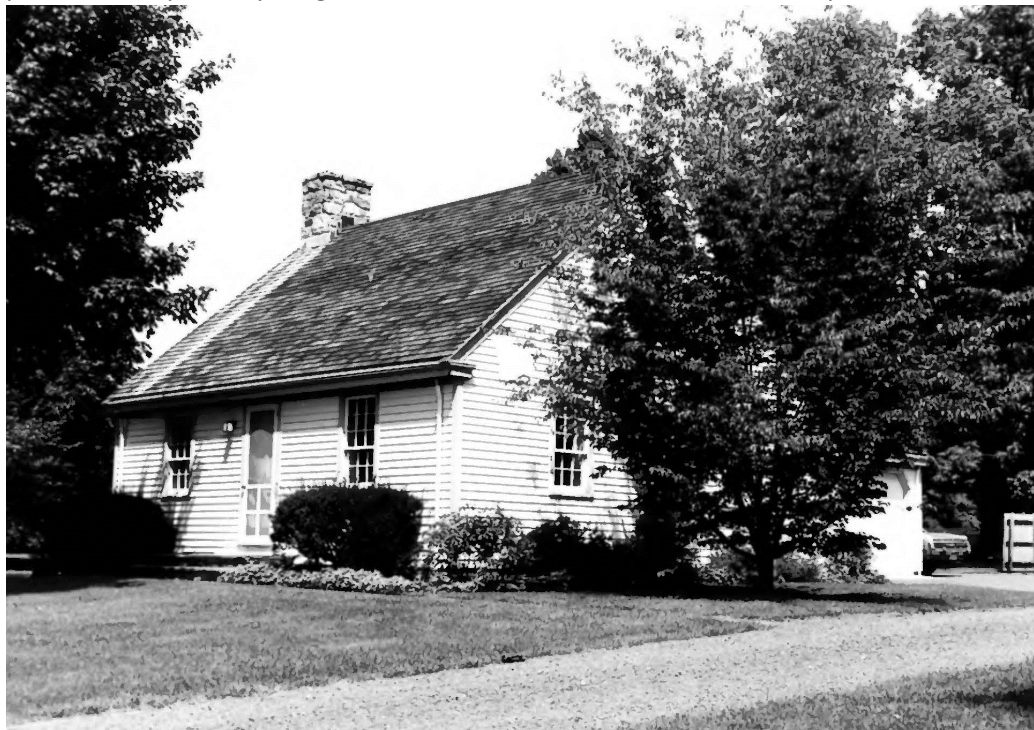
Figure 2.59 1974 NPS photograph of the Little House, added by Bertha Mather McPherson and built on the foundation of the former caretaker's cottage, located north of the Main House. Shrubs and groundcover beds line the cottage foundation. A narrow path leads from the gravel driveway to the front entry. Courtesy MHF.

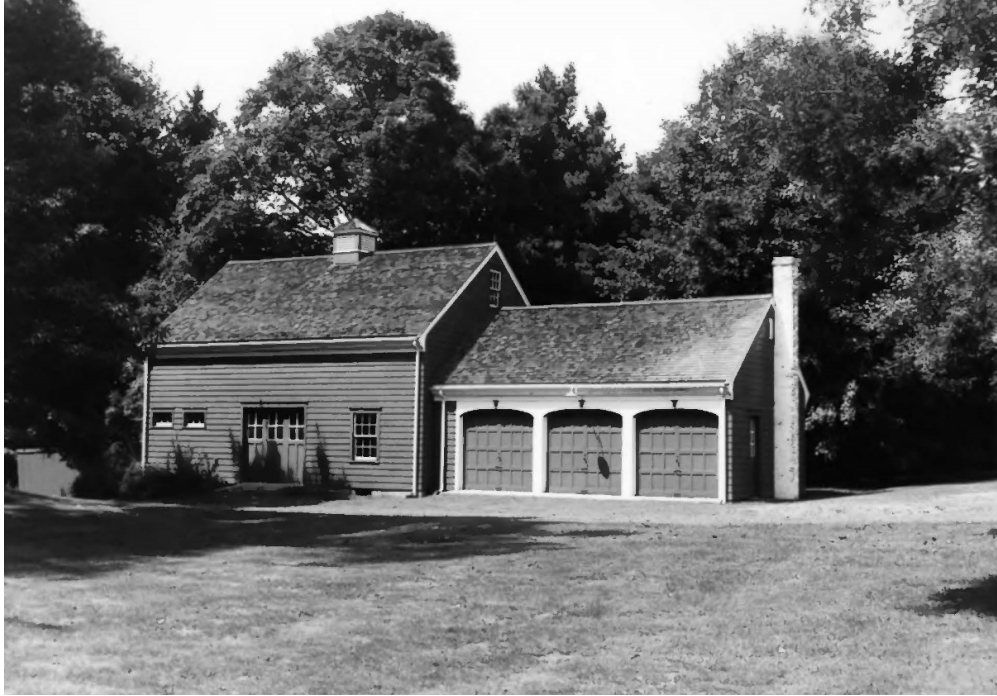
Figure 2.60 1974 NPS photograph of the barn and garage built in 1929, located northwest of the Main House. A dense wooded area of tall pines and deciduous trees is seen behind the barn. The foreground is surfaced with mown grass. A gravel drive approaches the barn from the right. Courtesy MHF.

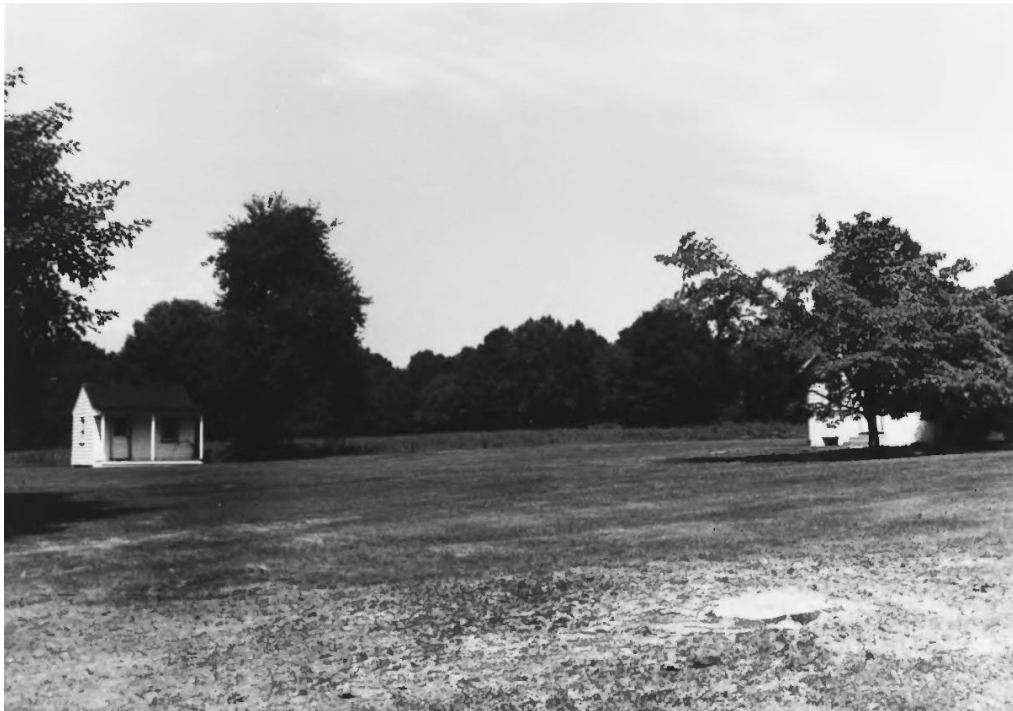
Figure 2.61 1974 NPS photograph of the playhouse (left) and the potting shed (right) in the field north of the Mather house. The ground plane in the foreground is covered in rough turf. Nearer to the structures, the turf appears more consistently maintained. One tree stands on the right side of the playhouse, and a smaller flowering tree obscures the view of the potting shed. In the background, taller grasses are visible. The field is enclosed by a dense line of trees. Courtesy MHF.

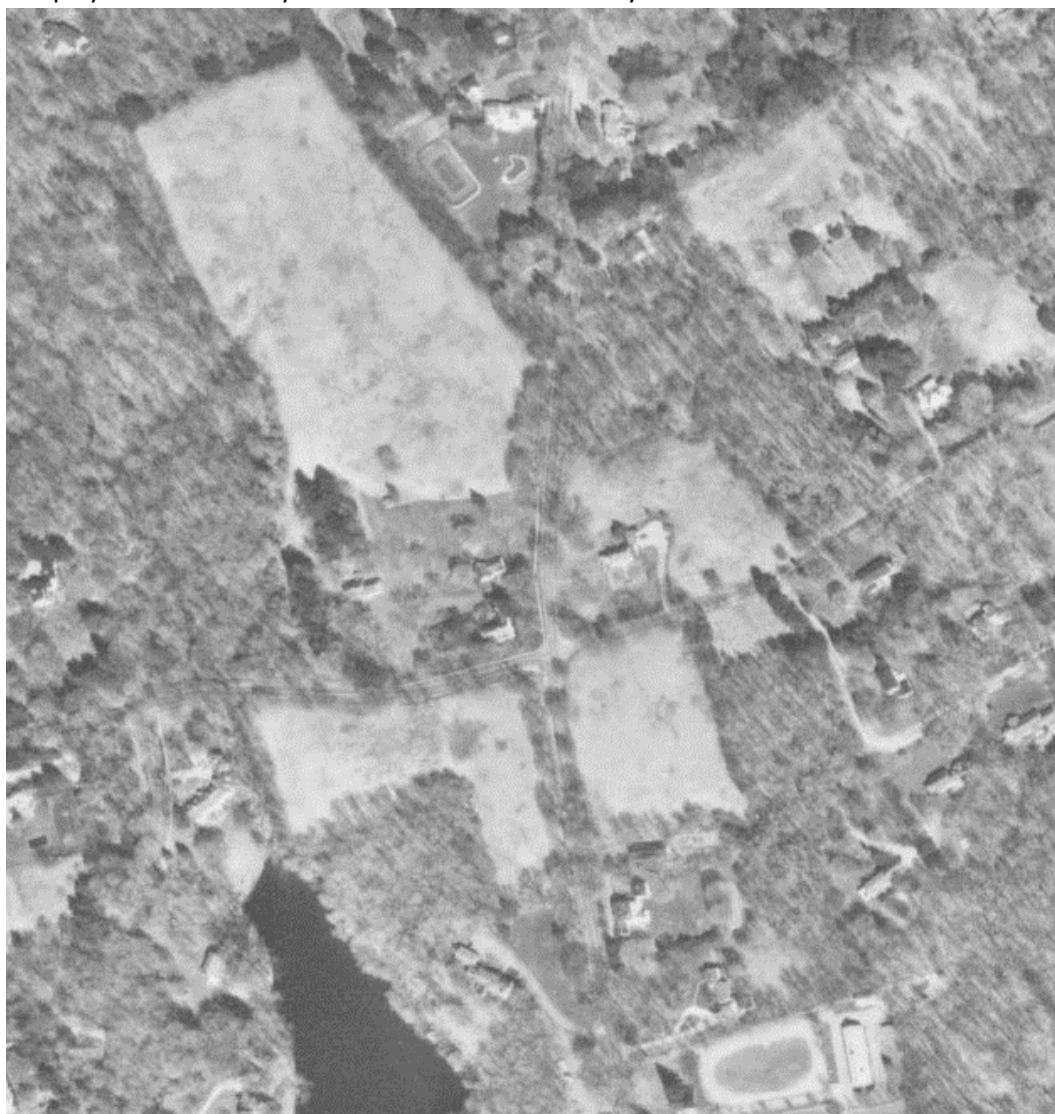
Figure 2.67a 1990 aerial detail shows dark woodlands to the west and a light tone on the large field. The lawn around the Main House, guest house, and barn is distinct in dark tone. Courtesy UCONN.

A 1990 aerial photograph captures the condition of the Mather Homestead landscape during the final years of Bertha Mather McPherson's life (**Figure 2.67**). The greenhouse and potting shed are no longer present, although the playhouse remains. Formerly productive areas north of the barn and the Little House (once the location of the caretaker's cottage) no longer retain evidence of cultivation. By 2004, two years after Edward McPherson's death, an aerial photograph shows the development of a private driveway across what was formerly the northern portion of the Mather Homestead property (**Figure 2.68**). That 2004 aerial view shows the initial incursion of a private drive into the Homestead fields. A subsequent 2013 aerial shows two completed private residences north of the Homestead, with a third house under construction (**Figure 2.69**). A 2015 aerial image records the property and its surrounding context at that date (**Figure 2.70**).

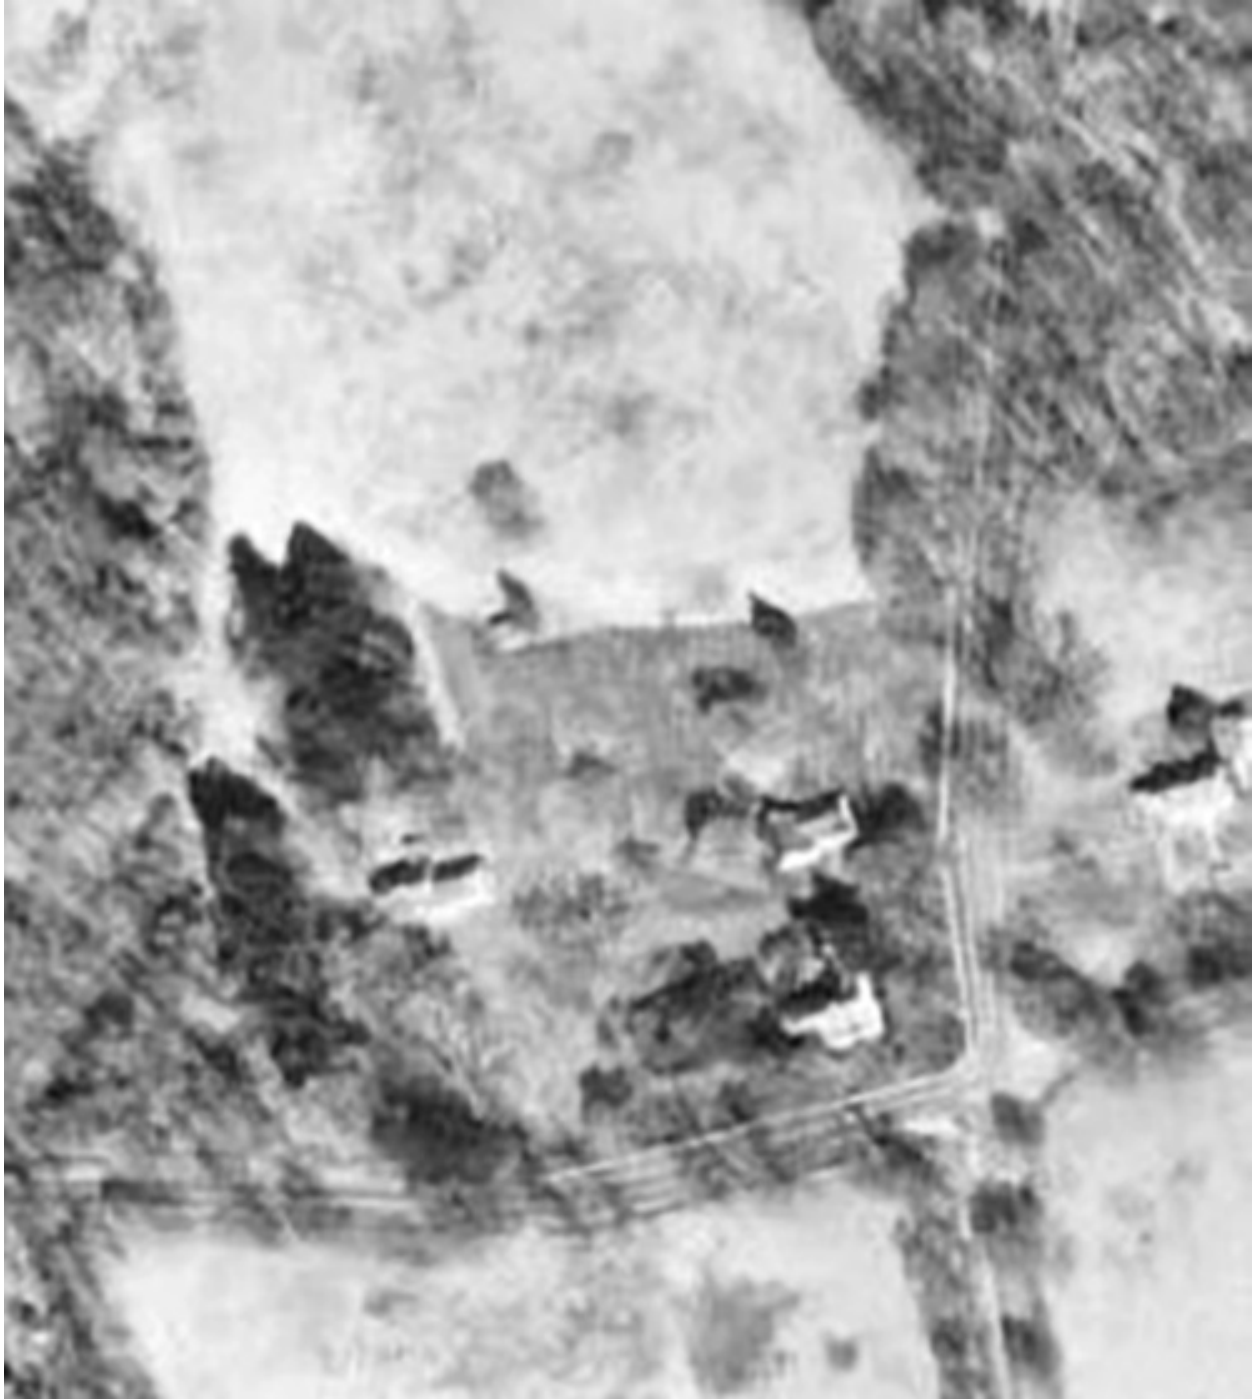
Figure 2.67b A closer, enhanced detail of the 1990 Mather Homestead. The greenhouse and potting shed, formerly located northwest of the guest house, are no longer present. Further north, the playhouse structure is retained. Courtesy UCONN.

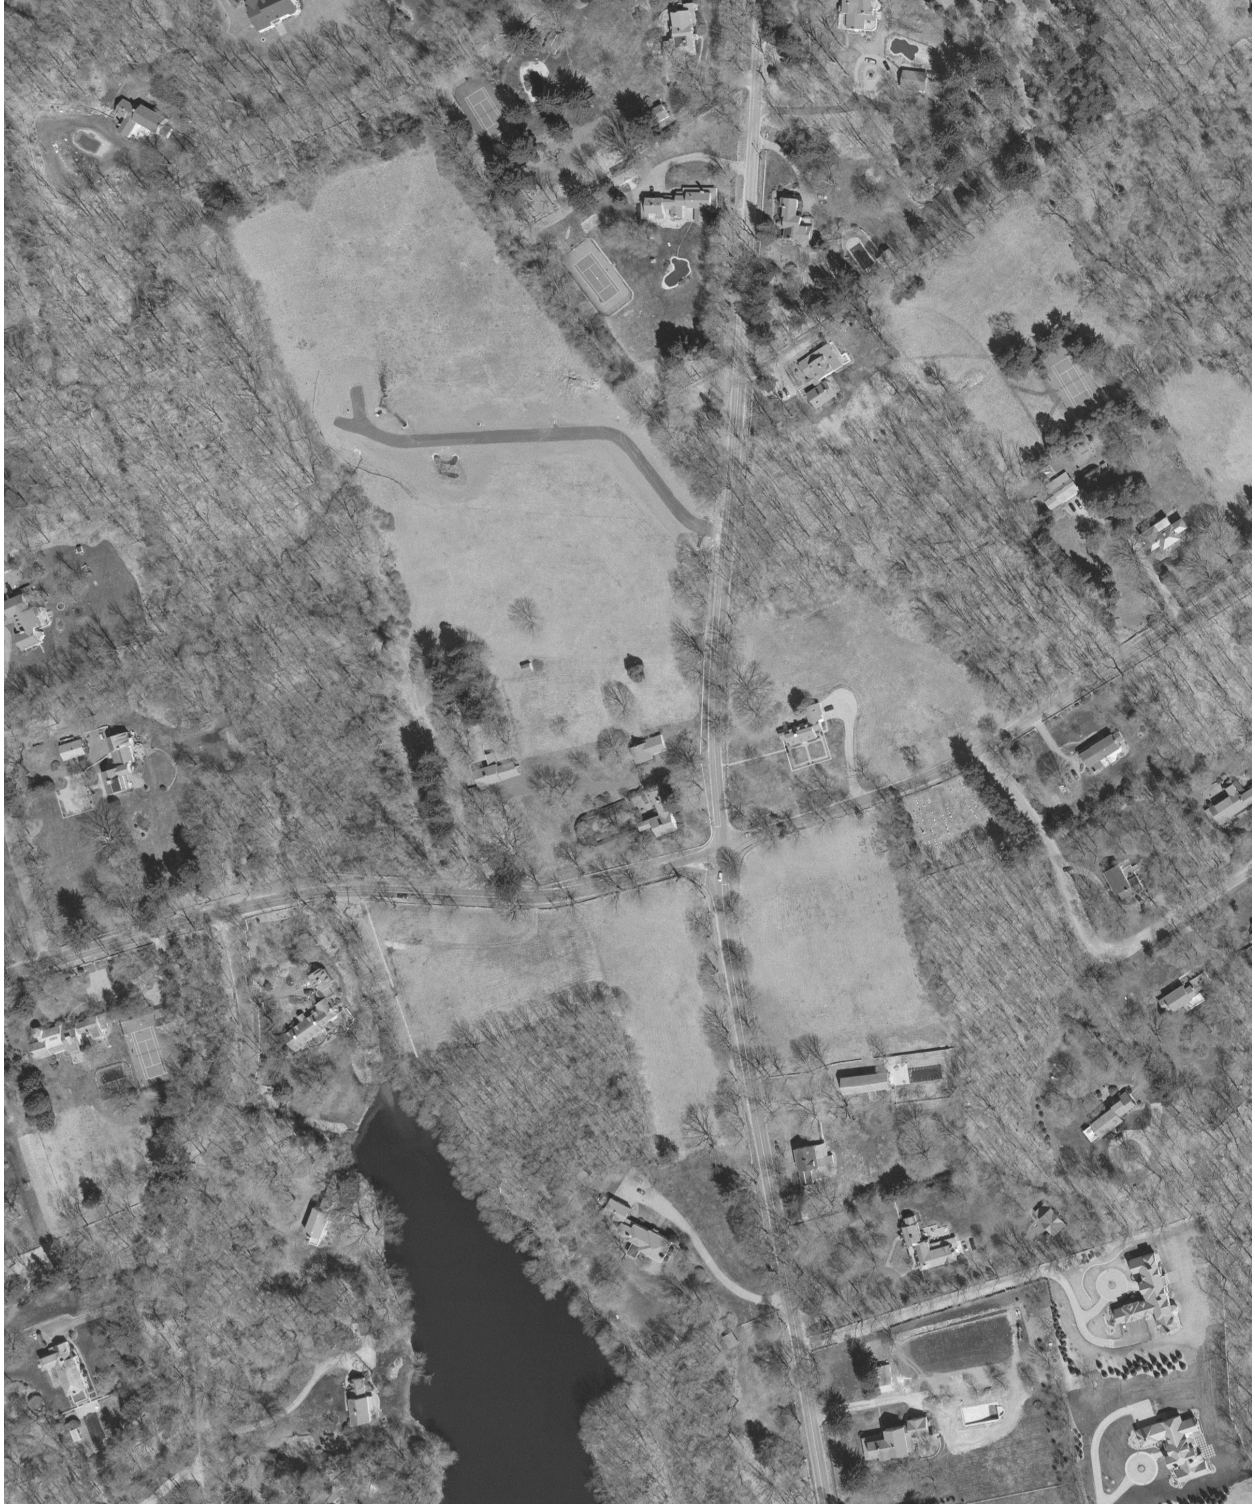
Figure 2.68a Detail of 2004 aerial photograph captures the early development of a private driveway cutting east-west across the field north of the Main House. The sale of this north lot likely preceded this image. Courtesy UCONN.

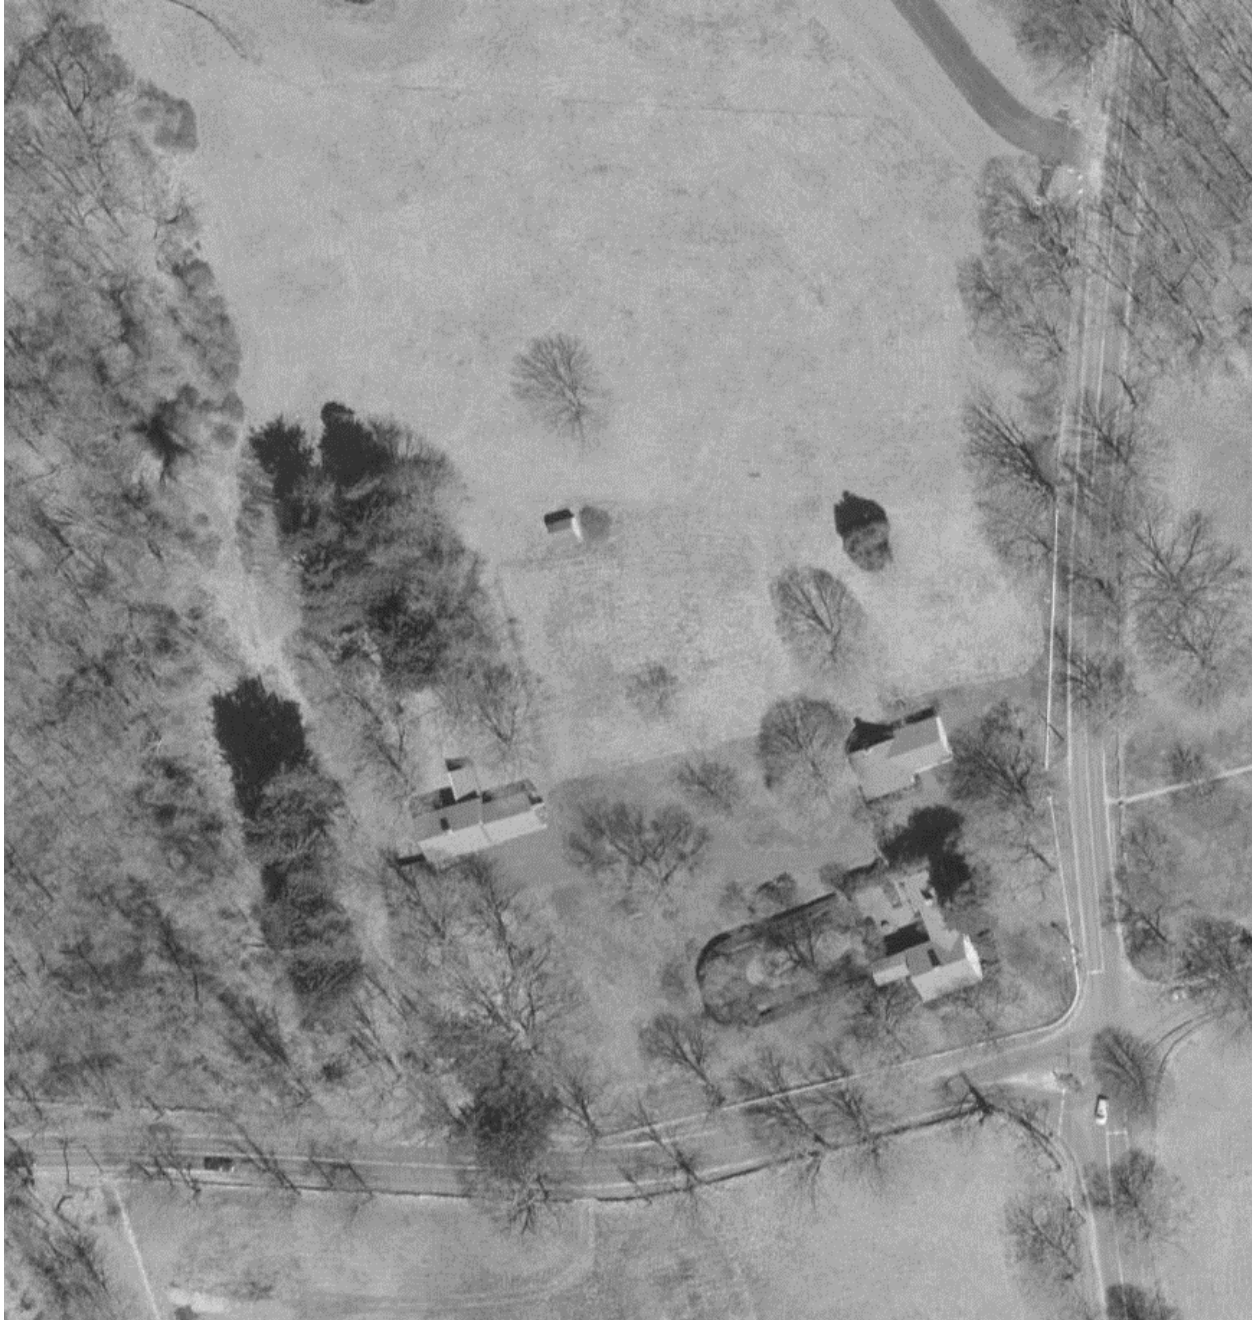
Figure 2.68b Closer detail of 2004 aerial. Along the west property boundary, the stand of trees historically composed solely of evergreens now exhibits a mix of deciduous (leaf-off) and evergreen. Courtesy UCONN.

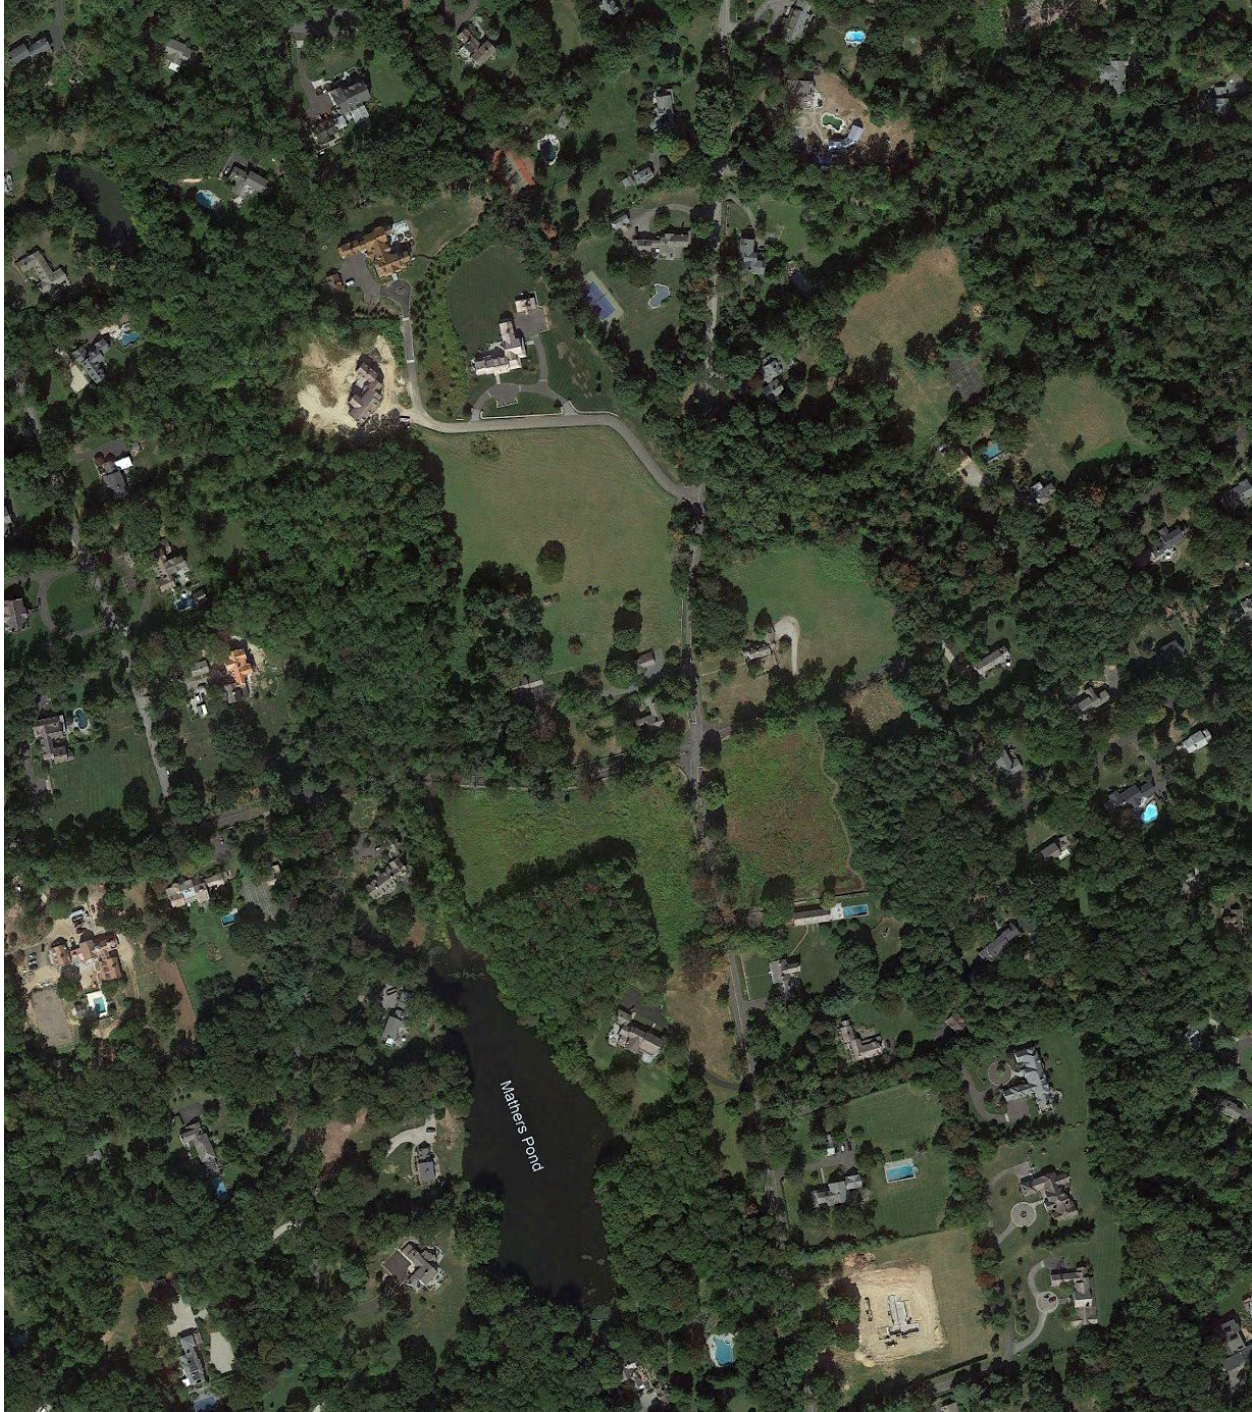
Figure 2.69 This 2013 aerial shows a uniform lawn north of the core area and the development of a third residential property beyond the open mown field. Courtesy Google Earth.
