MATHER HOMESTEAD CULTURAL LANDSCAPE REPORT

Mather Homestead Foundation
Draft for Review
January 2024

Heritage Landscapes LLC
Preservation Landscape Architects & Planners
Charlotte, Vermont & Norwalk, Connecticut

In 2023, the Mather Homestead Foundation commissioned Heritage Landscapes to prepare a thorough Mather Homestead Cultural Landscape Report (CLR) for this historically significant site. The CLR research findings indicate that originating as a productive, subsistence-based landscape, the Mather Homestead steadily evolved from its conception in 1778 to the present day. The property was designated as a National Historic Landmark in 1963 and inscribed on the National Register of Historic Places in 1966, with a boundary amendment in 1978.¹ The 1963 nomination notes its significance for its association

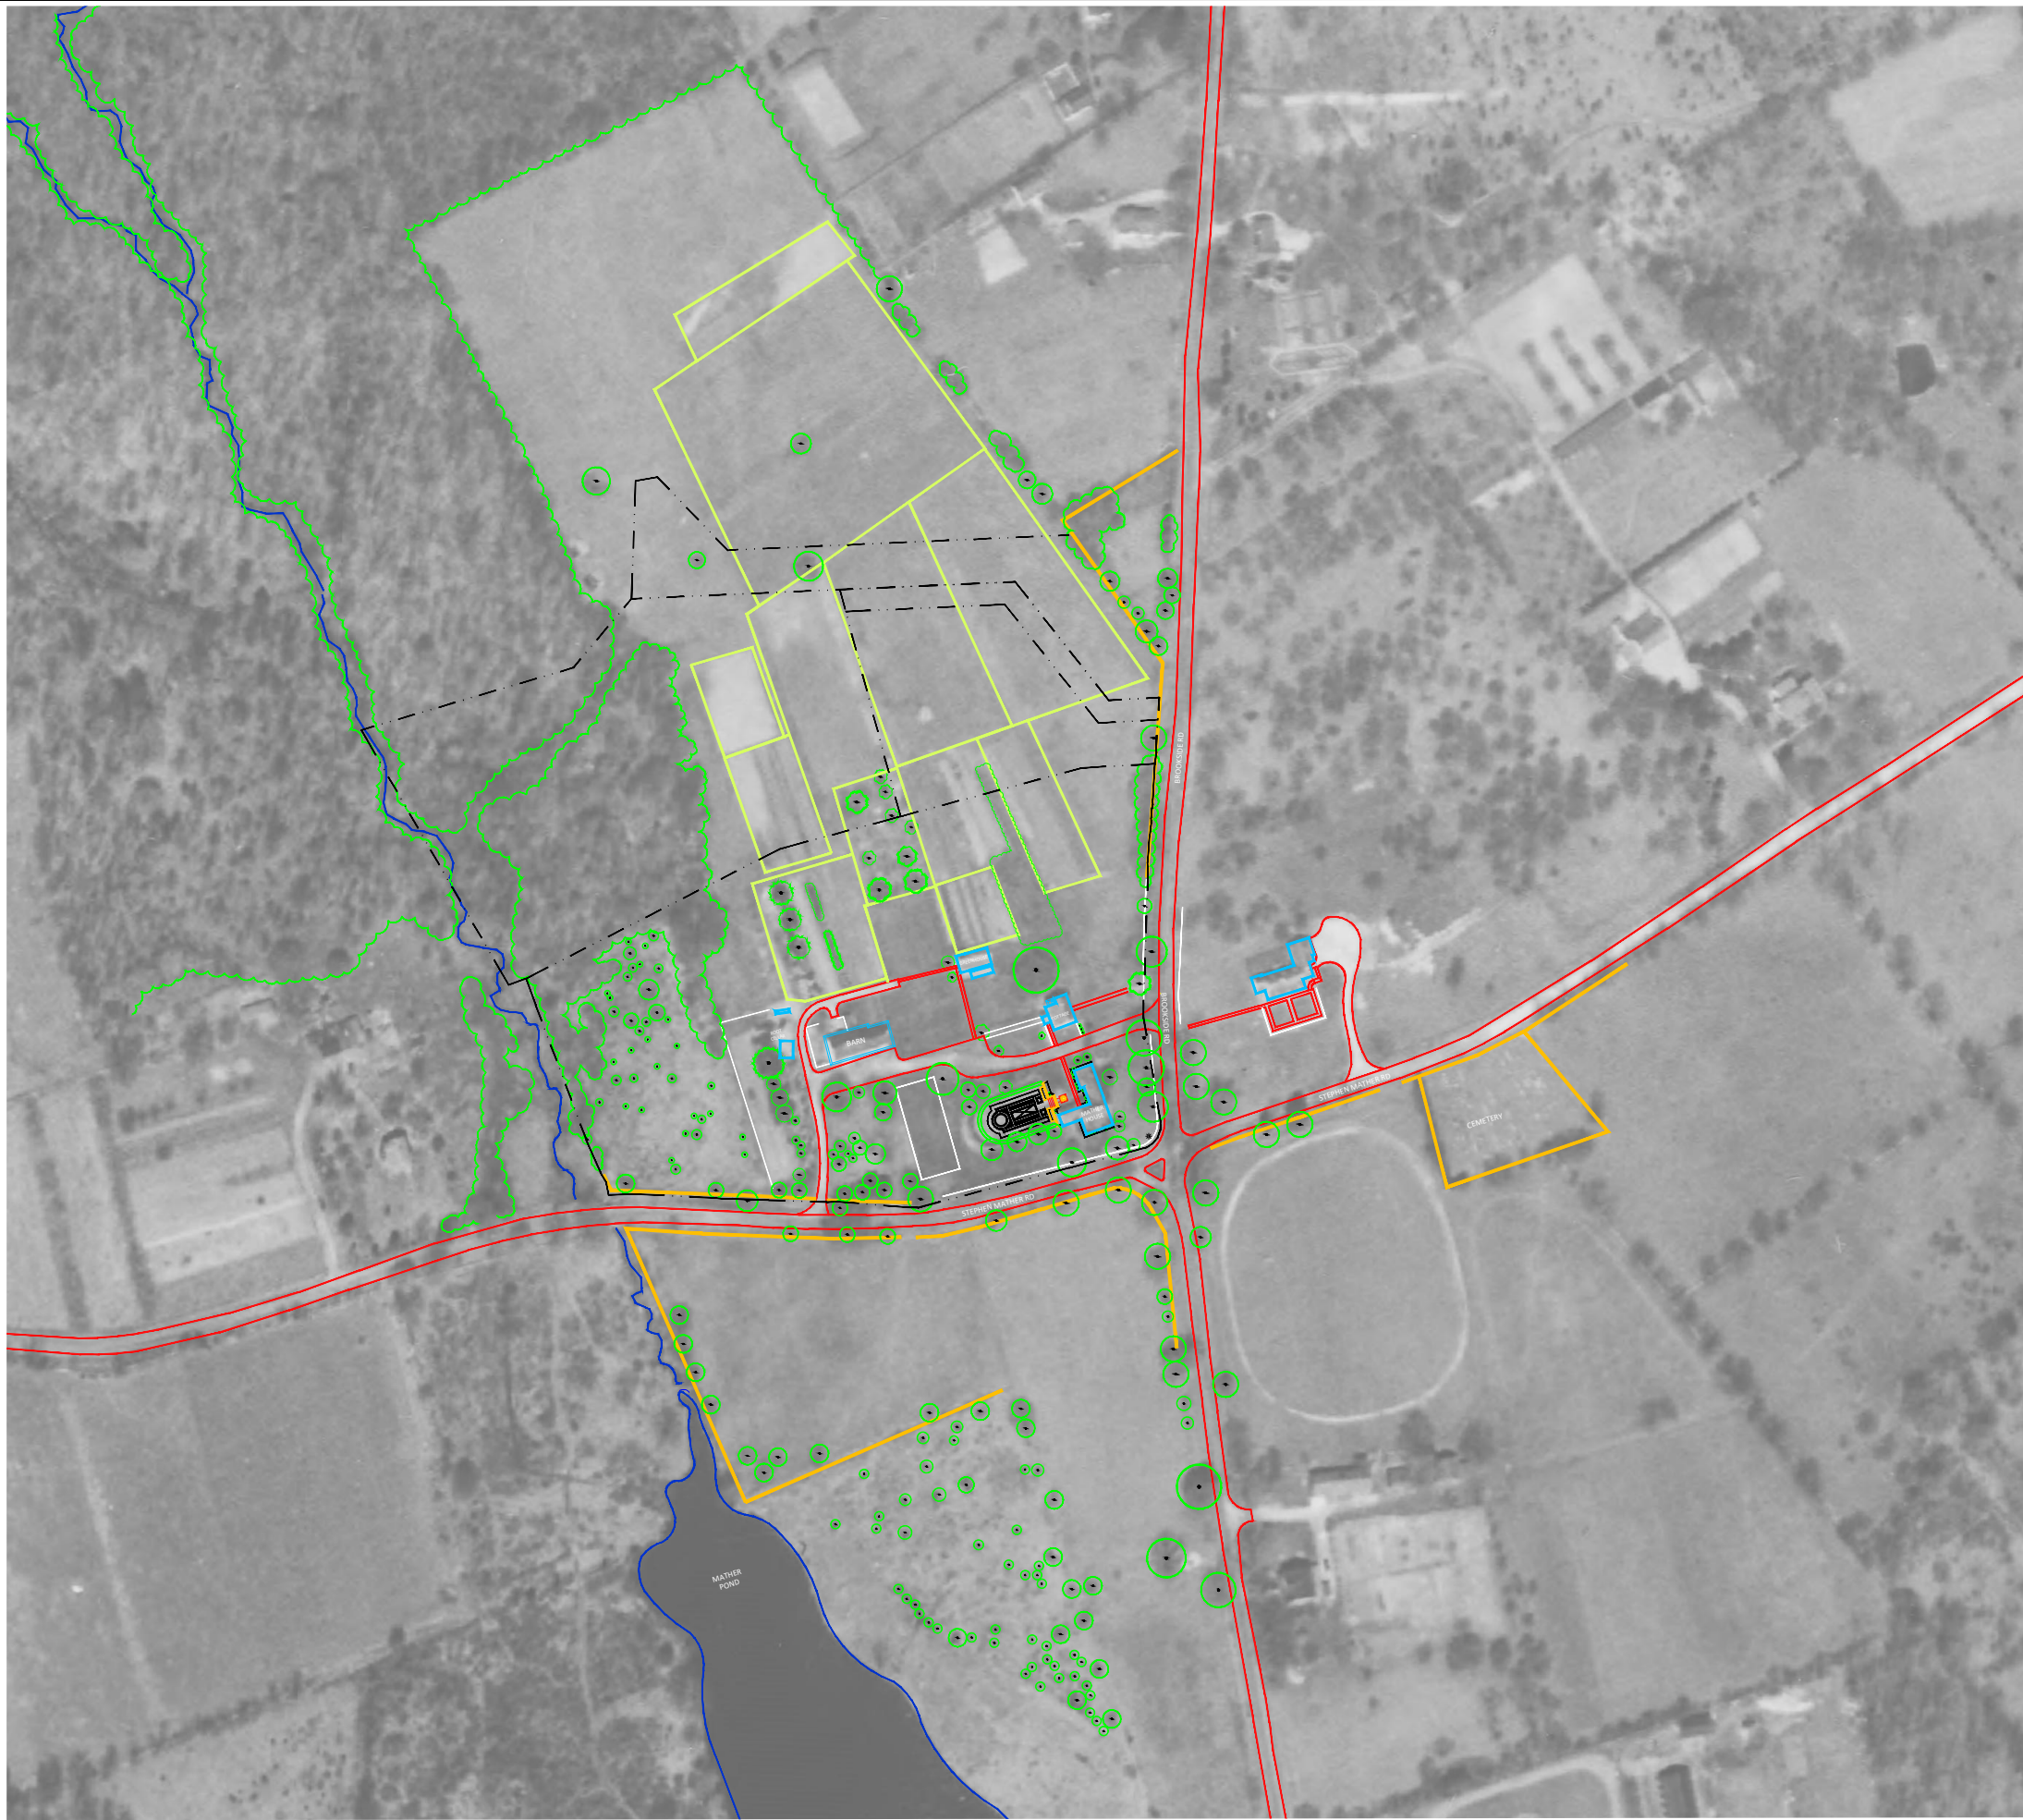
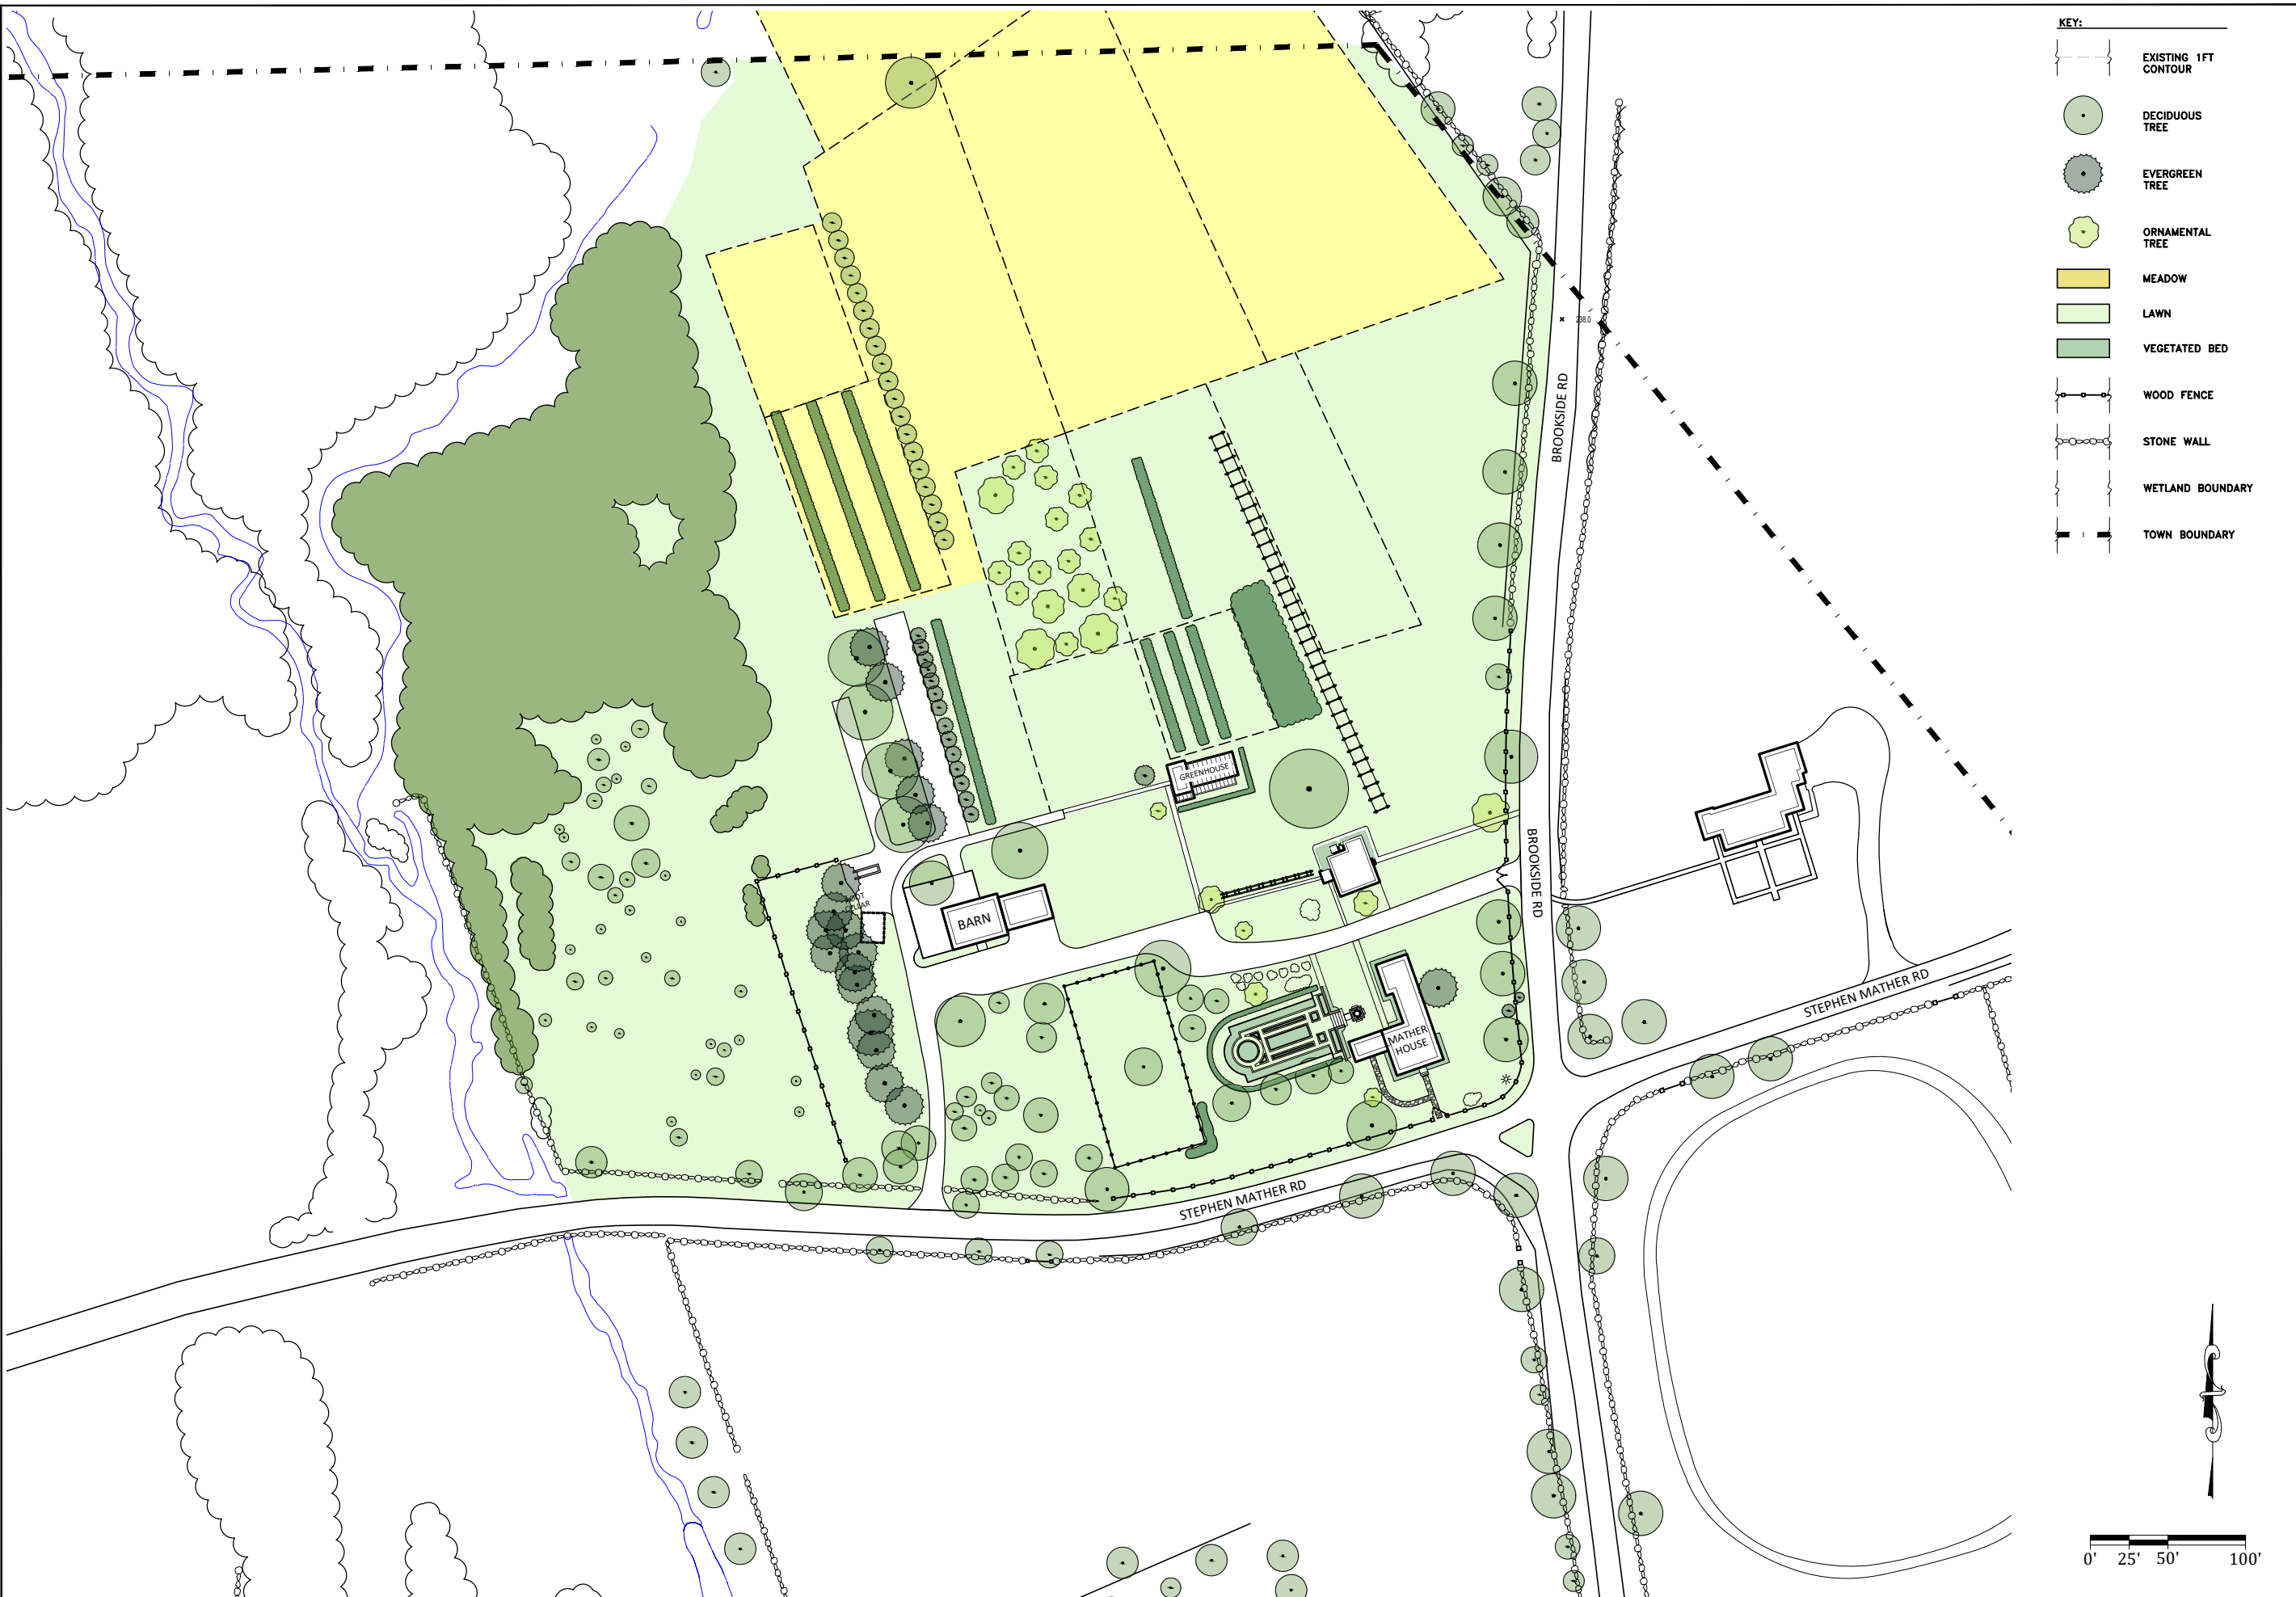
Sources: 1934 aerial photograph, courtesy CT State Library; 'Topographic Sketch of Property at Darien, Conn. Owned by Stephen T Mather,' unknown creator, circa pre-1927.

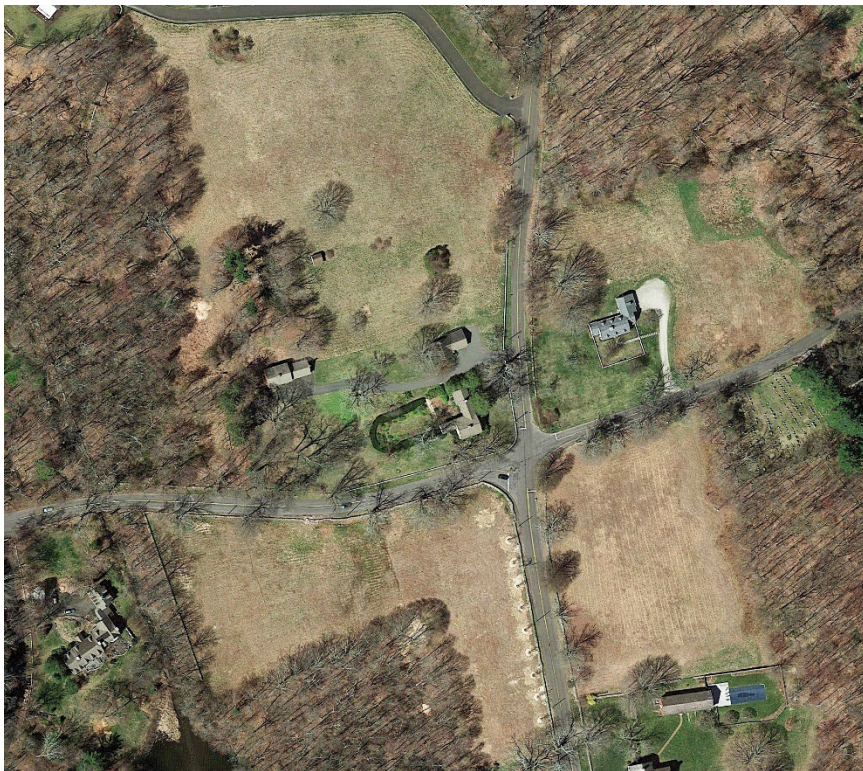
Figure 3.2b Detail of 2018 aerial. Newly planted trees are present along the east edge of the Darien Land Trust parcel south of Stephen Mather Road. Note the clear distinction between maintained turf lawn around core buildings and rough turf in the north property. Courtesy Google Earth.

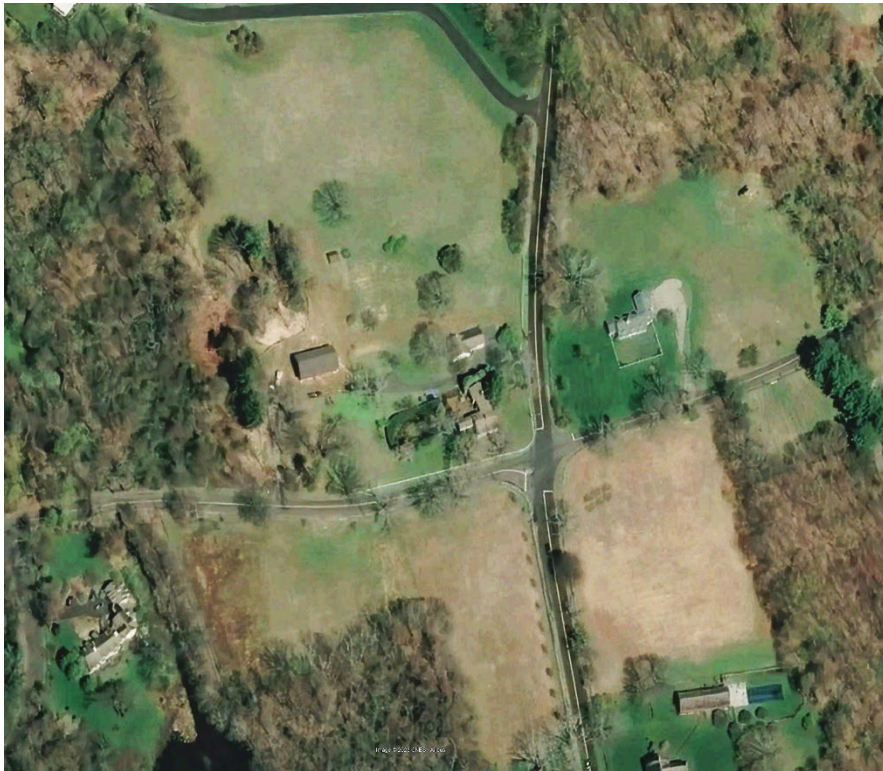
Figure 3.3b Detail of 2020 aerial. Disturbed area around the newly constructed Education Center. The lawn space between the Little House and the former barn is truncated by the new building. Along the northeast property boundary with Brookside Road, the stand of trees has filled in. Courtesy GE.

2020 The Mather Homestead Foundation, with support from the Darien Historical Society, completes the Elizabeth W. Chilton Education Center, also called 'the Barn.' The new building resembles an 18th-century dairy barn on the exterior, constructed in place of the deteriorating historic barn, with a 1,800 SF open interior that can accommodate up to 130 people.

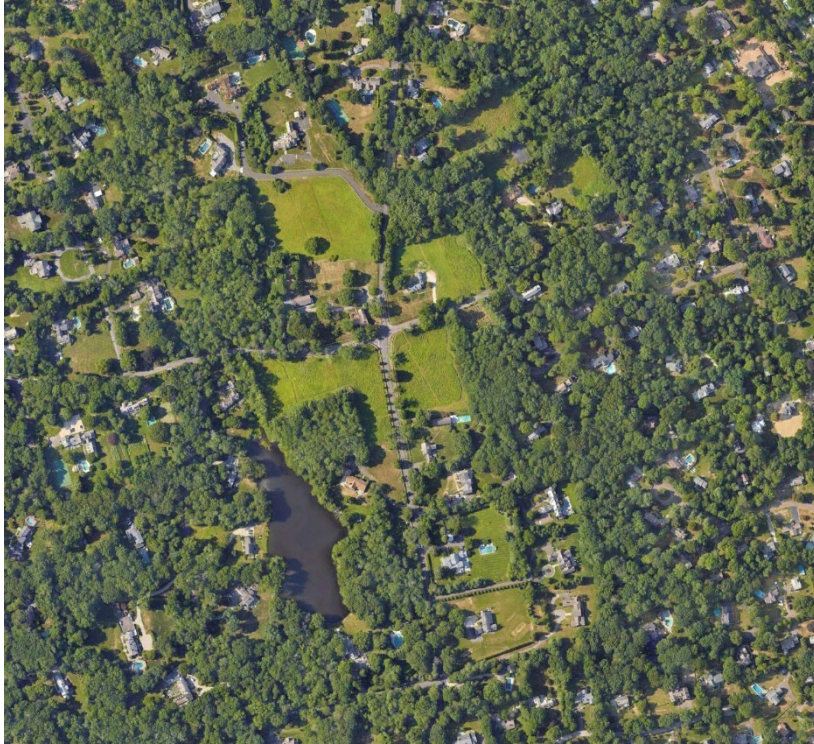
Figure 3.4a 2022 aerial. Courtesy Google Earth.

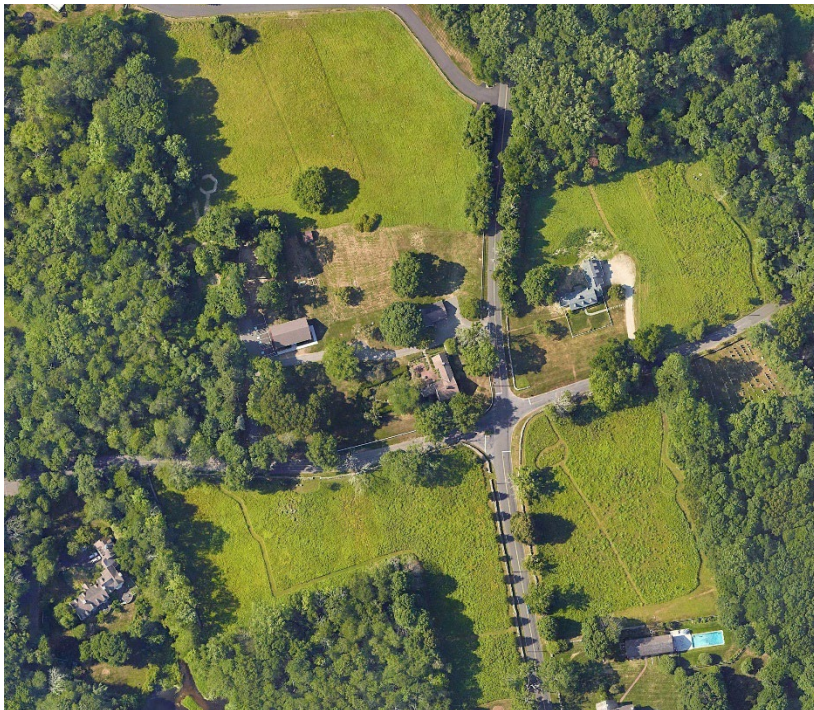
Figure 3.4b Detail of 2022 aerial. Asphalt-paved parking area is in place on the west side of the Education Center. Rectangular raised beds are present south of the playhouse. Four distinct turf management protocols are evident, with maintained lawn around the Homestead core, recently mown rough turf north to the playhouse, taller grass in the northeast portion of the property, and meadow in the northwest portion owned by the Darien Land Trust. Mown paths are cut through this latter meadow area, as well as the Land Trust parcels on the south side of Stephen Mather Road. Courtesy Google Earth

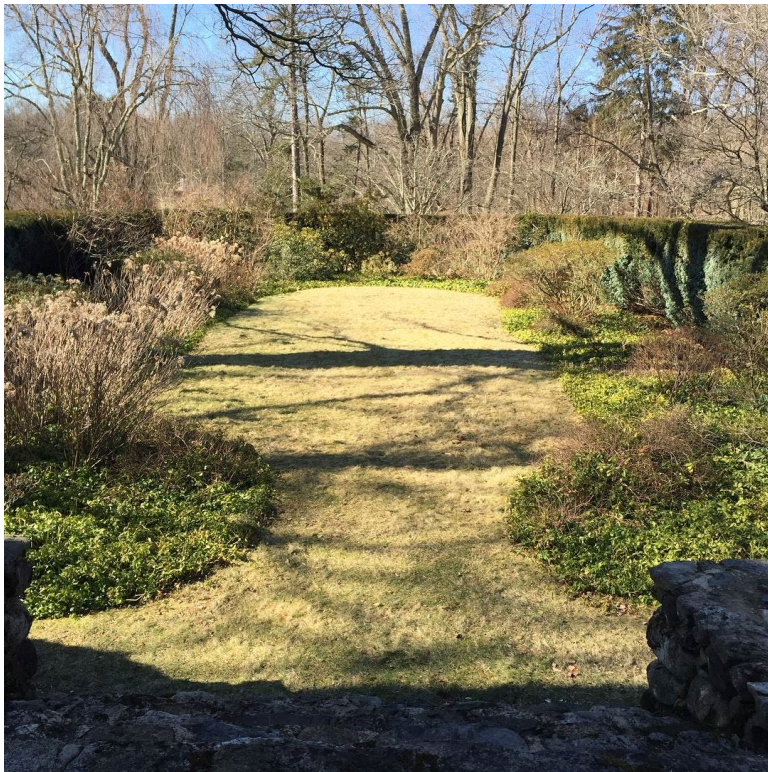
Figure 3.5a A 2018 photograph of the Sunken Garden prior to weeding and replanting. Courtesy MHF.

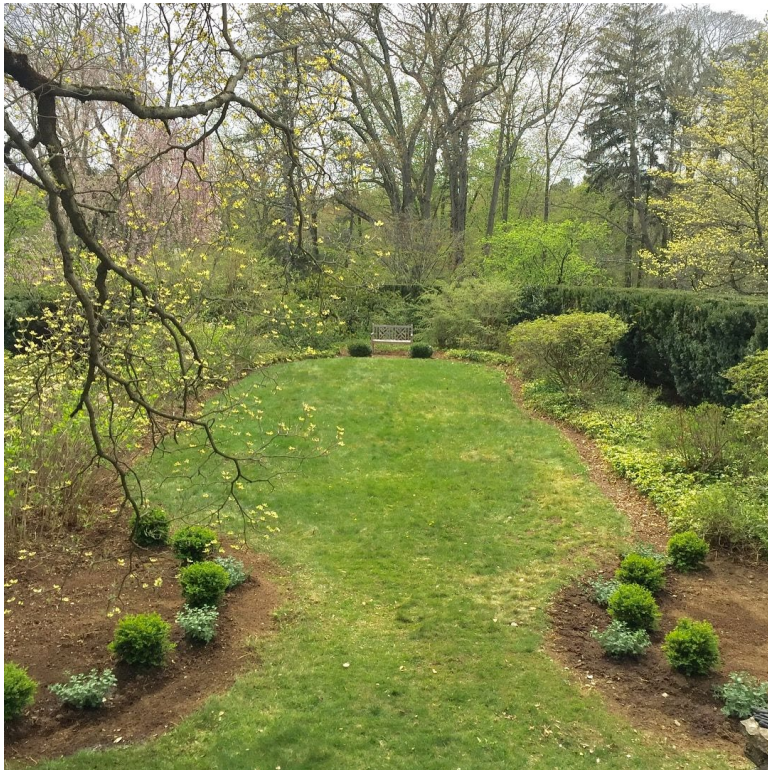
Figure 3.5b Spring 2018 photograph of the Sunken Garden after weeding and replanting. A wooden bench is installed at the terminus of the east-west axis through the garden. Dense groundcovers have been removed and young shrubs replanted. Courtesy MHF.

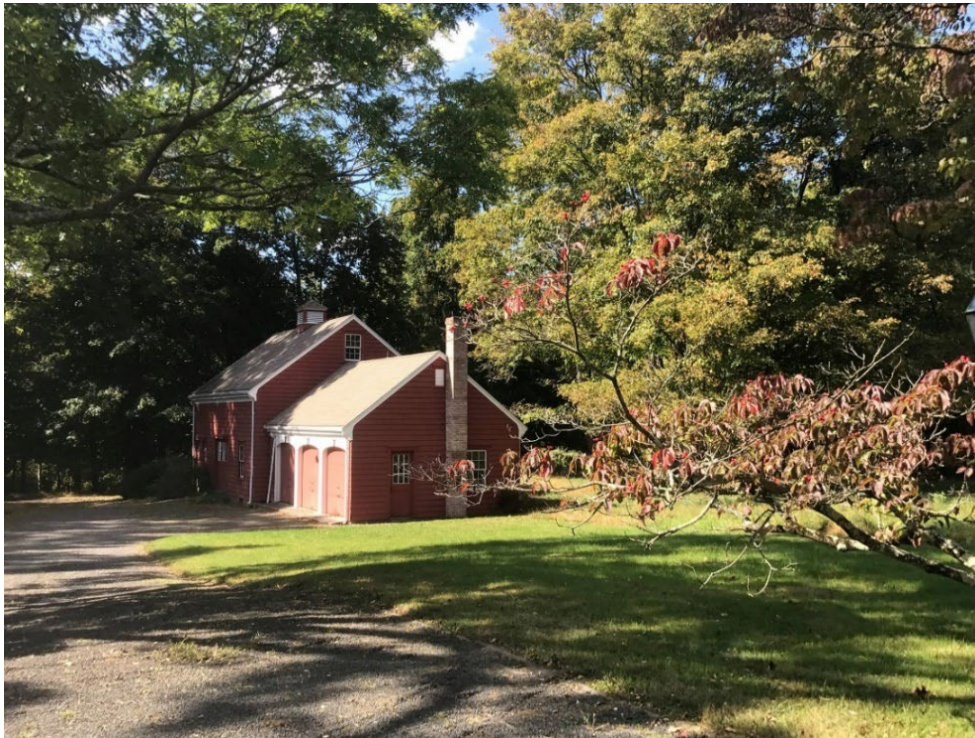
Figure 3.6a 2017 photograph of the barn built in 1905 by Stephen T. Mather. Courtesy MHF.

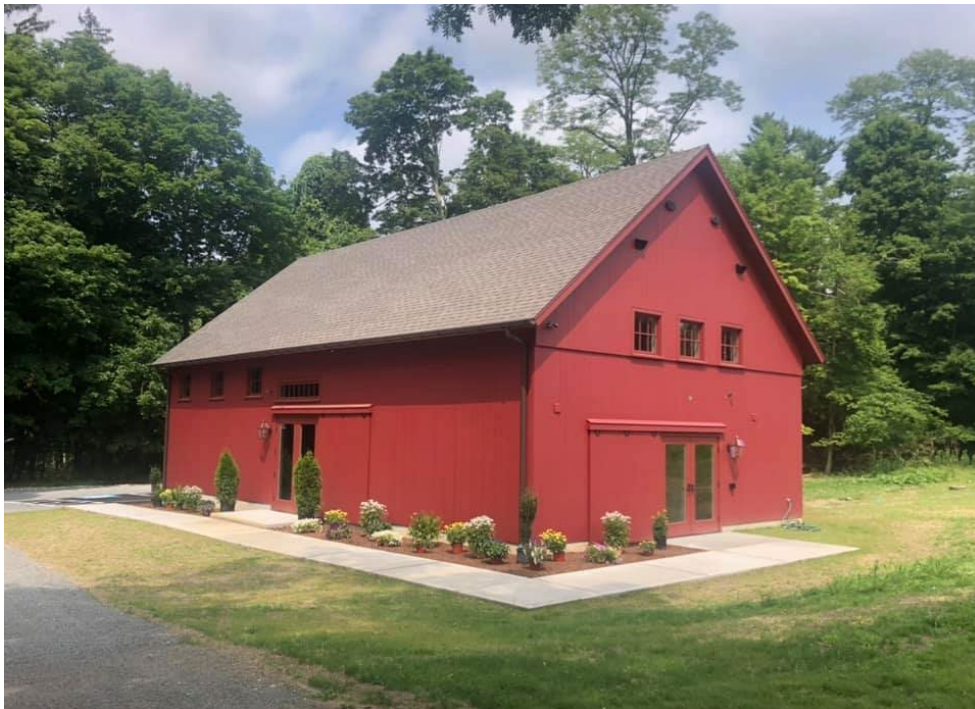
Figure 3.6b The Elizabeth W. Chilton Education Center, or the Barn, was built in 2020. A concrete walk wraps around the south and east sides of the building, providing access to two entries. Note the beds, not yet planted, between the walk and the facades. A wide strip of turf lawn divides the walk from the gravel drive. Courtesy MHF.

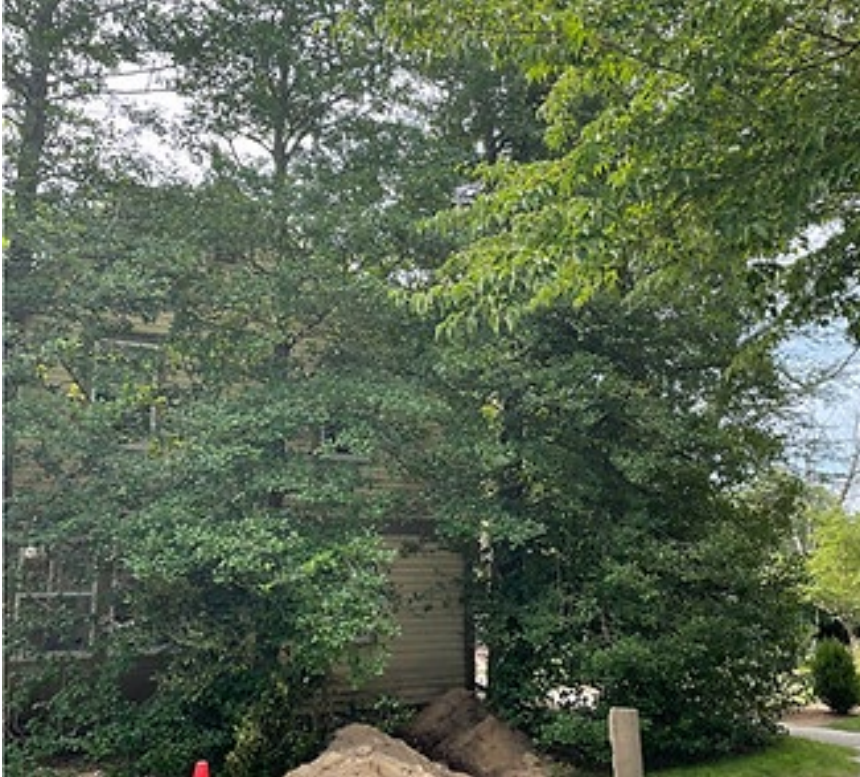
Figure 3.7a 2021 photograph of the east house façade, showing work underway to remove large trees near the building. Courtesy MHF.

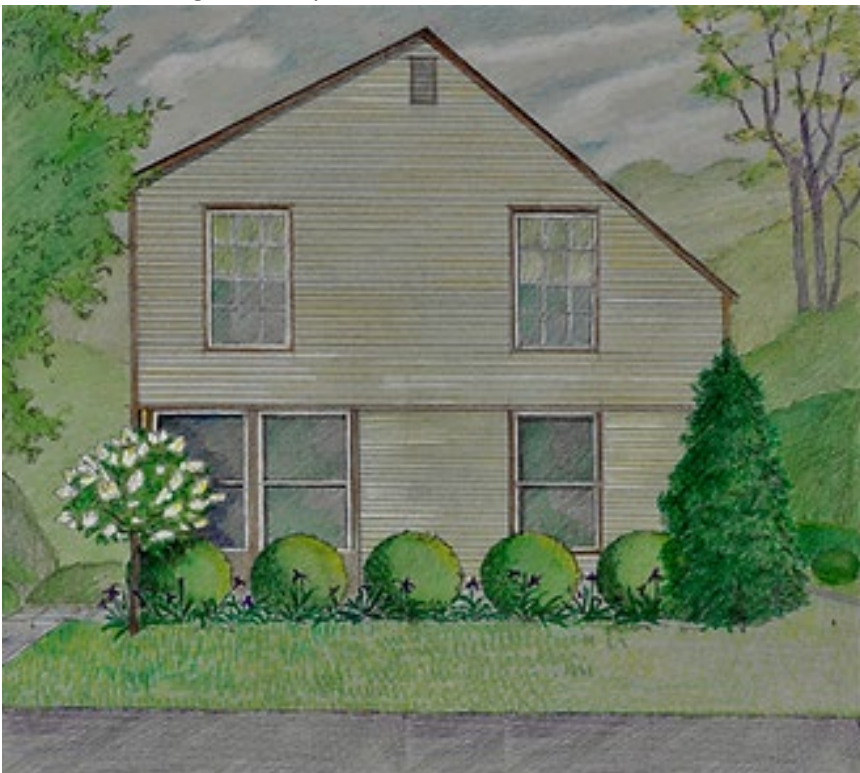
Figure 3.7b 2021 section drawing by Diana Galik of planting design by Heather O'Neill, Second Nature Landscape Design. Courtesy MHF.

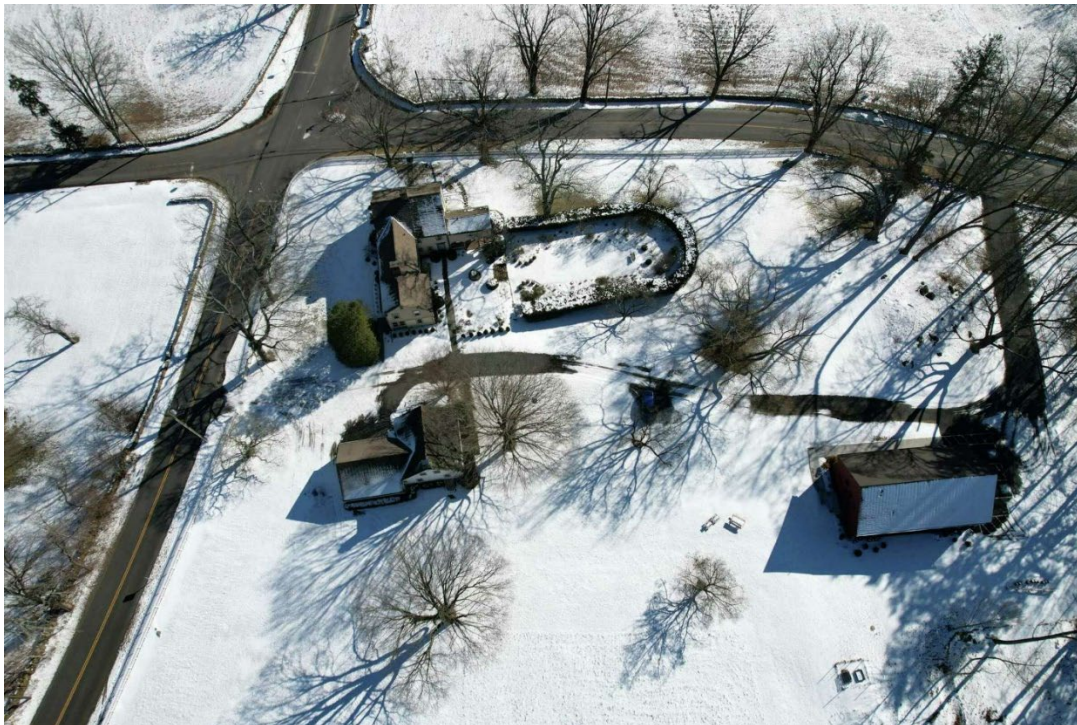
Figure 3.9 A 2022 aerial of the Mather Homestead in snow. Several raised beds enclosed by a rectangular fence appear in the lower right corner of the image, between the playhouse and the Education Center. Courtesy Tyler Sizemore, Hearst Connecticut Media, *The Darien Times*.

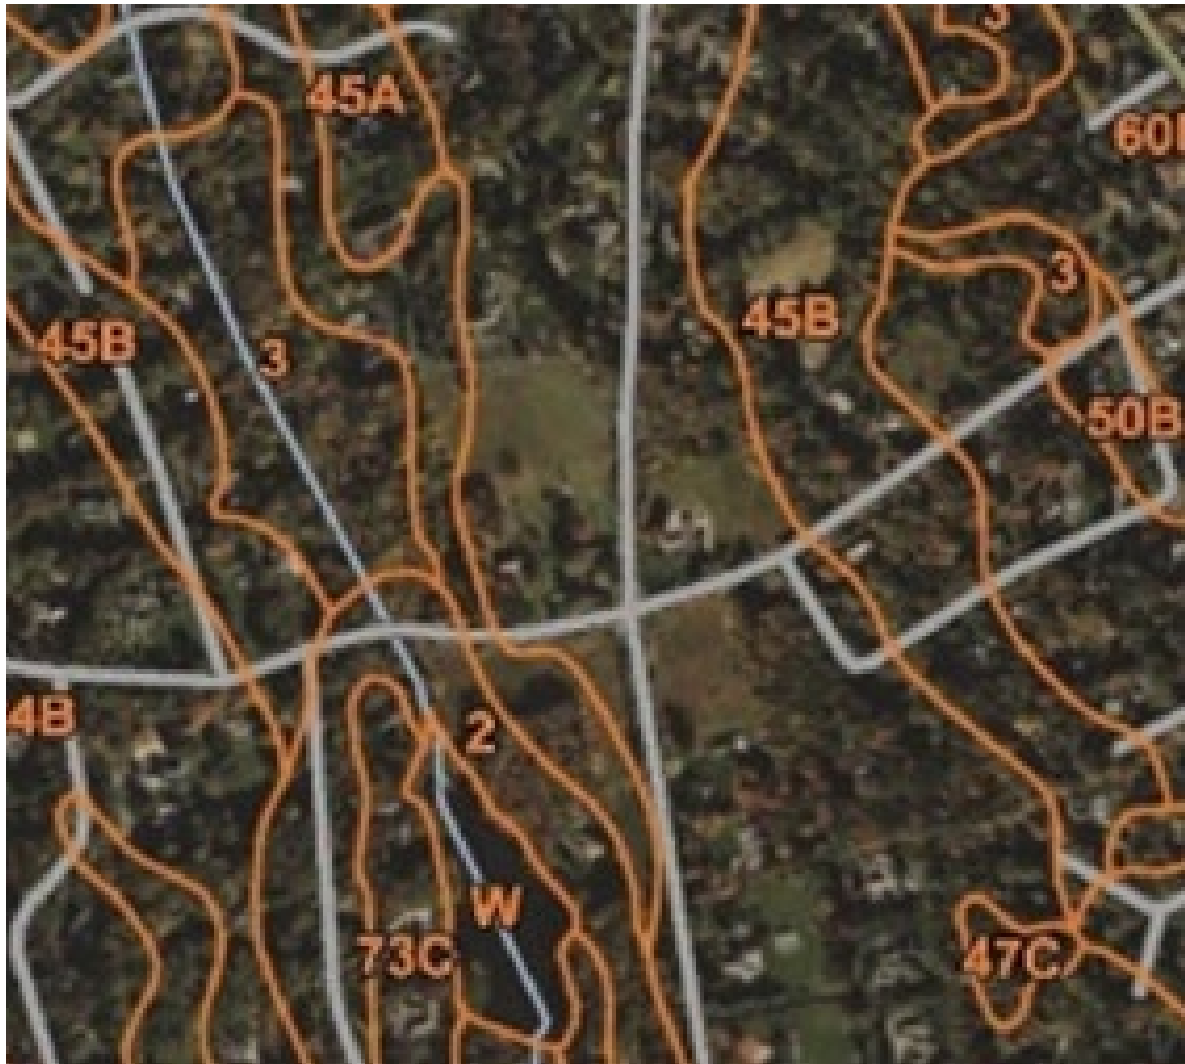
Figure 3.10b Detail of the soil map shows the central swath of Paxton and Montauk fine sandy loams (84B) through the Mather Homestead property. Along the east bank of the Goodwives River, soils include Woodbridge fine sandy loams (45A and 45B); Ridgebury, Leicester, and Whitman soils (3); and Ridgebury fine sandy loam (2). Courtesy USDA Web Soil Survey, Natural Resources Conservation Service.

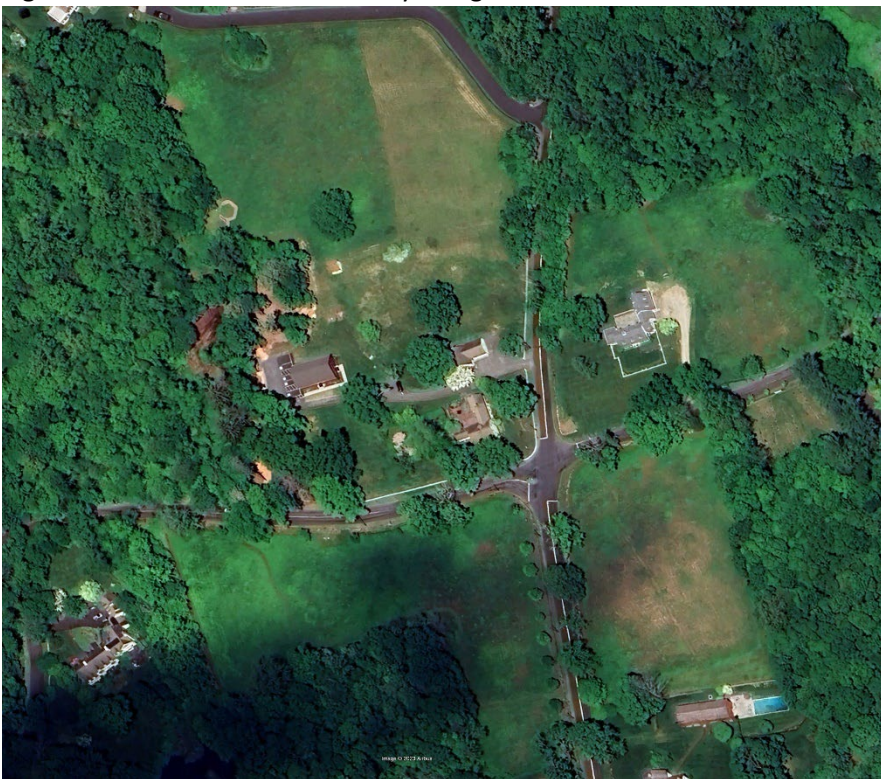
Figure 3.11b Detail of 2023 aerial. Clear distinction between Darien Land Trust meadow (northwest corner of property) and MHF northeast corner. Courtesy Google Earth.

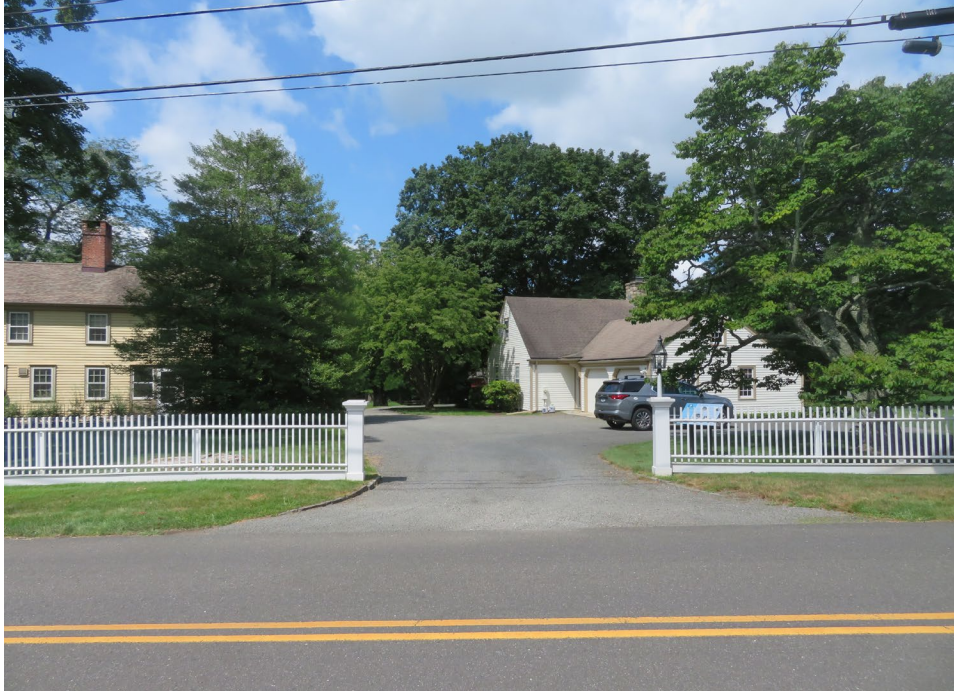
Figure 3.13 View from the drive entry on Brookside Road looking west. The Main House appears to the left and the Little House to the right. The white wooden picket fence marks the perimeter of the Mather property along Brookside Road at the east and continues around the perimeter along Stephen Mather Road to the south. HL 2023.

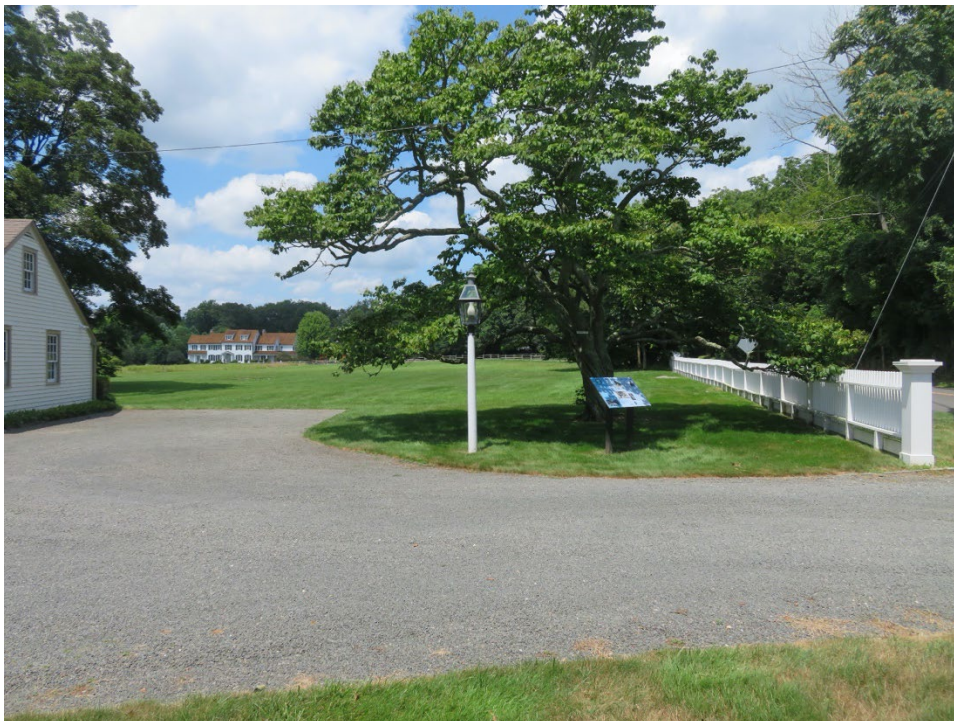
Figure 3.14 The view north from the Main House east lawn is framed by the Little House garage to the left and an antique flowering lilac tree (*Syringa reticulata*) to the right. This view extends across the mown turf and meadow beyond. A split rail fence marks the north end of the parcel. The neighboring residential property is visible in the background. HL 2023.

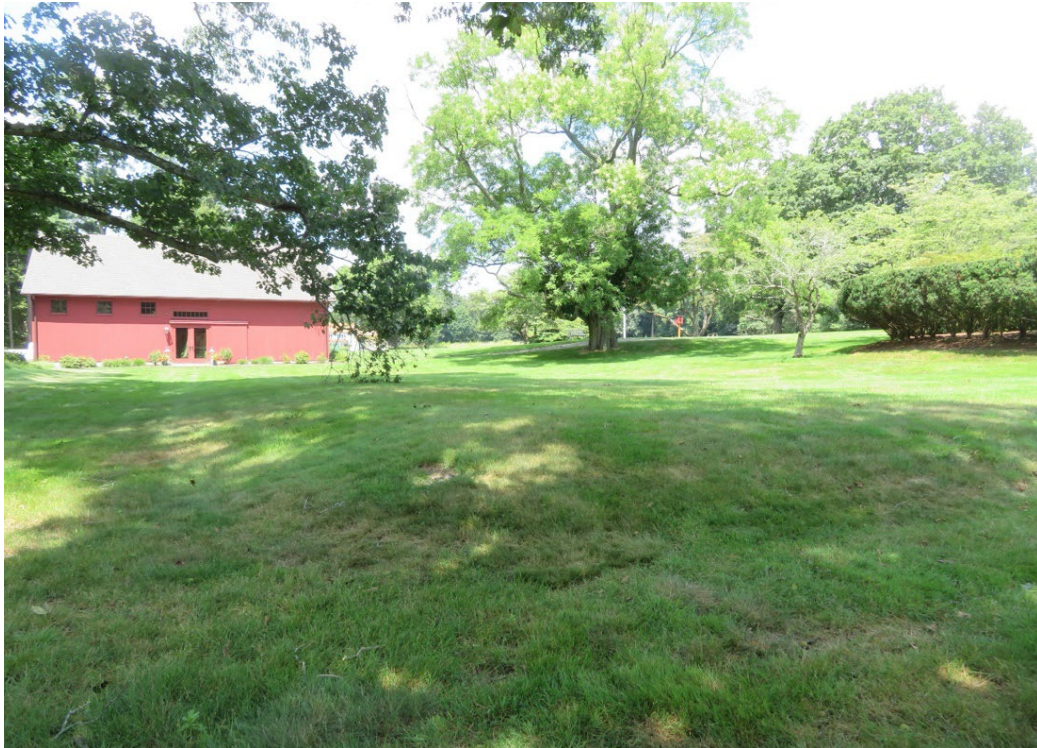
Figure 3.15 The graded terrace of the former tennis court is located west of the Sunken Garden. Today, the area is used to host lawn and tented events. The large historic Japanese Pagoda tree (*Styphnolobium japonicum*) in decline, appears to the east with the Education Center to the west. HL 2023.

The topography of LCA 1 generally slopes downward to the west from a relative high point at the intersection of Stephen Mather and Brookside Road. This gradual slope can best be seen along the property's southern fence, which runs parallel to Brookside Road. Exceptions to this overall slope are present, such as a naturally occurring knoll at the southwest corner of LCA 1. Evidence of human intervention is also noted, such as the artificial grading of the former tennis court and the level plane of the Sunken Garden, with the west end being graded slightly higher than the adjacent lawn space (**Figure 3.15**).

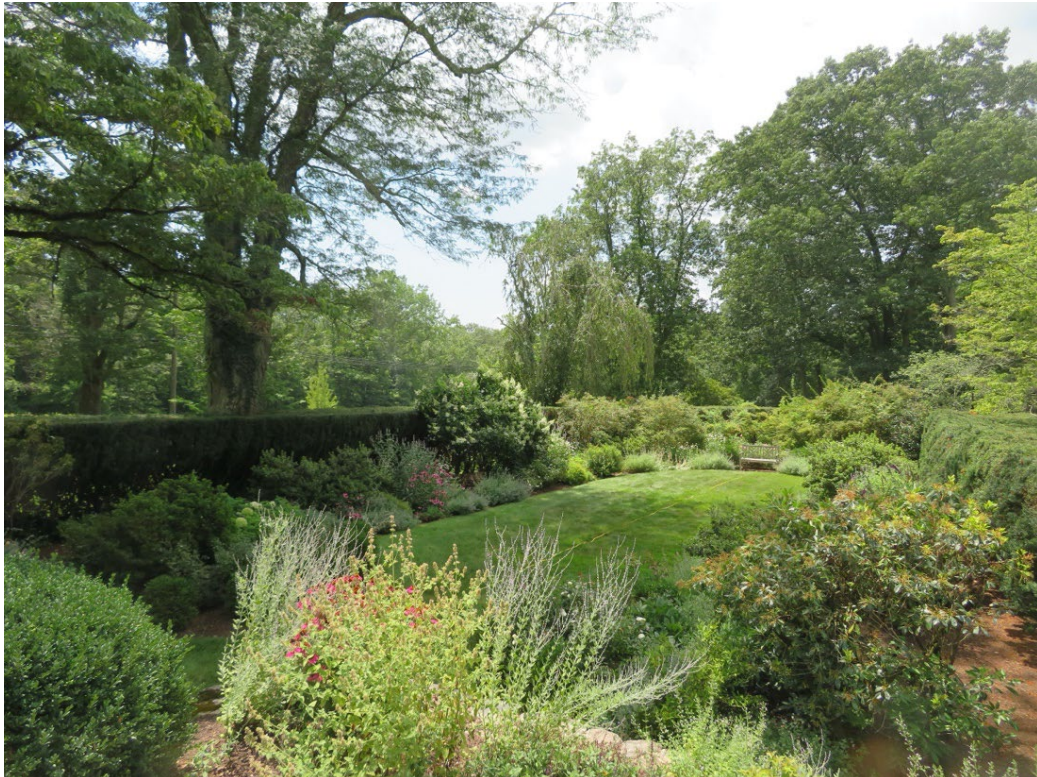
Figure 3.16 View into the Sunken Garden looking southwest from the Main House terrace across the central turf panel toward the tree grove on the natural knoll beyond. HL 2023.

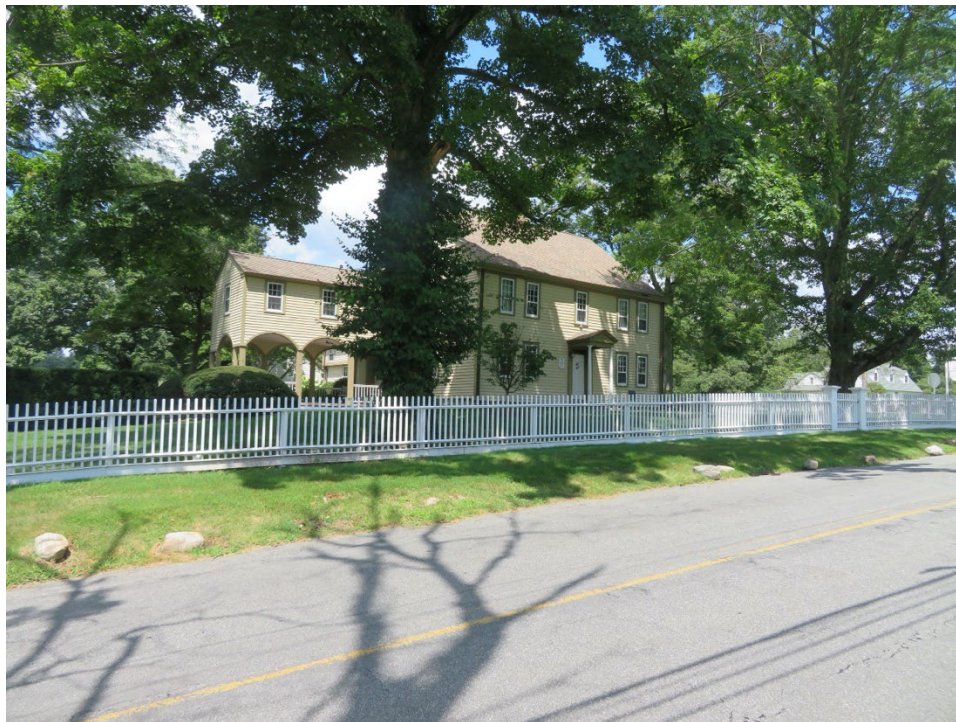
Figure 3.17 View of the white wooden picket fence and gate along the Stephen Mather Road south frontage. The Main House is framed by mature sugar maple trees (*Acer saccharum*). Several irregularly placed individual boulders prevent parking along the side of Stephen Mather Road. HL 2023.

Two mature red maple trees (*Acer rubrum*) frame the south façade of the Main House, with vining plants on the trunk of the westernmost maple tree (**Figure 3.17**). A small flowering sweetbay magnolia (*Magnolia virginiana*) sits in a mulched circular bed in the lawn near the southeast corner, and a young Kousa dogwood (*Cornus kousa*) is present along the flagstone walk. The turf lawn extends to the fence line along Stephen Mather Road. The west porch features ferns along the foundation and a large domed yew at the southwest corner. A 37-inch sugar maple (*Acer Saccharum*) dominates the west entrance of the Little House, balanced by an equally large sugar maple tree in the lawn to the north. To the west, at a corner of the drive, there is a 16-inch flowering dogwood (*Cornus florida*) surrounded by mown turf. Foundation plantings are also present along the façades of the Little House, including boxwood and andromeda, forming a hedge around the perimeter of the house.

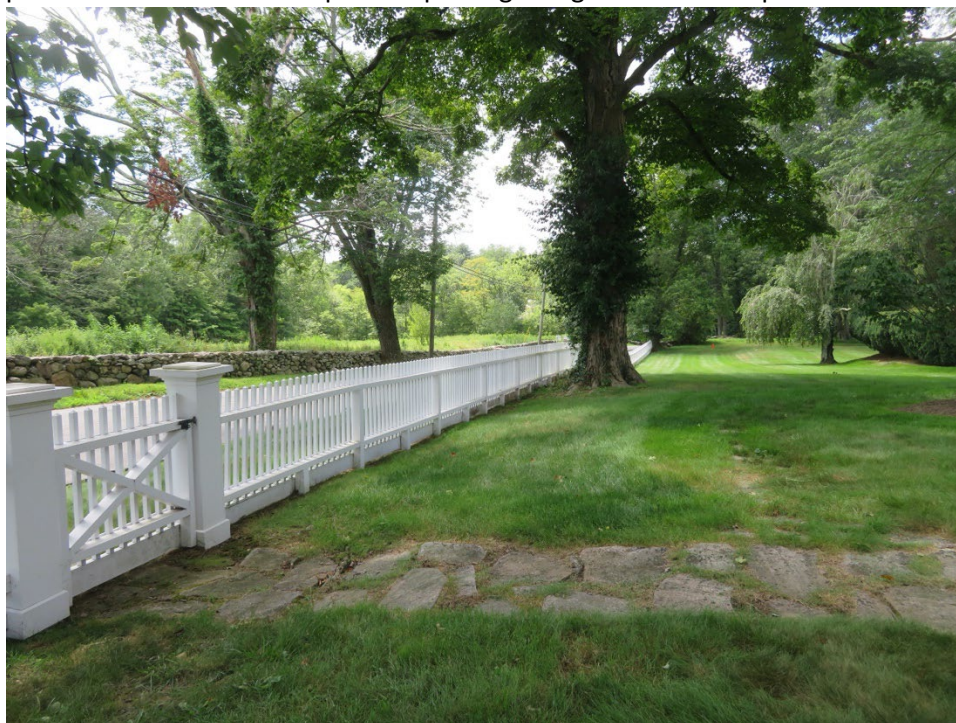
Figure 3.18 A wooden picket gate at Stephen Mather Road marks the pedestrian entrance to the Main House. The walk is paved with cut fieldstone between the gate and the main porch. A second walk segment, mostly obscured by grass, extends into the midground and provides access between the Main House front entrance and the covered west porch. HL 2023.
