MATHER HOMESTEAD CULTURAL LANDSCAPE REPORT

Mather Homestead Foundation
Draft for Review
January 2024

Heritage Landscapes LLC
Preservation Landscape Architects & Planners
Charlotte, Vermont & Norwalk, Connecticut

In 2023, the Mather Homestead Foundation commissioned Heritage Landscapes to prepare a thorough Mather Homestead Cultural Landscape Report (CLR) for this historically significant site. The CLR research findings indicate that originating as a productive, subsistence-based landscape, the Mather Homestead steadily evolved from its conception in 1778 to the present day. The property was designated as a National Historic Landmark in 1963 and inscribed on the National Register of Historic Places in 1966, with a boundary amendment in 1978.¹ The 1963 nomination notes its significance for its association

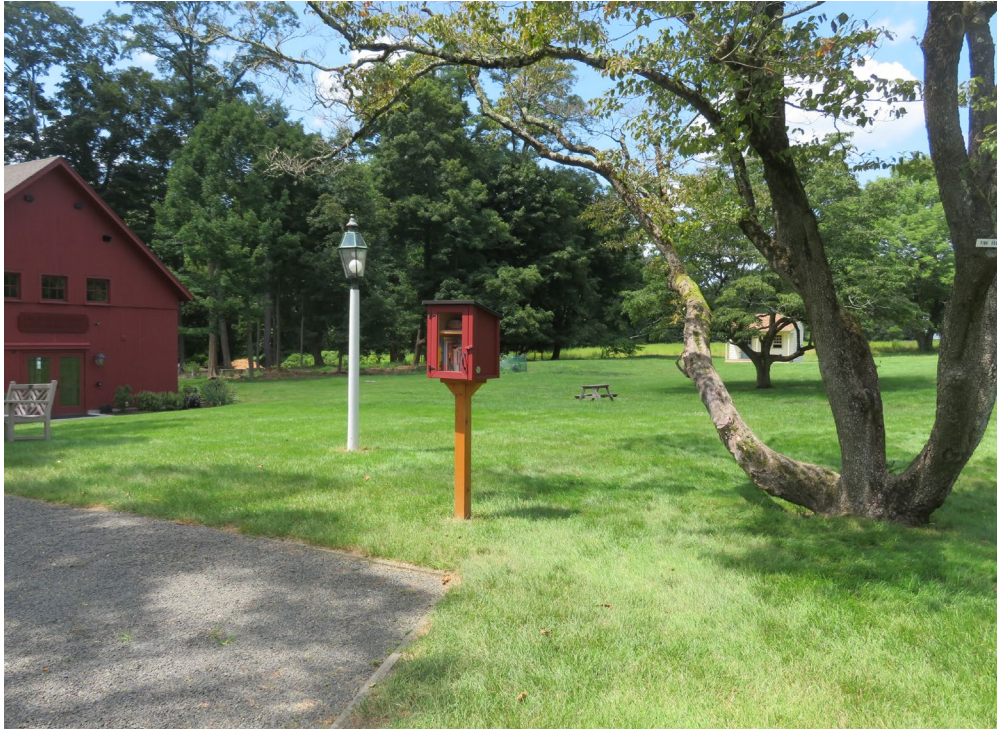
Figure 3.19 Small-scale features in LCA 1 include the free-standing Free Little Library cupboard and colonial-style light fixture atop a white-painted wood standard in the background. East of the Library cupboard is a multi-trunk pink flowering dogwood (*Cornus florida rubra*). HL 2023.

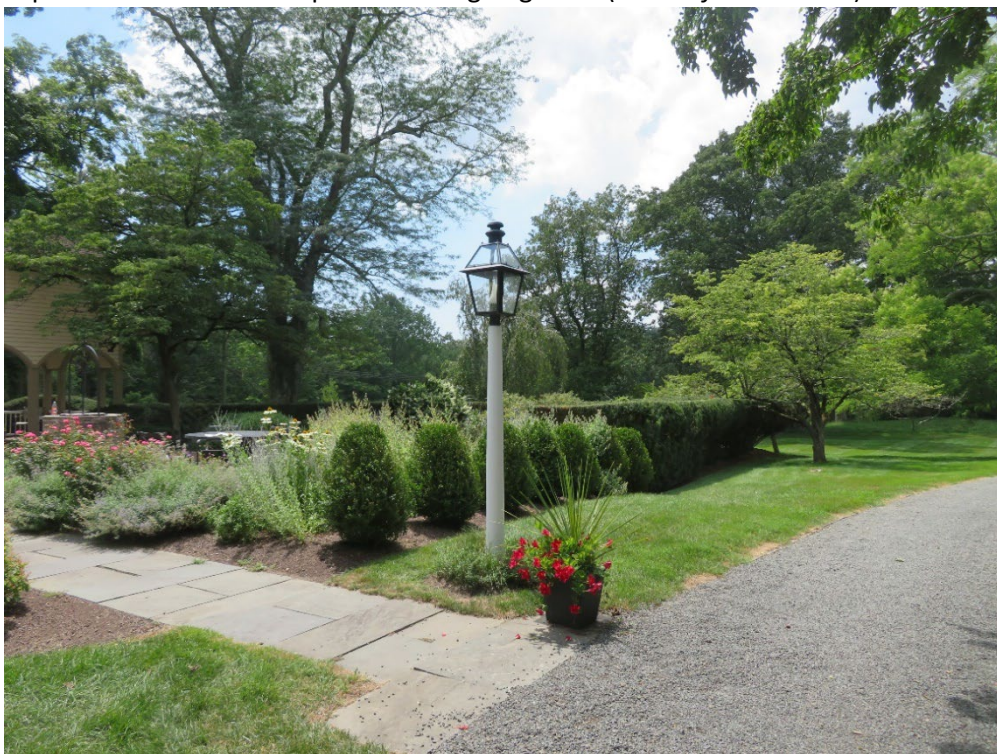
Figure 3.20 The colonial-style light fixture and wood standard located on the west side of the walk between the drive and brick terrace differs in style from the light fixture located further west along the drive. HL 2023.

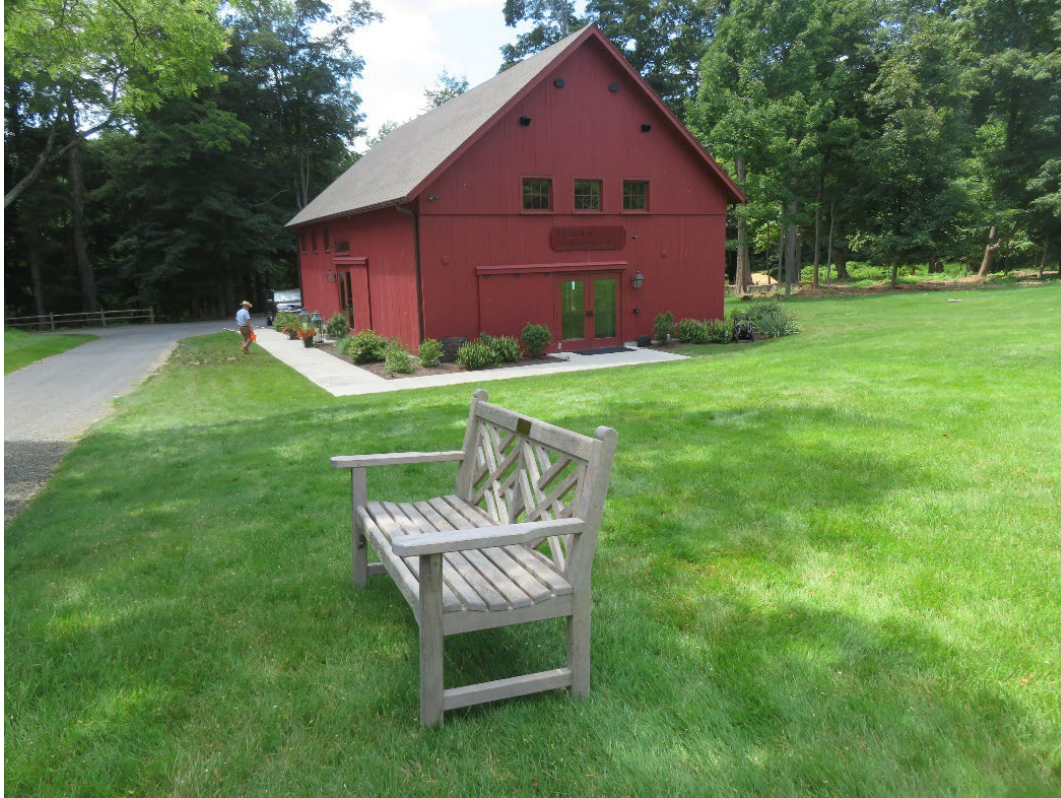
Figure 3.21 A movable teakwood bench is placed midway along the drive between the Main House and the Education Center in LCA 1 in this image. HL 2023.

Small-scale features in LCA 1 include several historic lampposts, a wrought iron table and chairs on the brick terrace, moveable outdoor seating in the covered west porch wing, interpretive signage near the drive entry from Brookside Road, and a Free Little Library structure beside the lamppost west of the Little House (**Figures 3.19 and 3.20**). Additional signage includes small hanging wooden signs identifying a number of trees and shrubs, a sign indicating the employee entrance on the east façade, the National Register plaque, a hanging signpost near the intersection, and two signs on the picket fence directing traffic to enter via Brookside Road. Wooden benches are present at the west end of the Sunken Garden and near the Free Little Library structure (**Figure 3.21**).

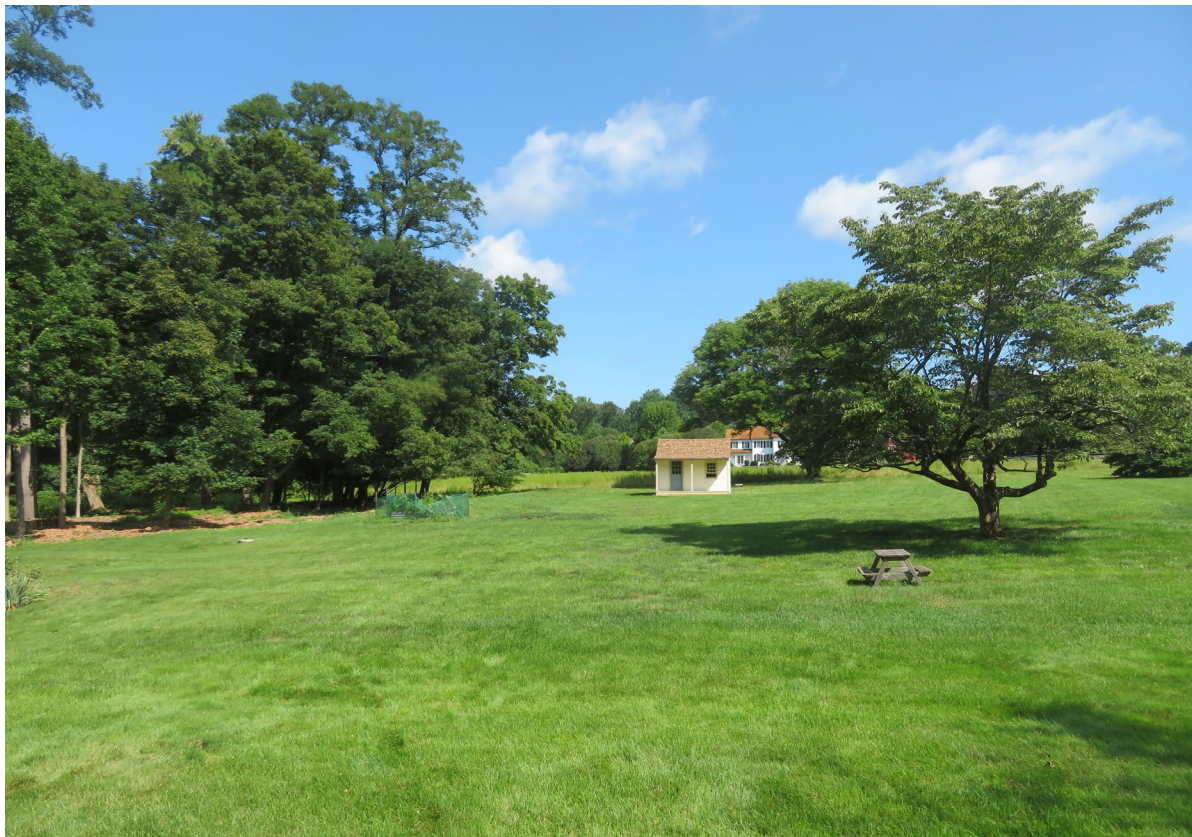
Figure 3.22 In this west view from LCA 2, the playhouse is seen in the background. To the west (left) is the dense vegetation mass marking the remnant linear planting of evergreen trees. To the east (right) a dogwood tree marks the west façade of the former greenhouse. HL 2023.

Outward views from LCA 2 are altered today. To the north, the historic vista is foreshortened by abutting residential properties (**Figure 3.22**). On the southern side, the view extends over the picket fence at Stephen Mather Road and beyond Mathers Meadows, reaching the woodland that defines the conservation land holdings. Looking east, upslope toward the Main House, the Sunken Garden border hedge sits below the elevation of the Main House. The turf foreground extends north across the west elevation of the Little House. Dominating this view is the multi-trunked Japanese pagoda tree (*Styphnolobium japonicum*) located at the curve in the driveway. Views west are obstructed by the densely wooded landscape within the wetland boundary of the river. The line of Norway spruce (*Picea abies*) along the west drive edge becomes a prominent foreground focus along with the mature maple trees on the knoll in the adjacent LCA 1.

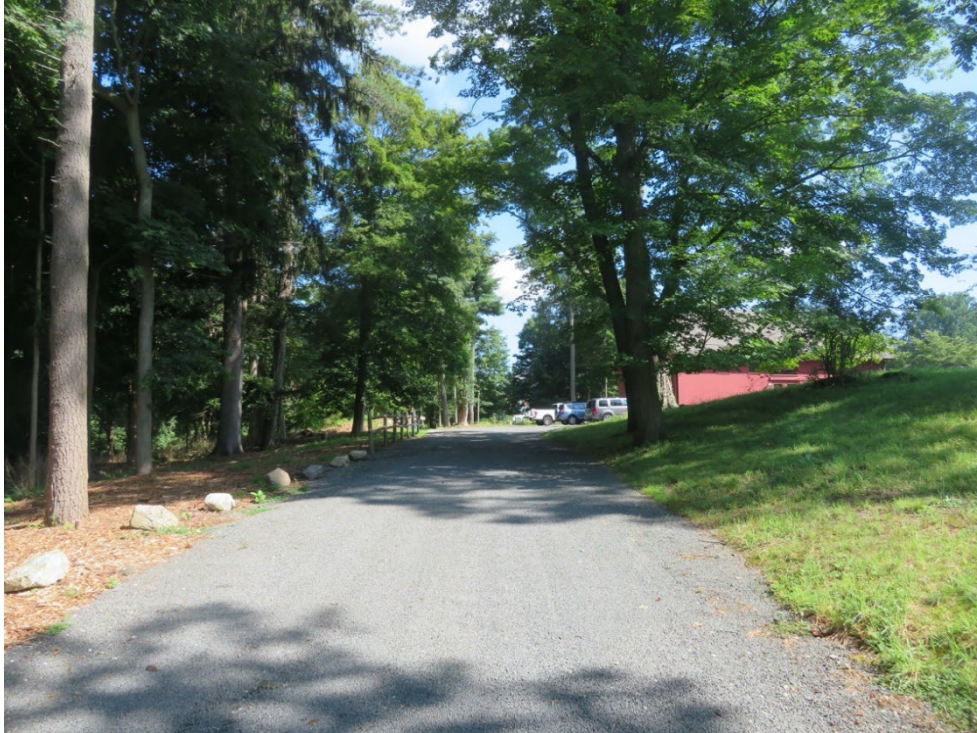
Figure 3.23 A gravel drive provides access from Stephen Mather Road to the western portion of the Homestead property. The gravel drive has an informal line of mature spruce trees to the west. To the east, the topography rises to the natural knoll and rock outcroppings dividing LCA 2 from LCA 1. HL 2023.

The gravel drive that enters from Stephen Mather Road is approximately 18 feet wide (**Figure 3.23**). This drive intersects at a right angle with the segment of the driveway approaching from the entry on Brookside Road. The 18-foot-wide portion of the gravel drive continues north alongside an asphalt-paved parking area on the west side of the Education Center. The parking area comprises four accessible spaces with access aisles, and one traditional parking space (**Figure 3.24**).

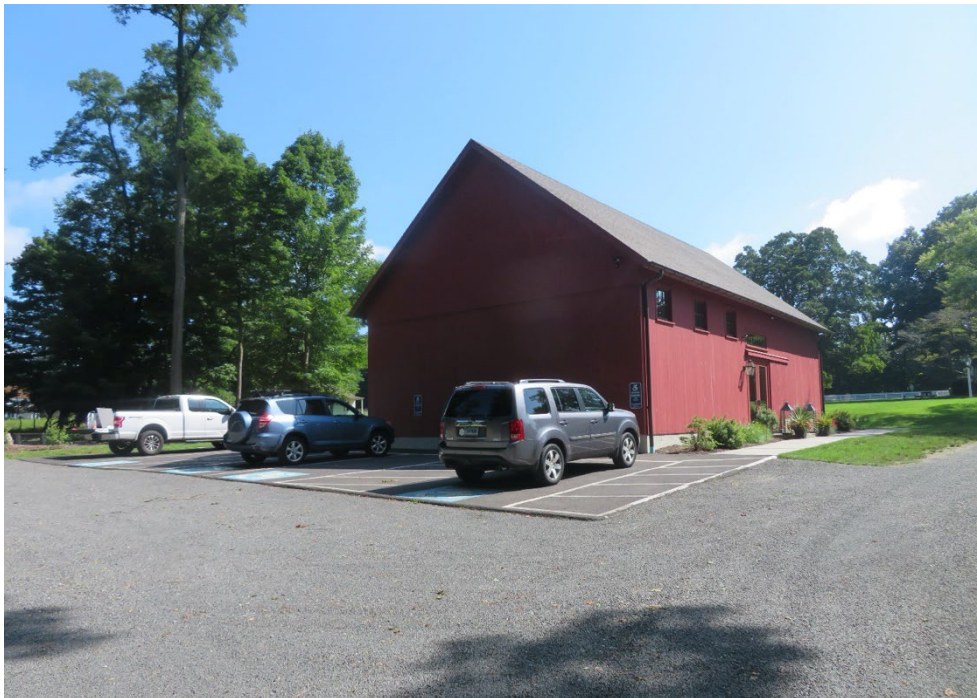
Figure 3.24 Visitor parking is located on the west side of the Education Center. The asphalt-paved parking area is set within the gravel driveway. Concrete walks provide access to entries at the south and east façades of the Education Center. A mature pine tree is seen north of the parking area, marking the southern end of a remnant evergreen allée. HL 2023.

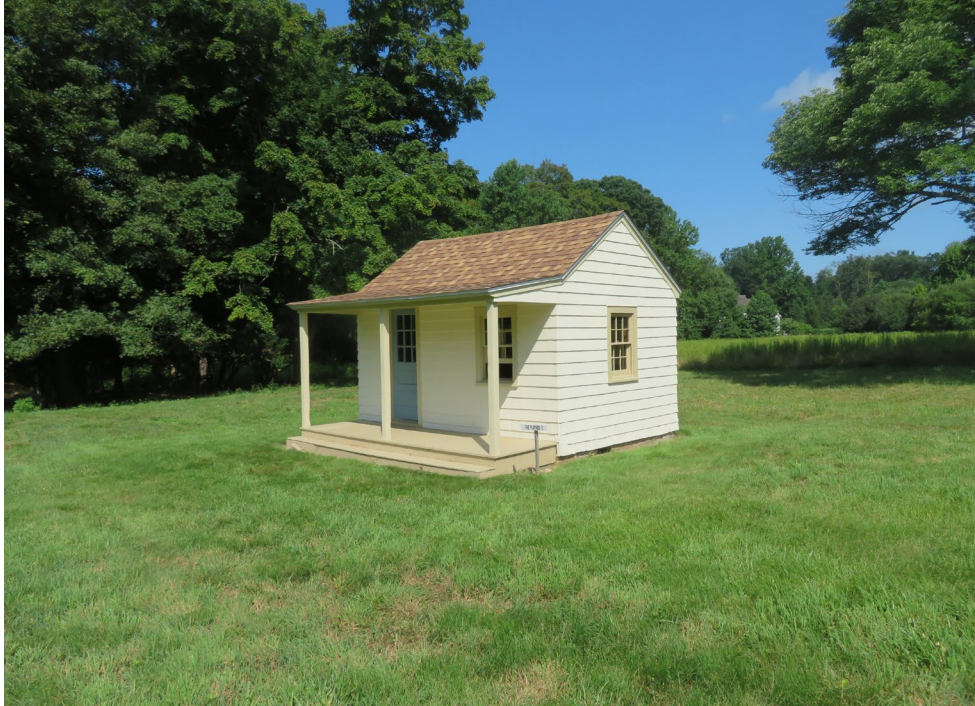
Figure 3.25 The playhouse is situated in the mown turf lawn, formerly marking the southern end of a small orchard of fruiting trees as seen in the 1934 aerial. This simple wood structure is set on a concrete footing and has a small wood porch, two steps above finish grade. The playhouse was recently restored in (0000) and is open for use by visiting children today. HL 2023.

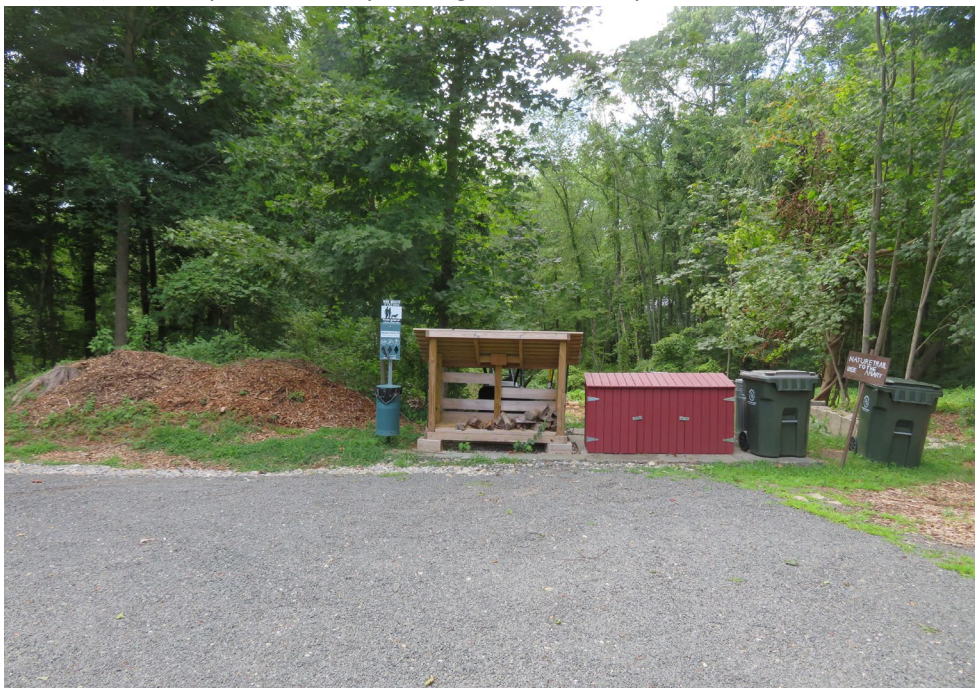
Figure 3.26 A small woodshed structure, wooden trashcan bin and recycling bins are located on the western edge of the drive on the west side of the Education Center. The mound of earth and organic material atop the root cellar can be seen at the left side of the image. A hand-painted wooden sign directs visitors north (right) to the apiary. HL 2023.

LCA 2 incorporates various small-scale features, including a dog waste station with a bag dispenser, a modest wood storage structure featuring an open face and shed-style roof, and a wooden bin for trash and recycling containers (**Figure 3.26**). Small wooden benches, constructed as part of a 2022 Eagle Scout project, serve as seating for the outdoor educational area located north of the Education Center (**Figure 3.27**). Along the west side of the drive, individual stones are placed to deter parking. Signage in LCA 2 includes a hand-painted sign indicating the mulch ‘Nature Trail’ leading to the apiary, markers for designated accessible parking spaces, and small metal botanical labels identifying selected plantings in foundation beds around the Education Center.

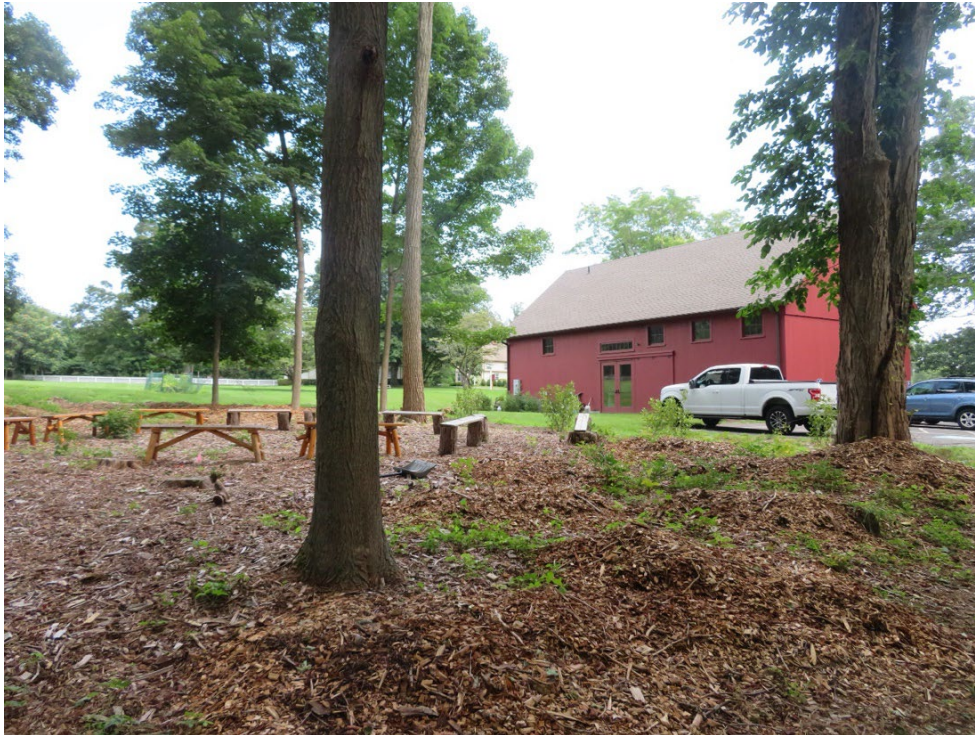
Figure 3.27 This image captures a circular arrangement of wooden benches in a clearing located north of the Education Center. The area serves as an outdoor educational space. Trees in the foreground comprise a remnant portion of the former evergreen allée in this area. HL 2023.

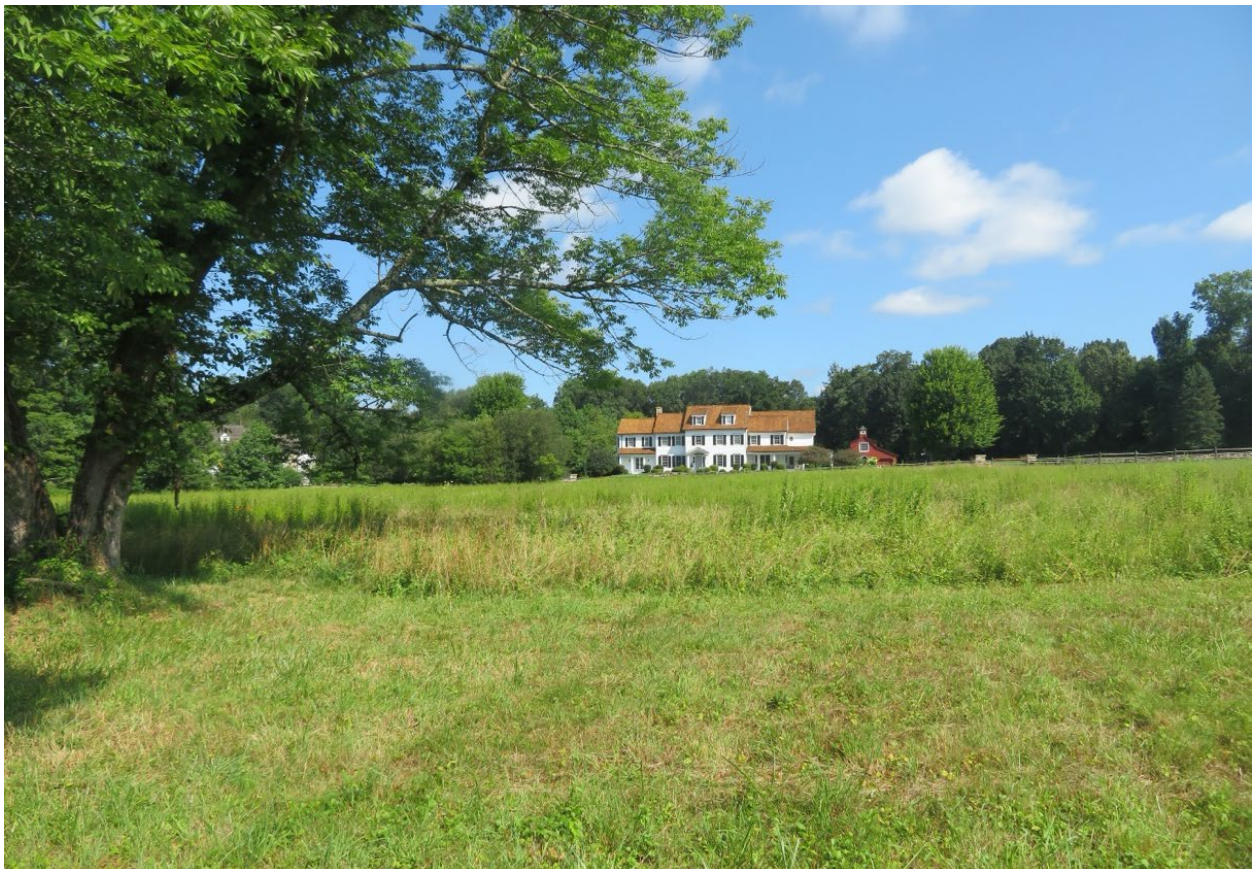
Figure 3.28 This north-facing image captures the transition between the mown turf lawn of LCA 2, in the foreground, and the managed meadow of LCA 3 in the midground. In the background, neighboring residences are clearly visible from the core of the historic Homestead property. HL 2023.

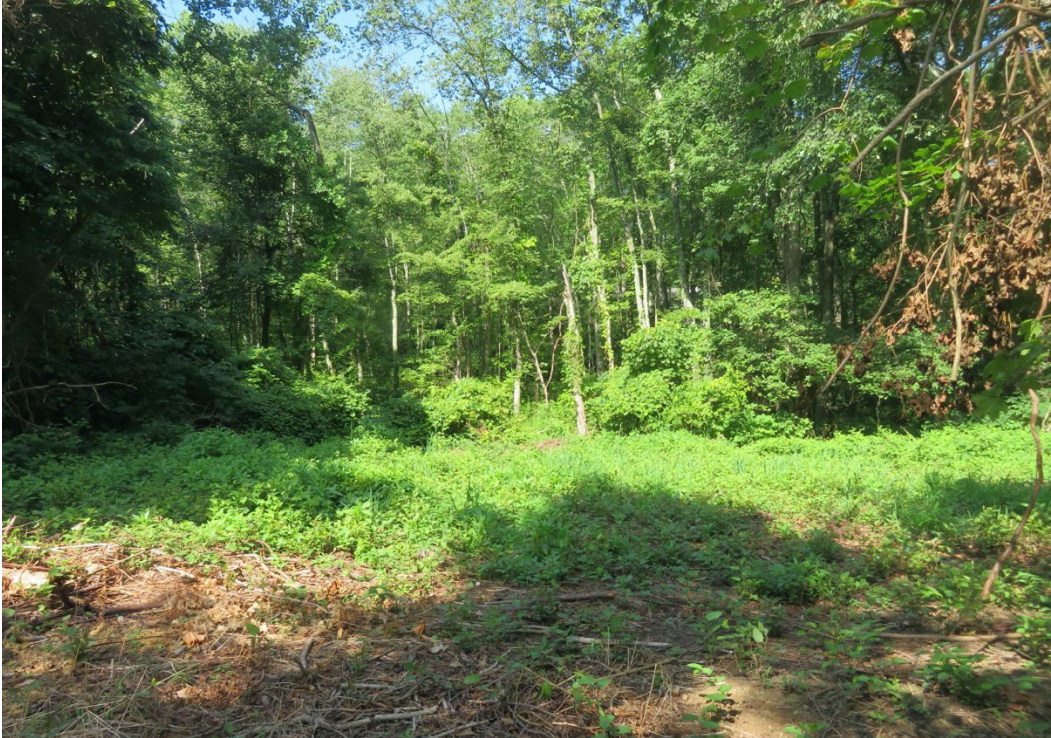
Figure 3.29 The vegetative cover along the western border within the conservation area is a mix of deciduous hardwood trees overhead and an invasive species understory. Japanese knotweed (*Fallopia japonica*) has recently been cleared, as evident in the foreground. HL 2023.

The vegetative cover in LCA 3 is best described in three distinct typologies: the mixed deciduous canopy and understory wetland cover (**Figure 3.29**), which spans the area between the meadow planting and the river's edge; the managed meadow; and the bi-annually mown turf cover as the extension of the Mather Homestead core area. Situated at the southwest corner of the meadow, a hexagonal garden plot, defined by wooden timbers, contains herbaceous pollinator plant species and functions as an educational exhibit. The garden plot, along with two beehives, was added in 2021. A single red maple (*Acer rubrum*) is located at the northern edge of the meadow closest to the shared private drive. Along the stone wall at Brookside Road, there is a stand of invasive Norway maple (*Acer platanoides*) trees that also contain slippery elm (*Ulmus rubra*) and black locust (*Robinia pseudocacia*) growing between four large stumps. Below this tree grouping, there is a mix of invasive species, herbaceous plants and vines, including poison ivy (**Figure 3.30**).

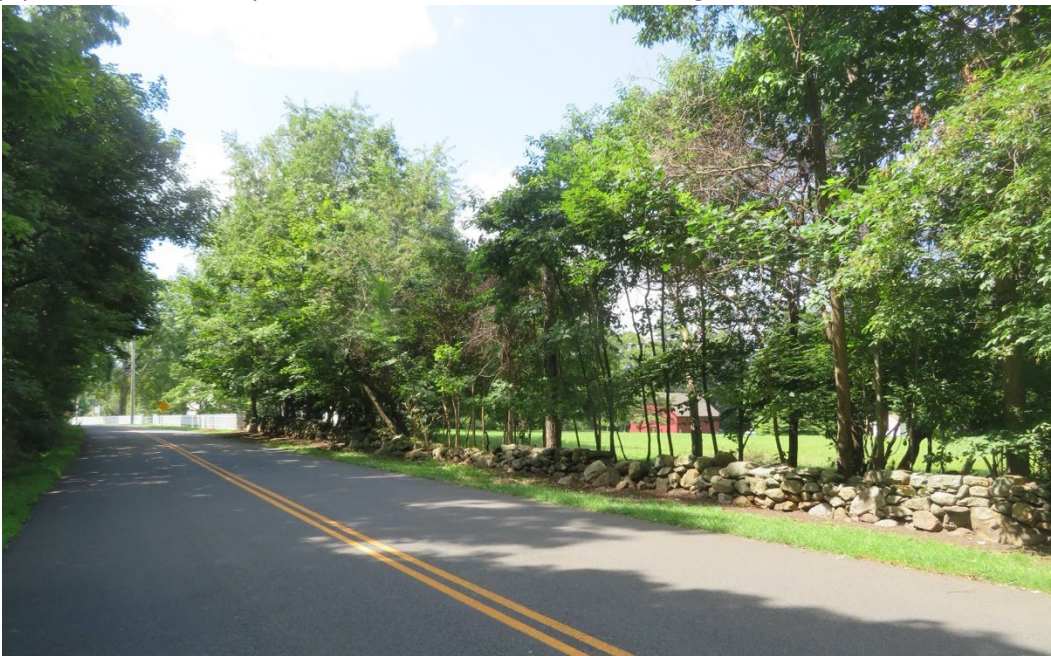
Figure 3.30 Stone walls along Brookside Road delineate the northern portion of the east property boundary. Behind the wall, successional vegetative growth includes a combination of black locust (*Robinia pseudoacacia*), black cherry (*Prunus serotina*), and Norway maples (*Acer platanoides*), accompanied by a variety of mixed herbaceous species below. Four large tree stumps remain inside of the wall. HL 2023.

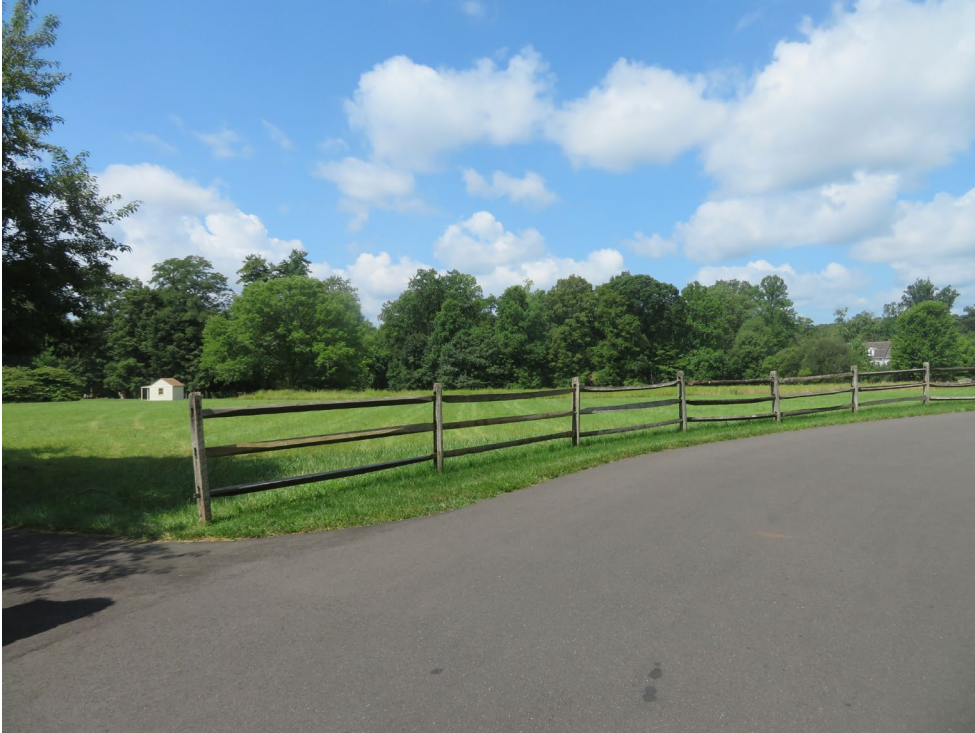
Figure 3.31 A three-rail split cedar fence defines the northern boundary of the property. The asphalt shared drive provides access to the three residential parcels north of the Homestead. To the south of the fence lies the right-of-way for vehicular access to the Darien Land Trust parcel. HL 2023.

The predominant landscape structure in LCA 3 is a three-rail, unfinished split rail fence (**Figure 3.31**). This fence lines the shared drive along the north end of the meadow and turf lawn, extending from the western property boundary to approximately eight feet short of the stone pier at Brookside Road. There are no buildings present within either the Darien Land Trust holdings or the extended turf field managed by the Mather Foundation.

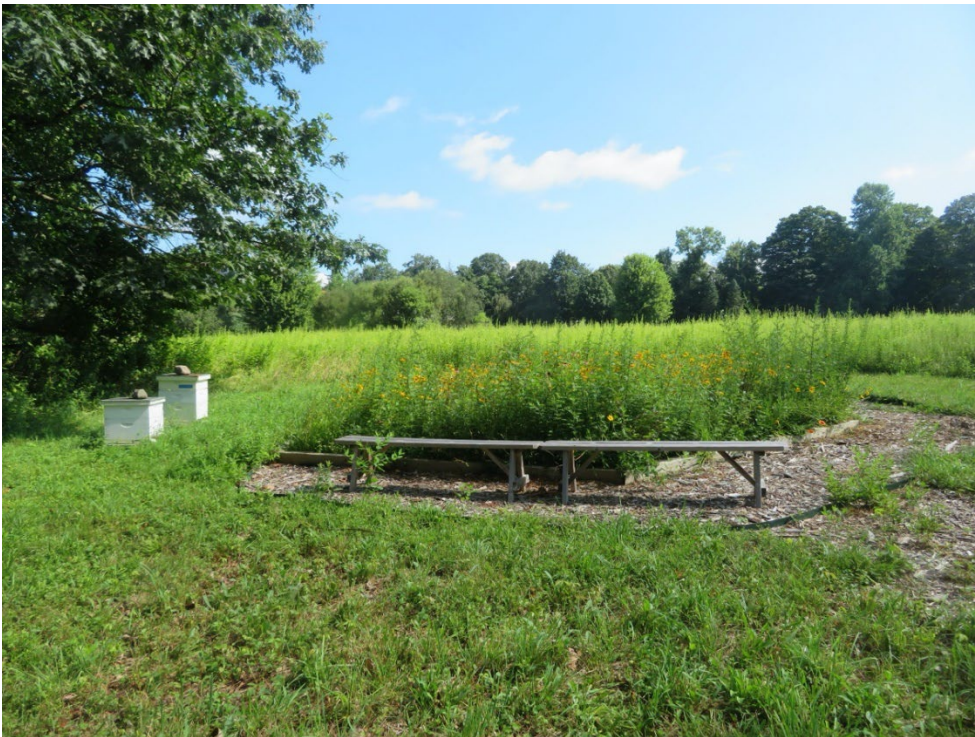
Figure 3.32 A small apiary, featuring two beehives, a pair of wooden benches, and a central garden bed planted with pollinator species, is located at the southwest corner of the meadow. The 1.5-acre meadow extends to the north property boundary. HL 2023.

Notable small-scale features in LCA 3 include two wooden beehives and backless wood benches as components of the apiary located at the southwest corner of the meadow (**Figure 3.32**).

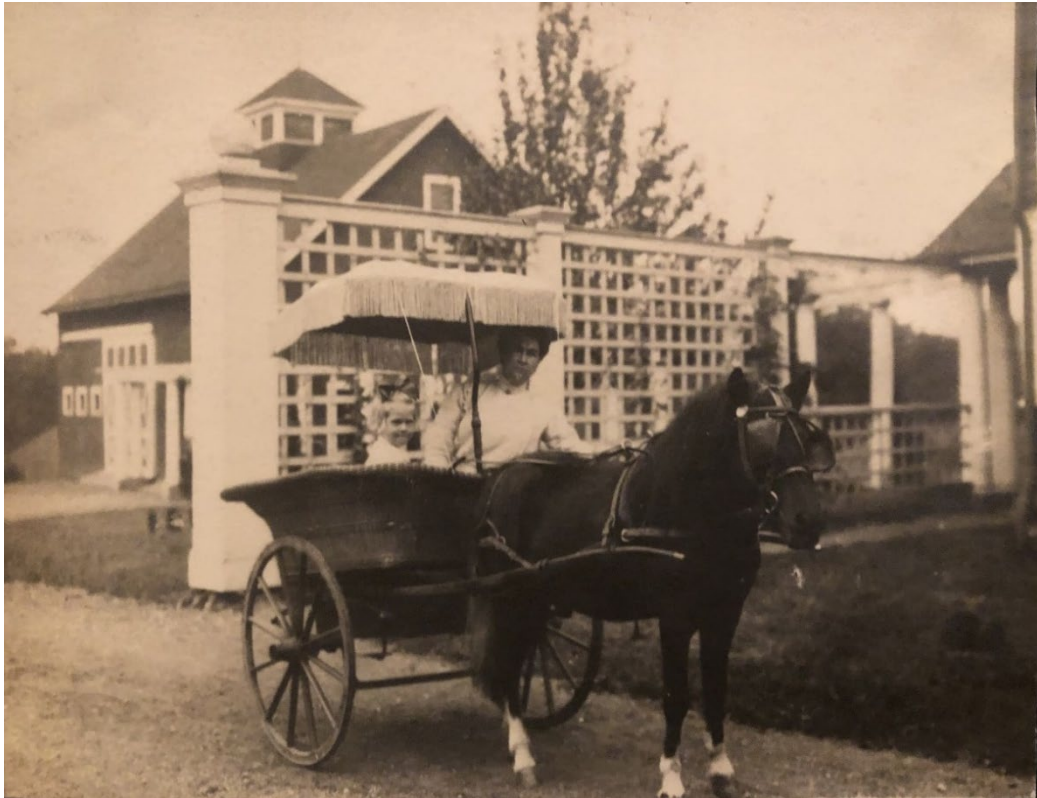
Figure 4.1a This circa 1909 photograph of Bertha and Jane Mather in a horse-drawn cart in the gravel drive also captures the laticework trellis extending north to the entry portico of the caretaker's cottage, and the pergola extending west from the portico to the barn built in 1906. A gravel path runs along the inside of the trellis from the drive to the portico. Courtesy McPherson-Nickerson family.

In the domestic core of LCA 1, several space-forming elements from the Stephen T. Mather era are now absent. These include two parallel white wooden latticework trellises, which ran north-south between the Main House and the Little House; the white wooden pergola for climbing wisteria, extending west from the Little House to the northwest corner of the driveway; and the grape arbor, extending north from the Little House (**Figure 4.1a.b**).

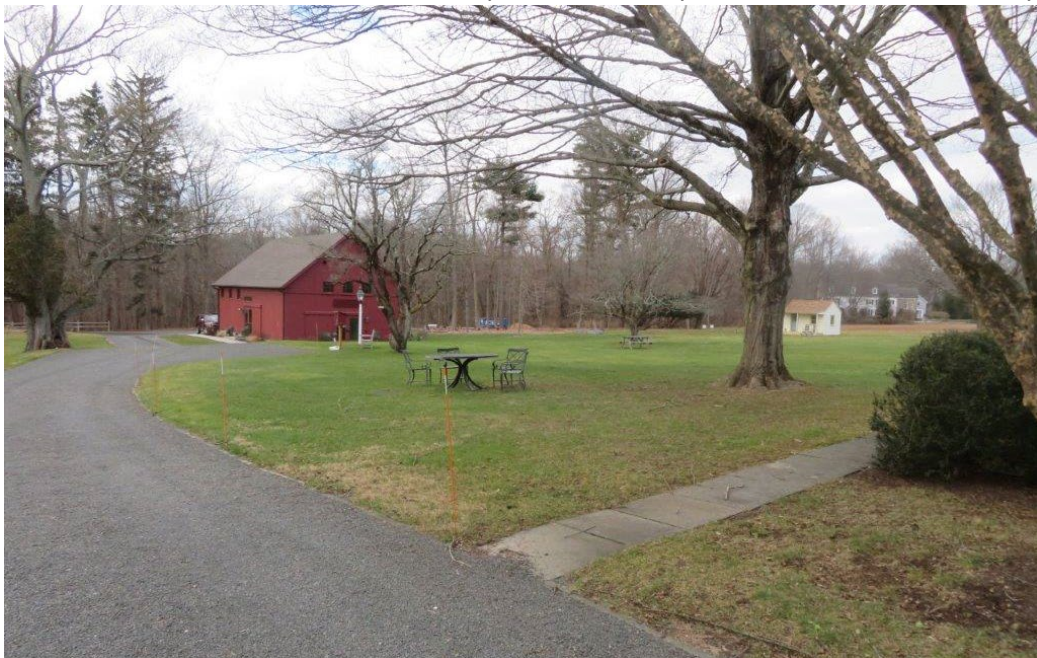
Figure 4.1b This 2024 repeat photograph captures the gravel drive in the foreground and the slate path leading north to the Little House. The laticework trellis and wooden pergola are both missing, and the footprint of the historic 1906 barn is now mown lawn. HL 2024.

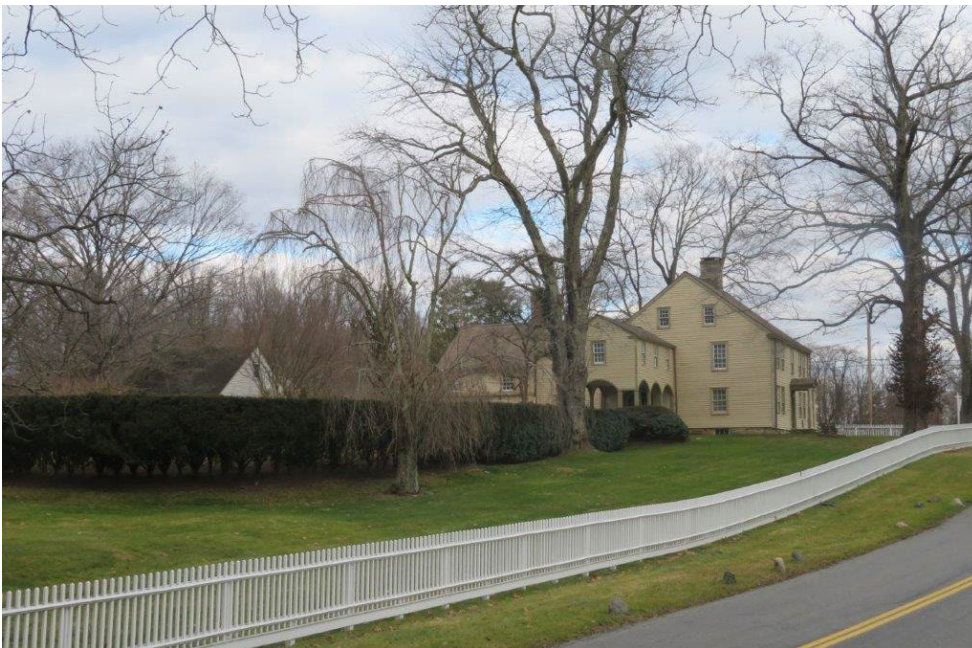
Figure 4.2b Repeat view in 2024 shows the same gentle grade rising to the west along Stephen Mather Road toward the Main House. The Little House, built in 1965, is one story shorter than the former caretaker's cottage, and the increased height of the yew hedge around the Sunken Garden partly obscures the view of the smaller structure. Mature shade and flowering trees stand between the Sunken Garden and the road, which is lined sporadically with stones to discourage parking. HL 2024.

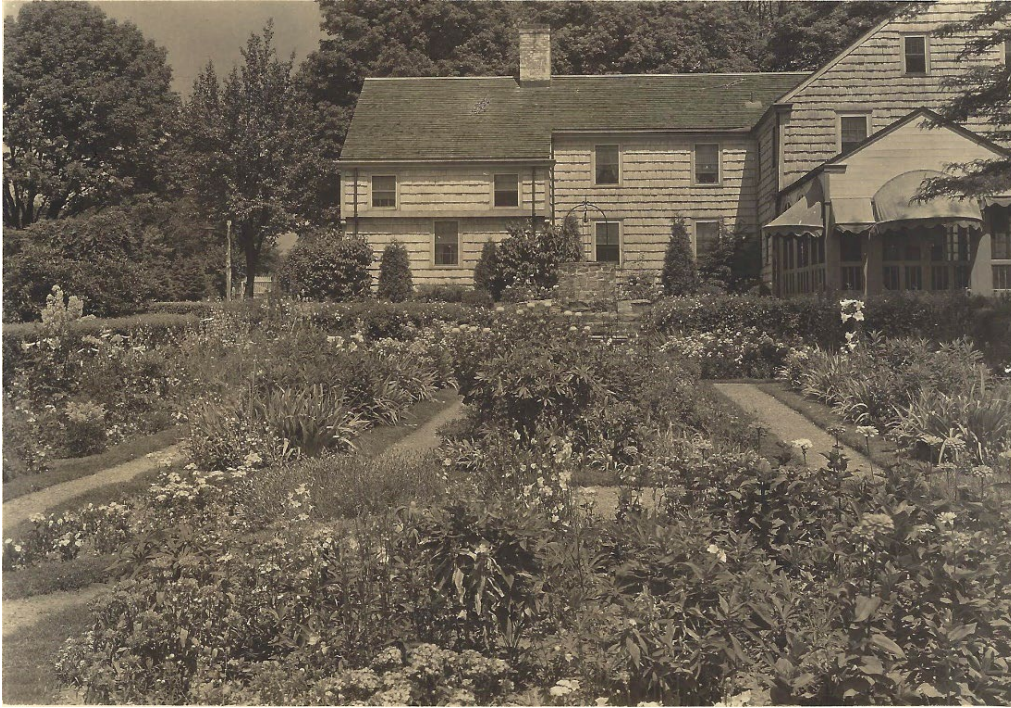
Figure 4.3a Circa 1929 view east from the Sunken Garden toward the Main House. Geometric planted beds occupy the center of the garden, divided by narrow gravel paths. The stone wellhead appears in the background. Conical evergreen shrubs line the Main House foundation. A low hedge encircles the perimeter of the garden. Courtesy MHF.

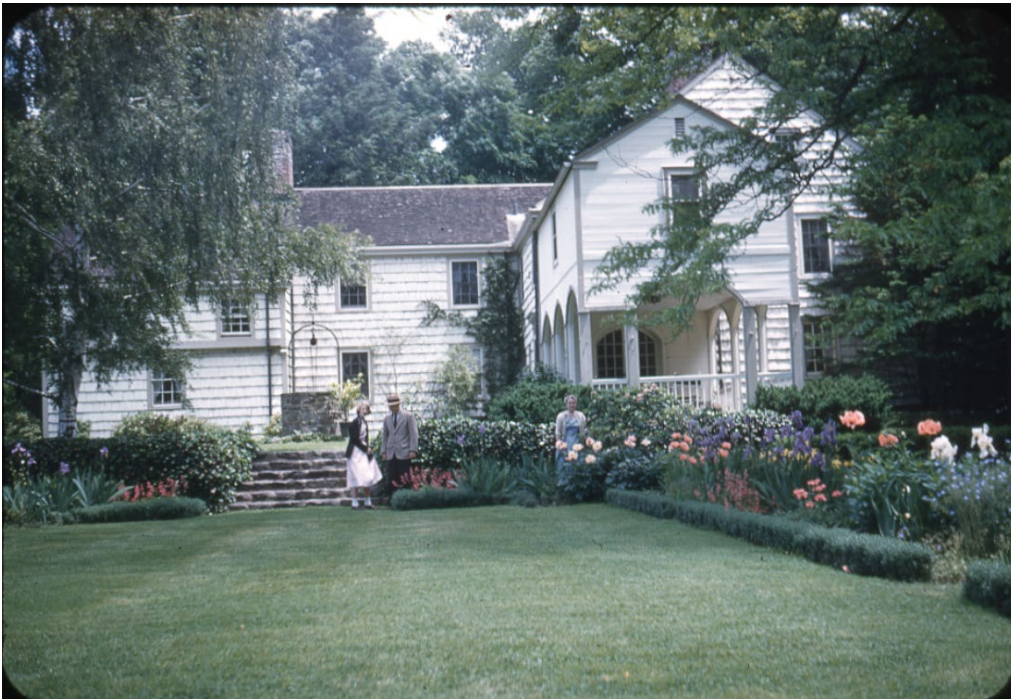
Figure 4.3b 1954 photograph of the view east from the Sunken Garden toward the Main House. A mown lawn panel has replaced the planted beds. A flowering border fills the space between the perimeter yew hedge and a low grassy edge. The stone steps ascending to the well are visible. A weeping birch tree hangs over the northeast corner of the garden. Courtesy MHF.

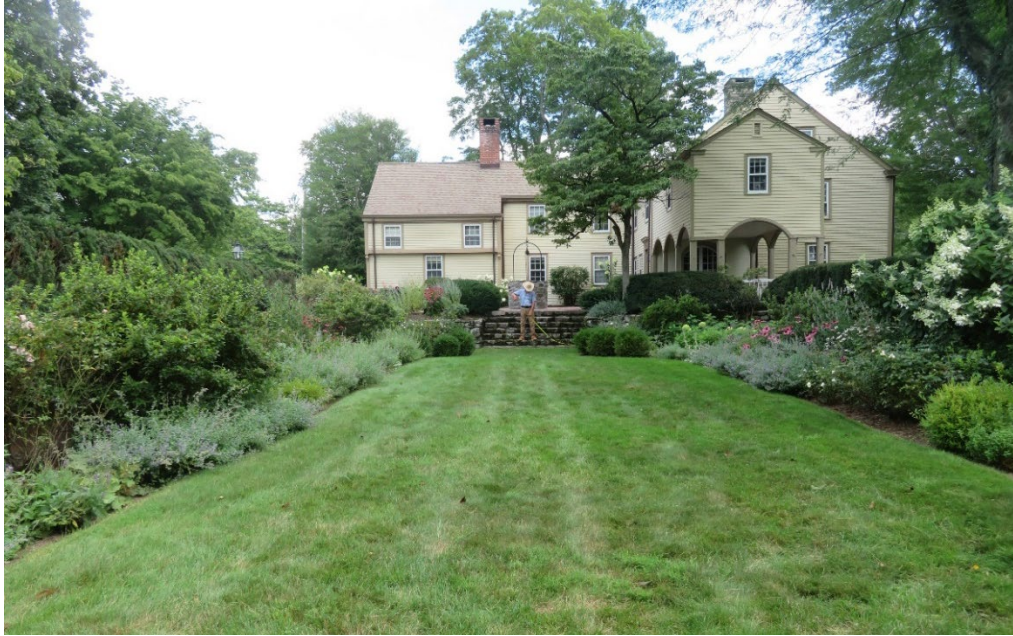
Figure 4.3c In 2023, a deciduous tree near the west porch wing partly obscures the view of the Main House. The weeping birch on the north side is now missing. The planted beds around the perimeter of the Sunken Garden are wider, resulting in a narrower lawn panel, and lack the defined edges that appear in the 1954 image. HL 2023.

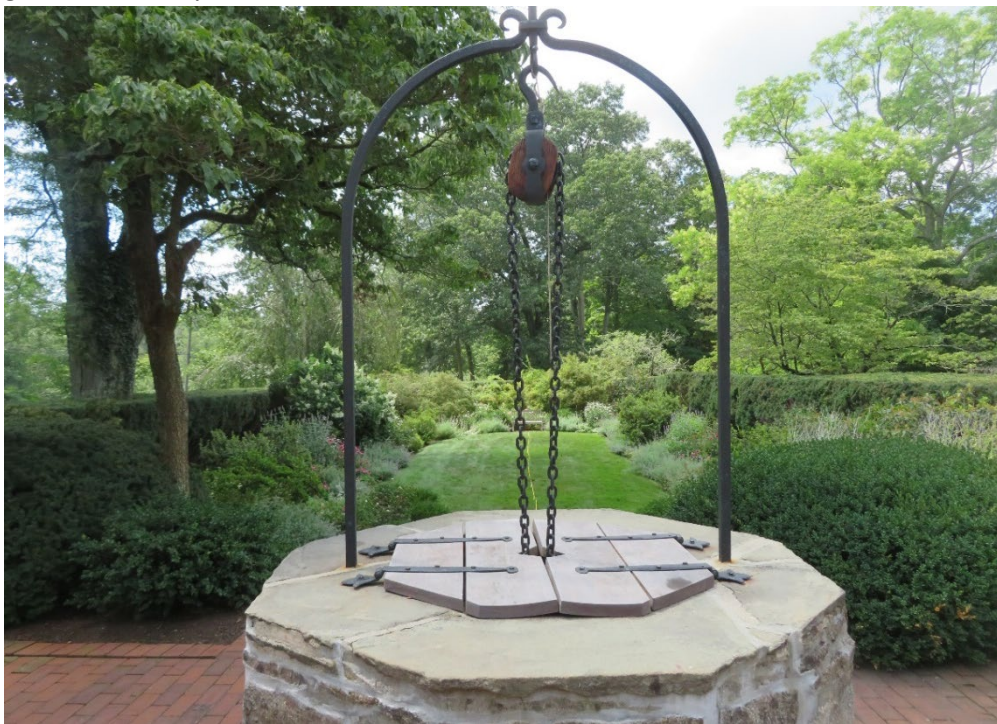
Figure 4.4c In 2023, the perimeter yew hedge and the domed hedges above the retaining walls have both grown in scale. The 1962 brick terrace is in place around the wellhead. The formerly linear edges of the central lawn panel within the Sunken Garden are now naturalistic, with a smaller area of open lawn.

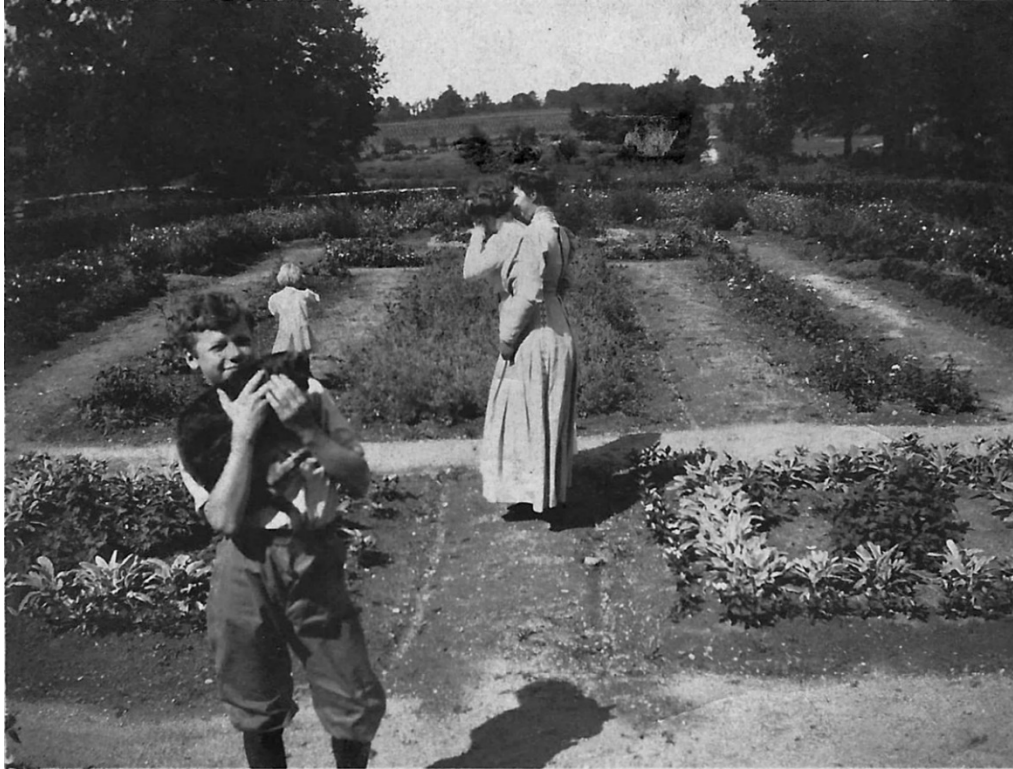
Figure 4.5a This 1912 photograph shows the western view from the Sunken Garden. On the left side of the image, a stone wall lines Stephen Mather Road. In the background, a shrub- and tree-dotted expanse descends to another stone wall that marks the property boundary with Goodwives River. Beyond the river, the grade rises to a neighboring open field. In the foreground, four individuals stand in the Sunken Garden, including Jane Mather (center) and young Bertha Mather. Courtesy MHF.

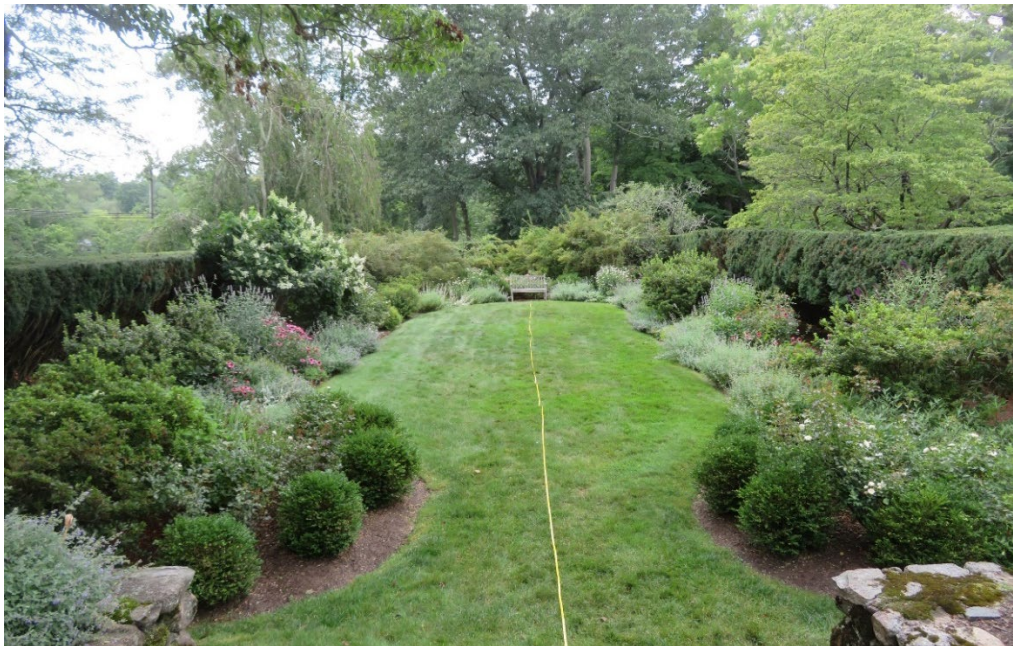
Figure 4.5b This view of the Sunken Garden in 2023 exhibits significant change from the 1912 condition, although the open lawn panel and flowering border align with Lilian Egleston's 1938 design. To the west, dense woodland vegetation blocks the view over Goodwives River. HL 2023.

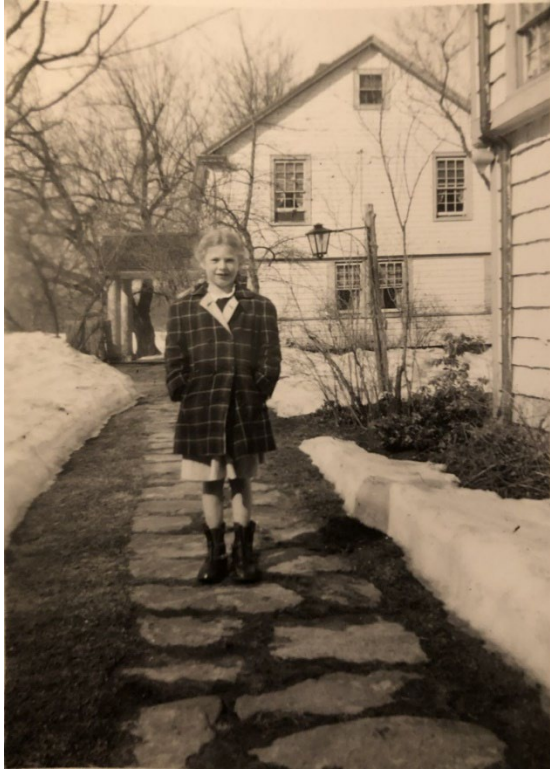
Figure 4.6a Circa 1950 photograph of Jane McPherson standing on the fieldstone walk between the Main House (right) and the caretaker's cottage. The ground plane is surfaced with grass. The latticework trellis between the two houses is no longer present. A lantern light fixture is installed atop a wooden post on the right side of the path. Low shrubs line the foundation of the Main House to the right. Courtesy McPherson-Nickerson family.

The lantern light posts present today are not the same light fixtures that appear in historic photographs (**Figure 4.6a,b, and 4.9b**).

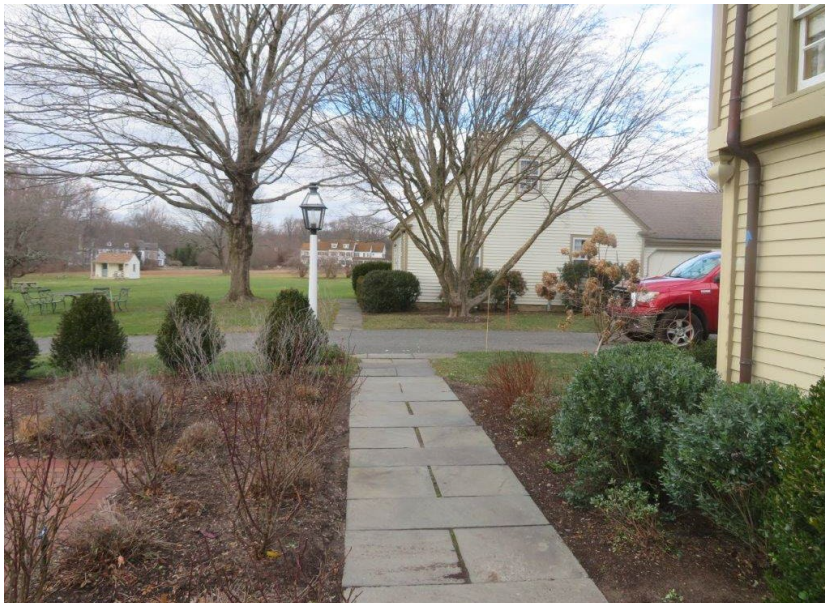
Figure 4.6b 2024 image showing the slate walk, no longer fieldstone, leading alongside the brick terrace to the gravel drive. A second, slightly offset slate walk resumes on the north side of the drive and proceeds to the Little House. Rounded yew shrubs line the Main House foundation. Bordering shrub plantings around the brick terrace flank the left side of the walk.

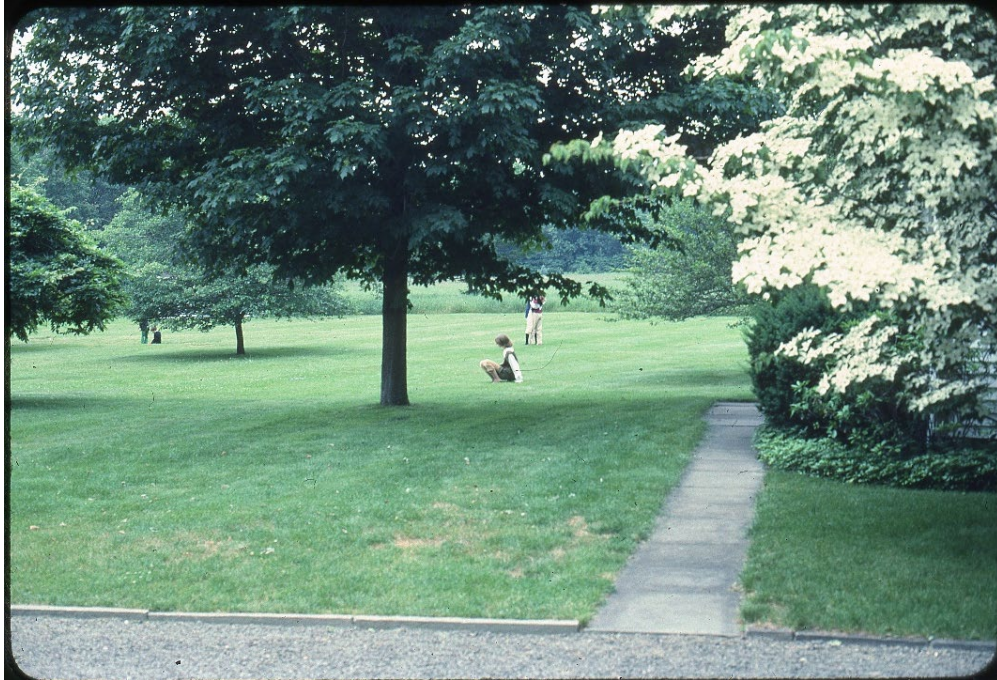
Figure 4.7a 1978 view north from the drive captures the bluestone walk to the Little House front (west) entry. The wisteria pergola is no longer present, nor is the greenhouse. A mown lawn extends north, meeting tall grasses that continue north to a woodland area. The playhouse sits in the left background, obscured by a flowering or fruiting tree in the lawn. Courtesy MHF.
