MATHER HOMESTEAD CULTURAL LANDSCAPE REPORT

Mather Homestead Foundation
Draft for Review
January 2024

Heritage Landscapes LLC
Preservation Landscape Architects & Planners
Charlotte, Vermont & Norwalk, Connecticut

In 2023, the Mather Homestead Foundation commissioned Heritage Landscapes to prepare a thorough Mather Homestead Cultural Landscape Report (CLR) for this historically significant site. The CLR research findings indicate that originating as a productive, subsistence-based landscape, the Mather Homestead steadily evolved from its conception in 1778 to the present day. The property was designated as a National Historic Landmark in 1963 and inscribed on the National Register of Historic Places in 1966, with a boundary amendment in 1978.¹ The 1963 nomination notes its significance for its association

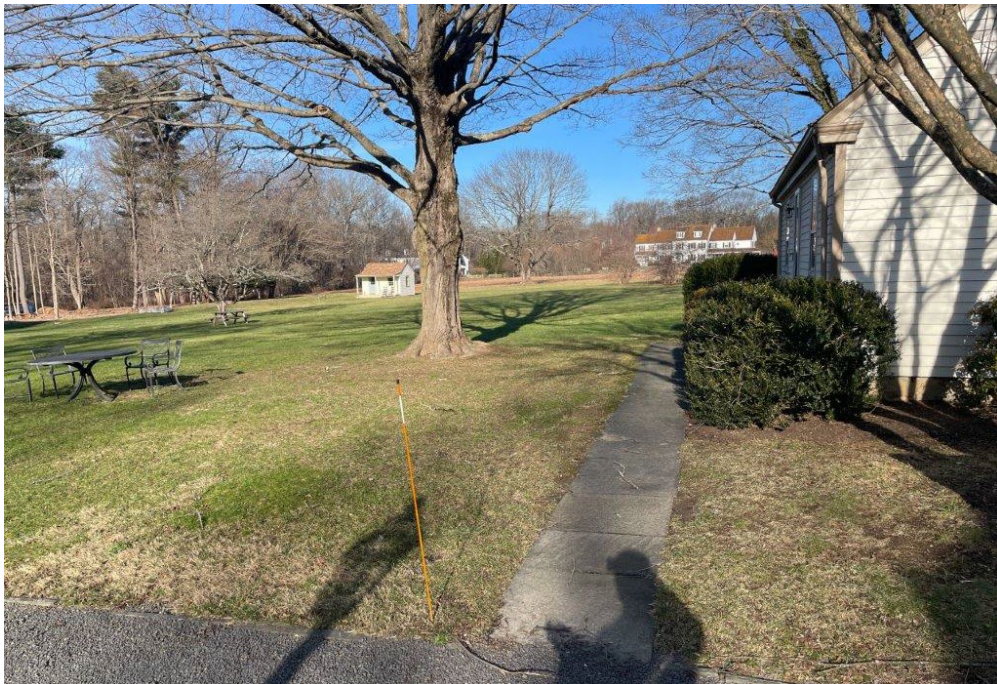
Figure 4.7b Repeat view in 2024 captures the slate walk leading from the curb-edged gravel drive to the front entry of the Little House. The mature sugar maple west of the house is present, and the branches of the Kousa dogwood appear on the right side of the image. The playhouse is visible in the background, as is the neighboring residential property to the north. The patio table and chairs, formerly located on the brick terrace, have been moved to the lawn. HL 2024.

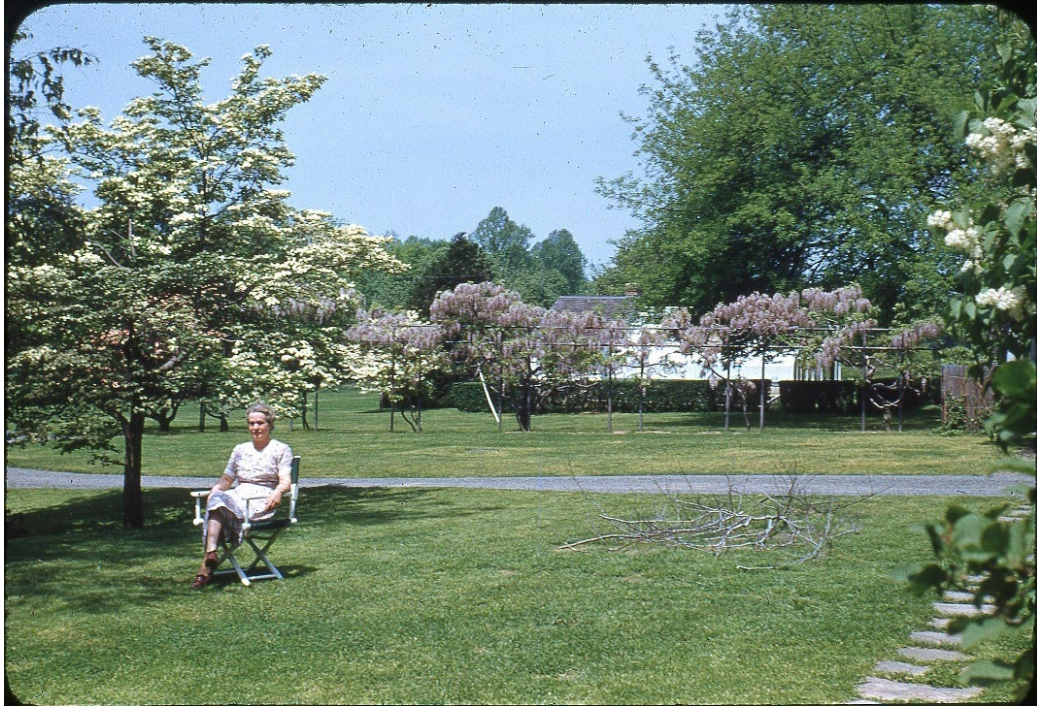
Figure 4.8a This 1951 image captures the bluestone walk from the Main House to the Little House and the wisteria pergola, now constructed with metal poles, extending west from the Little House. Beyond the pergola, a low hedge flanks the greenhouse. Courtesy MHF.

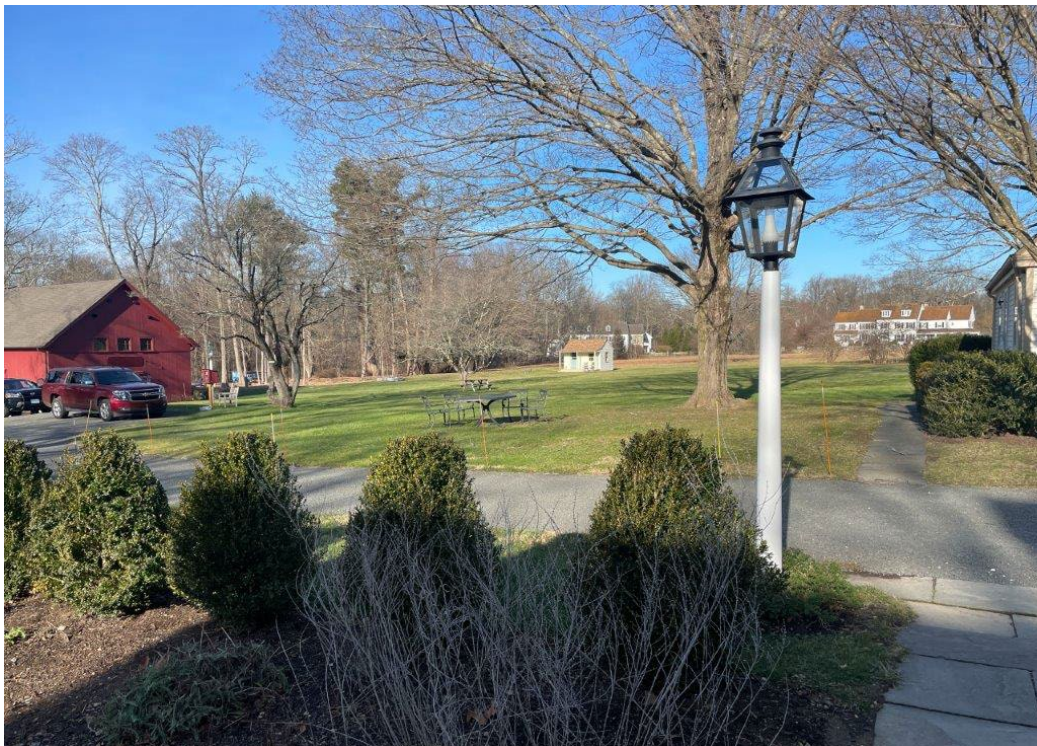
Figure 4.8b In 2024, perimeter beds planted with shrubs enclose the brick terrace along the west façade of the Main House. A linear planting of evergreen shrubs lines the northern border of the bed along the gravel drive. A lamppost stands on the west side of the bluestone path. In the distance, the wisteria arbor, greenhouse, and surrounding hedge have been removed. HL 2024.

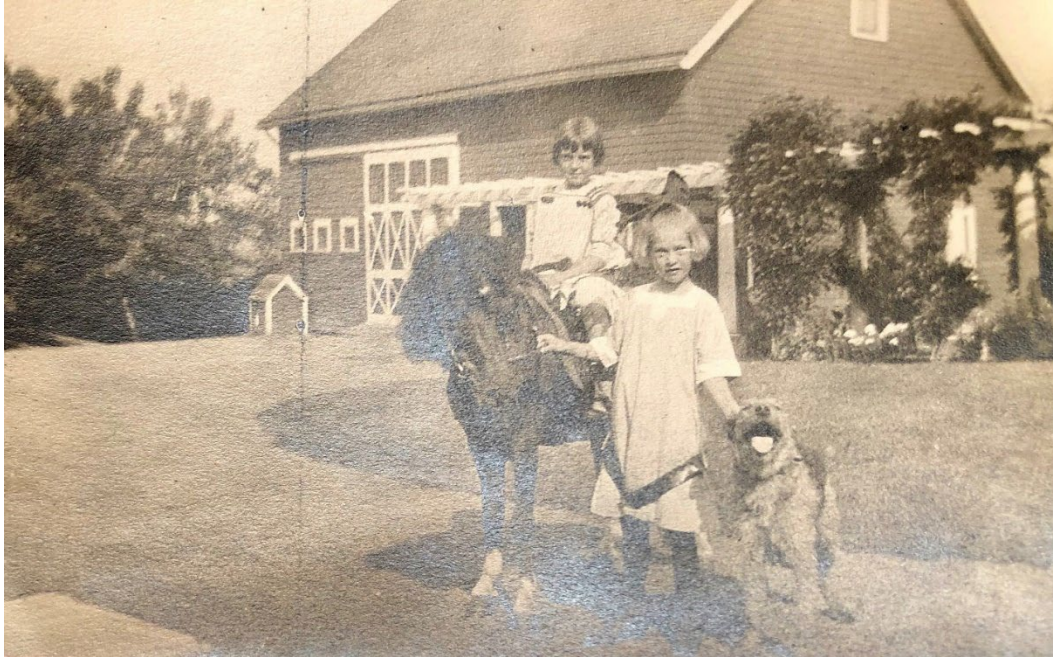
Figure 4.9a Circa 1910-11 photograph of the 1906 barn. Bertha Mather and another child stand in the driveway with a pony and dog. The white wooden pergola, laden with wisteria, extends from the caretaker's cottage over the lawn to the barn. The gravel drive curves north and widens to form a parking area against the south façade of the barn. A small doghouse structure is seen near the west corner. Courtesy McPherson-Nickerson family.

The lantern light posts present today are not the same light fixtures that appear in historic photographs (**Figure 4.6a,b, and 4.9b**).

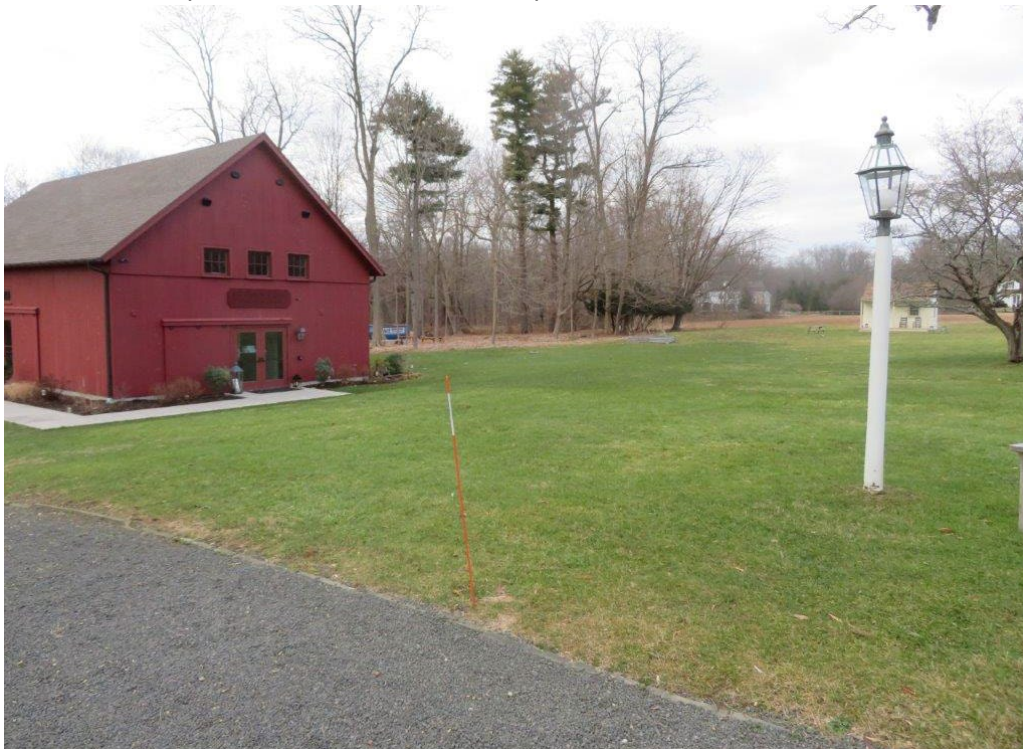
Figure 4.9b Repeat view in 2024 shows the open lawn in the former location of the 1906 barn built by Stephen T. Mather, and the Education Center, built in 2020, that replaced Stephen T. Mather's 1929 barn. HL 2024.

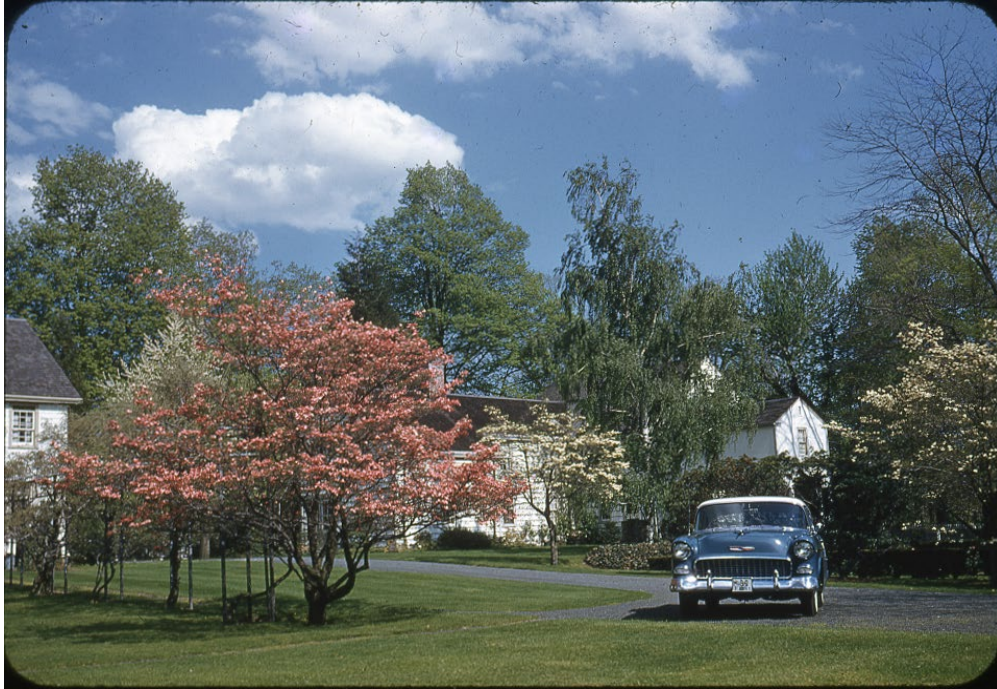
Figure 4.10a 1955 photograph of the parking area along the north side of the gravel drive, taken from the lawn panel in the location of the former 1906 barn. A pink dogwood tree stands at the west end of a metal pergola that extends from the Little House (left). The Main House appears in the background. Courtesy MHF.

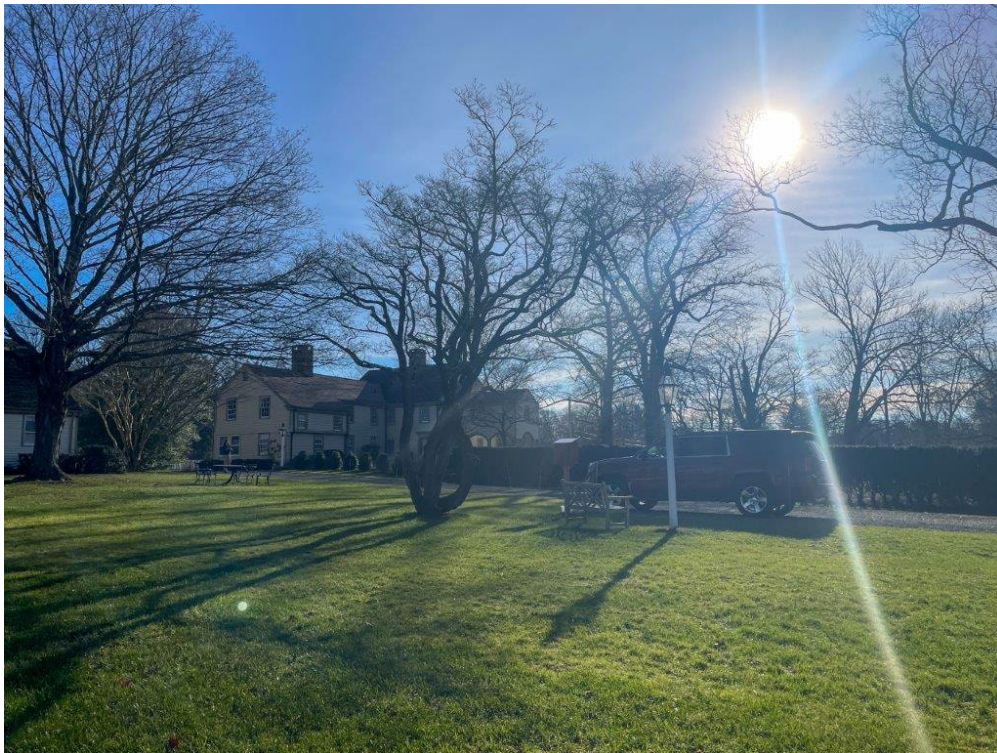
Figure 4.10b This repeat 2024 photograph shows the continued function of the wide area of the gravel drive for parking today. The wisteria arbor that extended west off of the Little House is not present, although the pink dogwood tree at the west end of the structure remains. HL 2024.

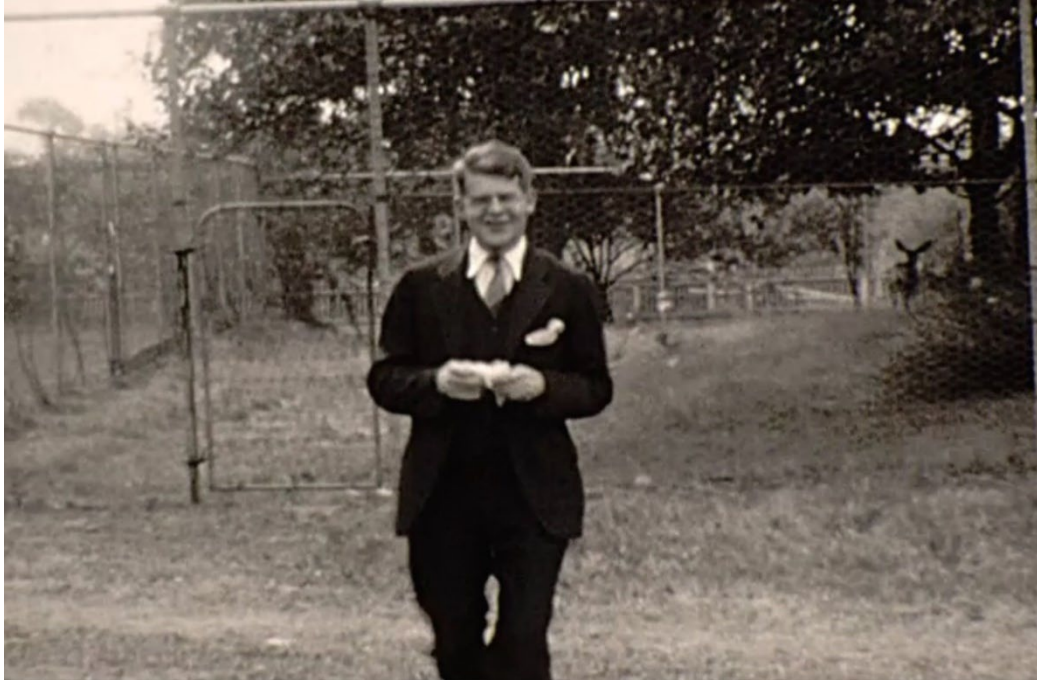
Figure 4.11a Circa 1929 still image capture from a Mather family home video, shows a man in the driveway in the foreground and the fenced tennis court in the background. Mature deciduous trees are present to the west, or right side of the fenced area. What appears to be a young deer stands inside the fence. Courtesy McPherson-Nickerson family.

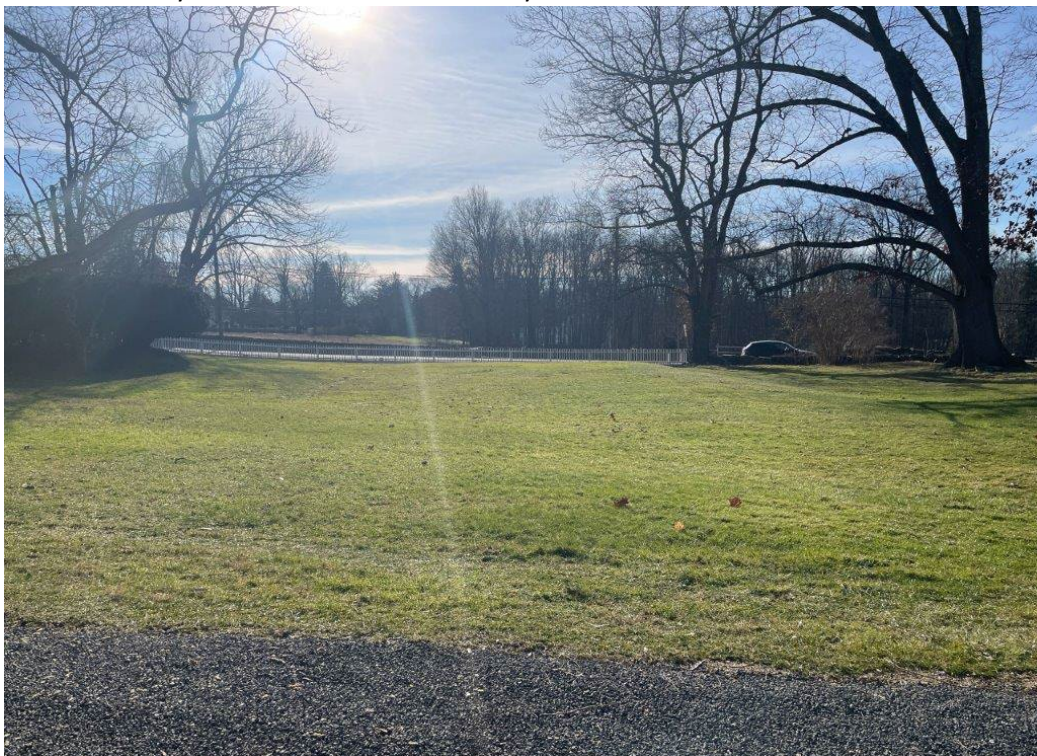
Figure 4.11b The lifted grading of the tennis lawn remains evident in 2024. Viewed from the gravel drive, the enclosing fencing is missing. Historic trees within and surrounding the tennis fenced area are not present, allowing views to extend south over Stephen Mather Road to Mather Meadows. HL 2024.

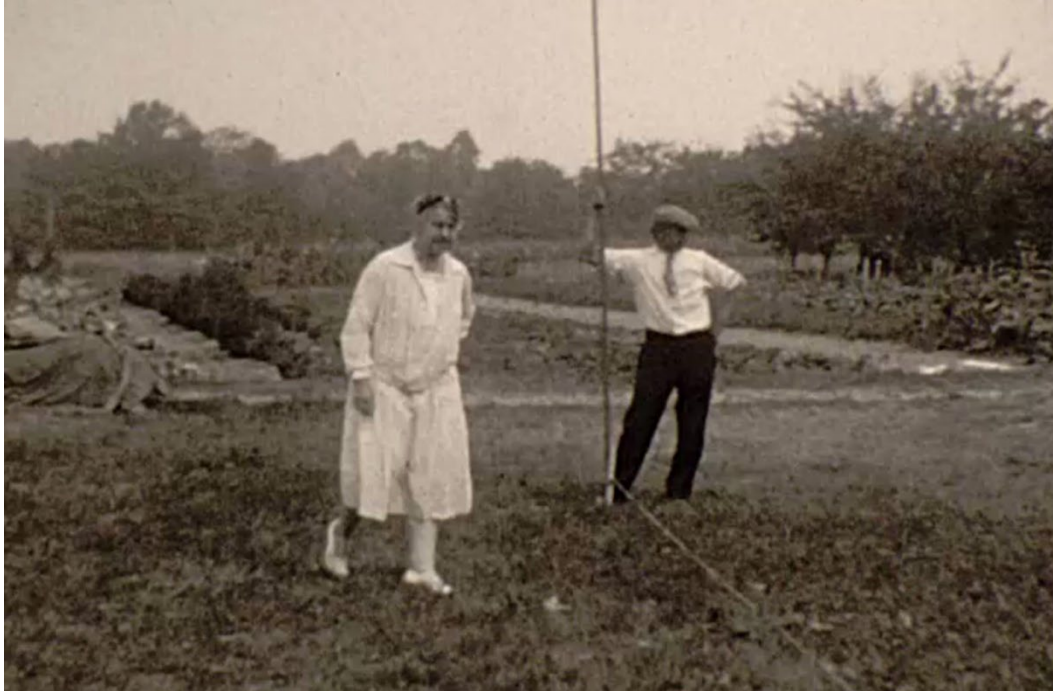
Figure 4.12a Circa 1929 still image capture from a Mather family home video of the construction of the new barn. Grace Floy, the aunt of Bertha Mather, walks in the foreground. Row crops extend north in the background. An orchard appears to the east (right). Courtesy McPherson-Nickerson family.

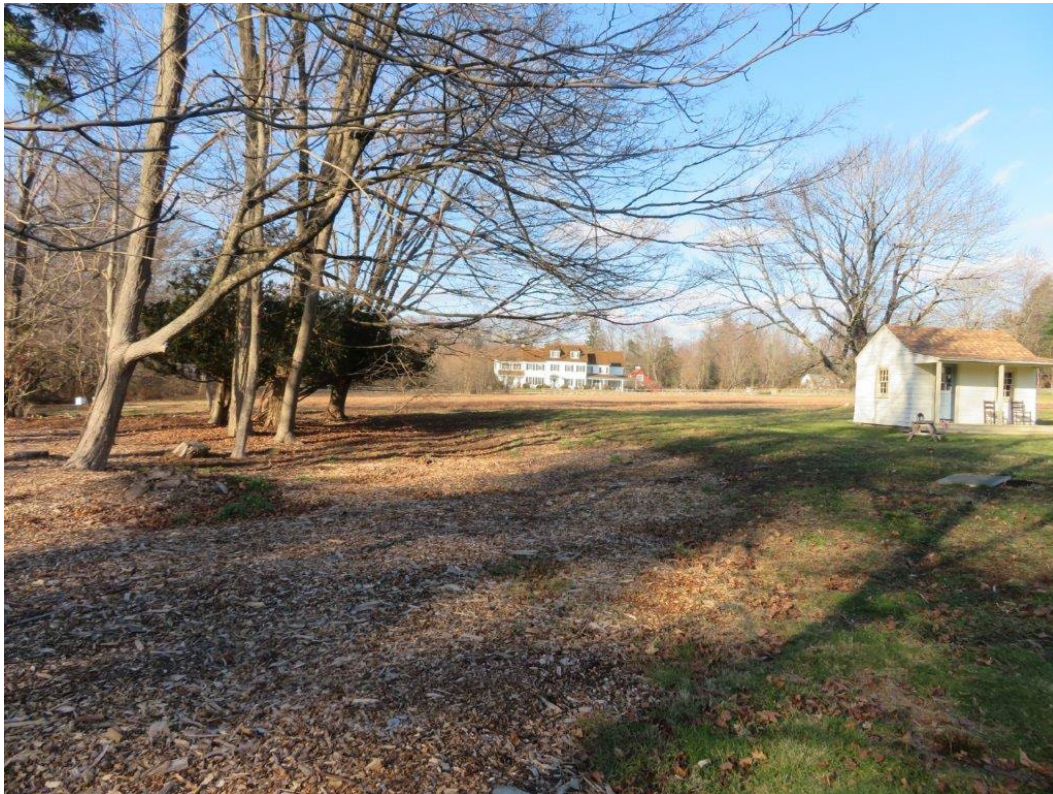
Figure 4.12b This northward view from the north façade of the Education Center shows the east edge of a wooded area, where it transitions to mown lawn around the playhouse. The orderly cultivated plantings seen in the 1929 capture are not present, nor is the historic use legible today. HL 2024.

In 2024, land use in LCA 2 is associated primarily with the Education Center and visitor parking. The scope of programming related to the Education Center extends to the building's surroundings, incorporating areas such as the Outdoor Classroom space situated in a circular clearing to the north. There is no productive land use or linear organization of the landscape north of the Education Center (**Figure 4.12b**).

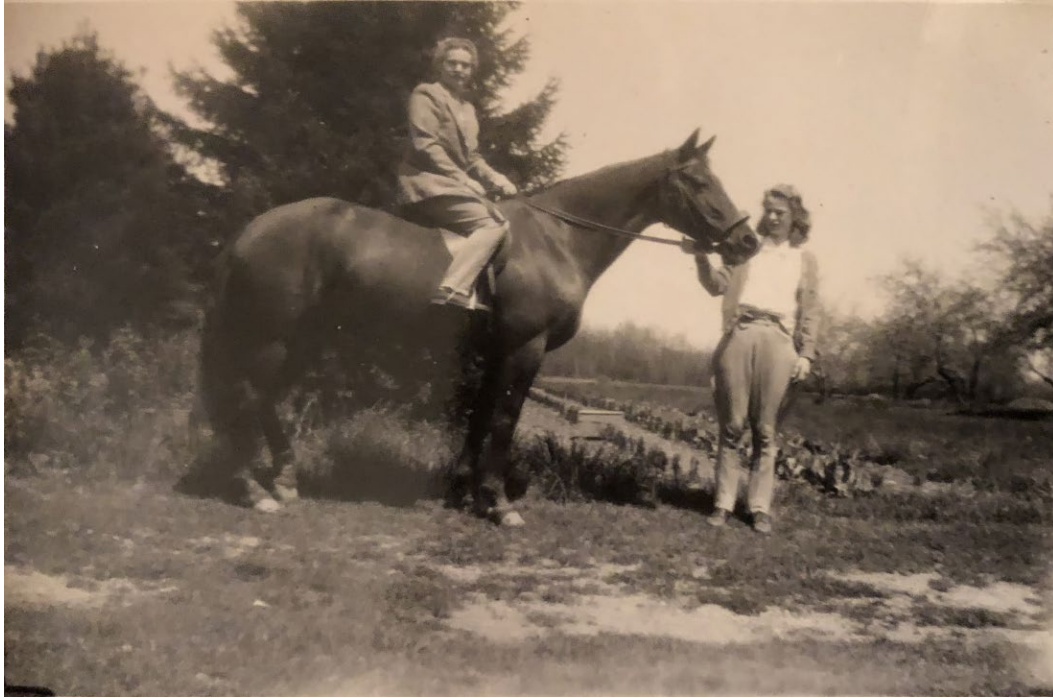
Figure 4.13a Circa 1947 photograph of Bertha Mather McPherson and her daughter with a horse, standing north of the barn. The allée of evergreens extends north behind them, flanked by a double-row vegetable garden. Several orchard trees are visible to the right on the east side of the adjacent lawn. Courtesy McPherson-Nickerson family.

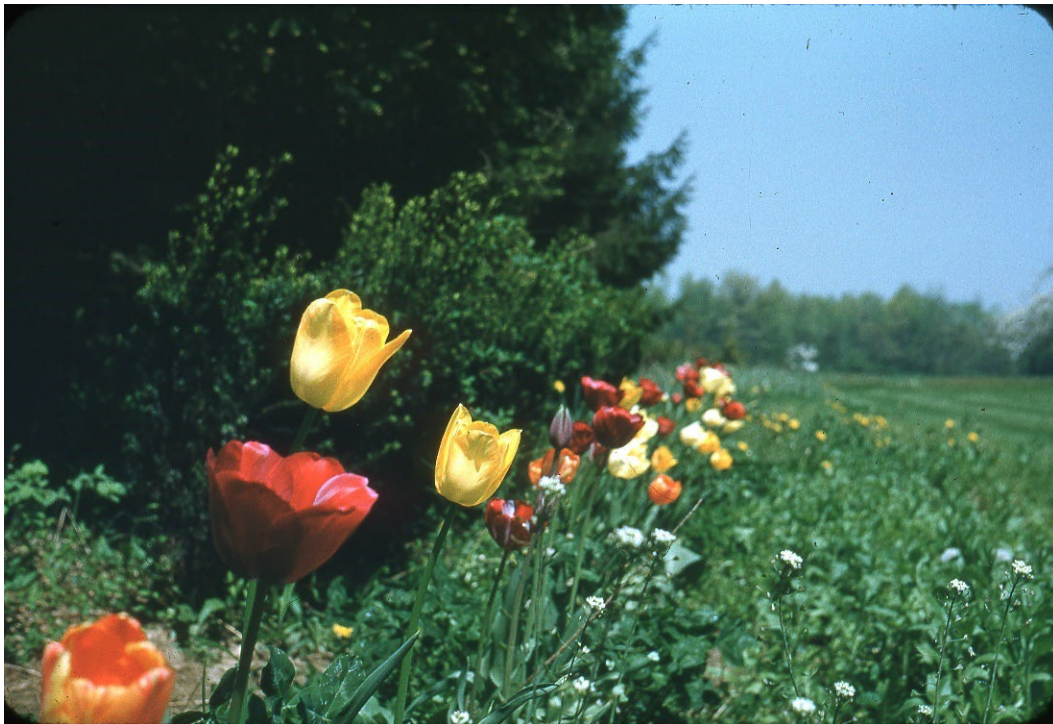
Figure 4.13b 1953 detail photograph of a linear border planted with tulips and smaller wildflowers along the east side of the evergreen allée extending north of the barn. The evergreens create a dense screen to the west, offering a shaded contrast to the open and sunny mown lawn to the east. Courtesy MHF.

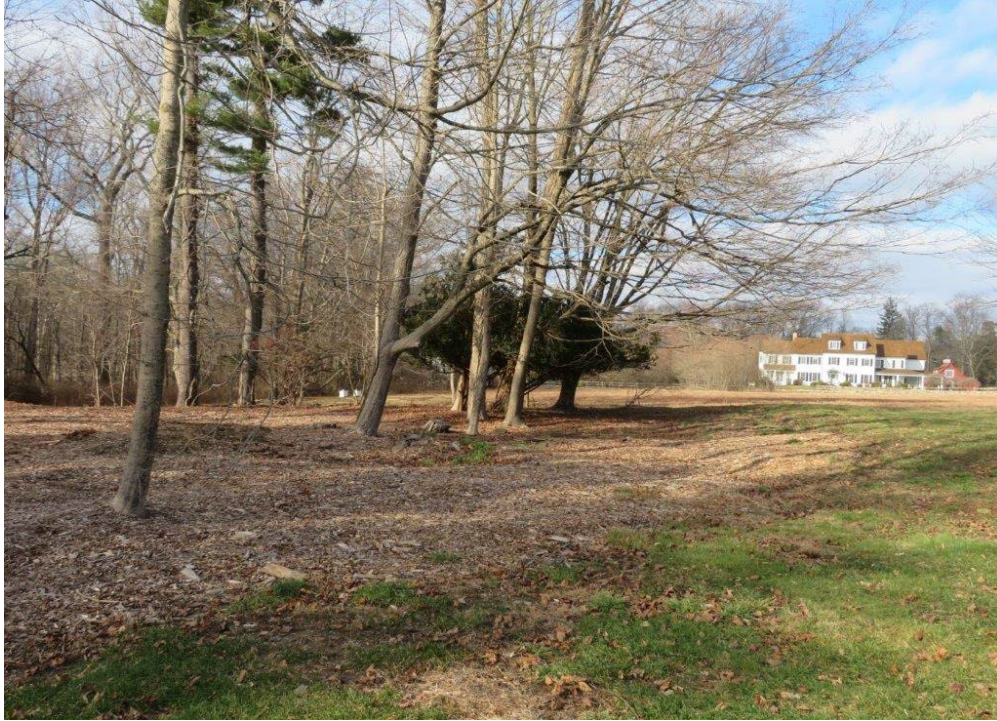
Figure 4.13c The defined edge of the evergreen allée is missing in 2024. Two pine trees appear in the background to the northwest, and a tall evergreen shrub is present to the north. The ground plane in the wooded area, covered with leaf litter, blends with the lawn to the east. There are no linear plantings to define this boundary. HL 2024.

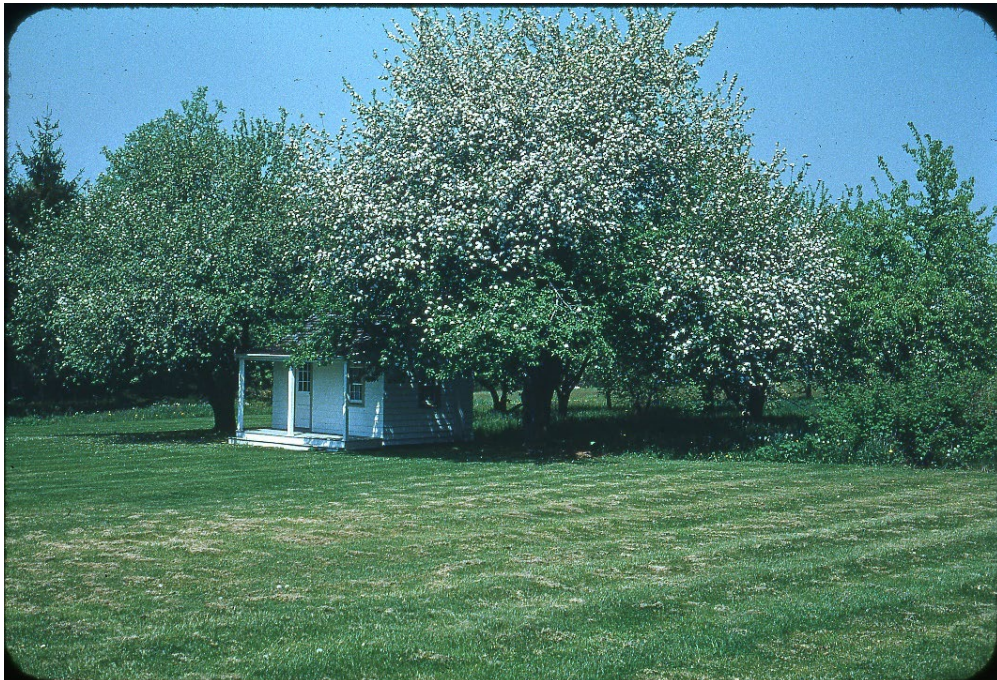
Figure 4.14a 1953 photograph of the playhouse at the south end of the orchard, situated between two apple trees. A mown lawn panel extends through the foreground, south of the playhouse, and continues north in the background. One of the evergreen trees in the allée north of the barn appears on the left side of the image. Courtesy MHF.

North and northeast of the Education Center, changes in land use, including the loss of cultivated vegetable beds and the orchard north of the current playhouse, have led to less visually distinct LCA boundaries (**Figure 4.14a-c and Figure 4.15a,b**). The present turf lawn seamlessly blends into the groundcover in LCA 1 and the eastern part of LCA 3.

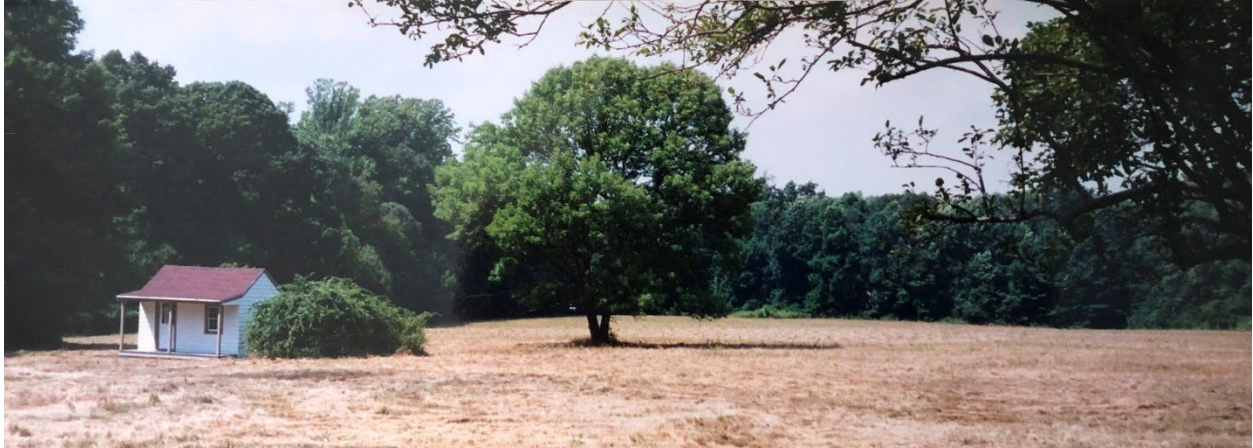
Figure 4.14b Circa 1970-80 image of the playhouse. A low shrub mass flanks the west side of the structure, and a lone ash tree is present further north in the surrounding field. There is no differentiation between the groundcover in the foreground and in the northern portion of the property beyond. Tree branches frame the view overhead. Courtesy MHF.

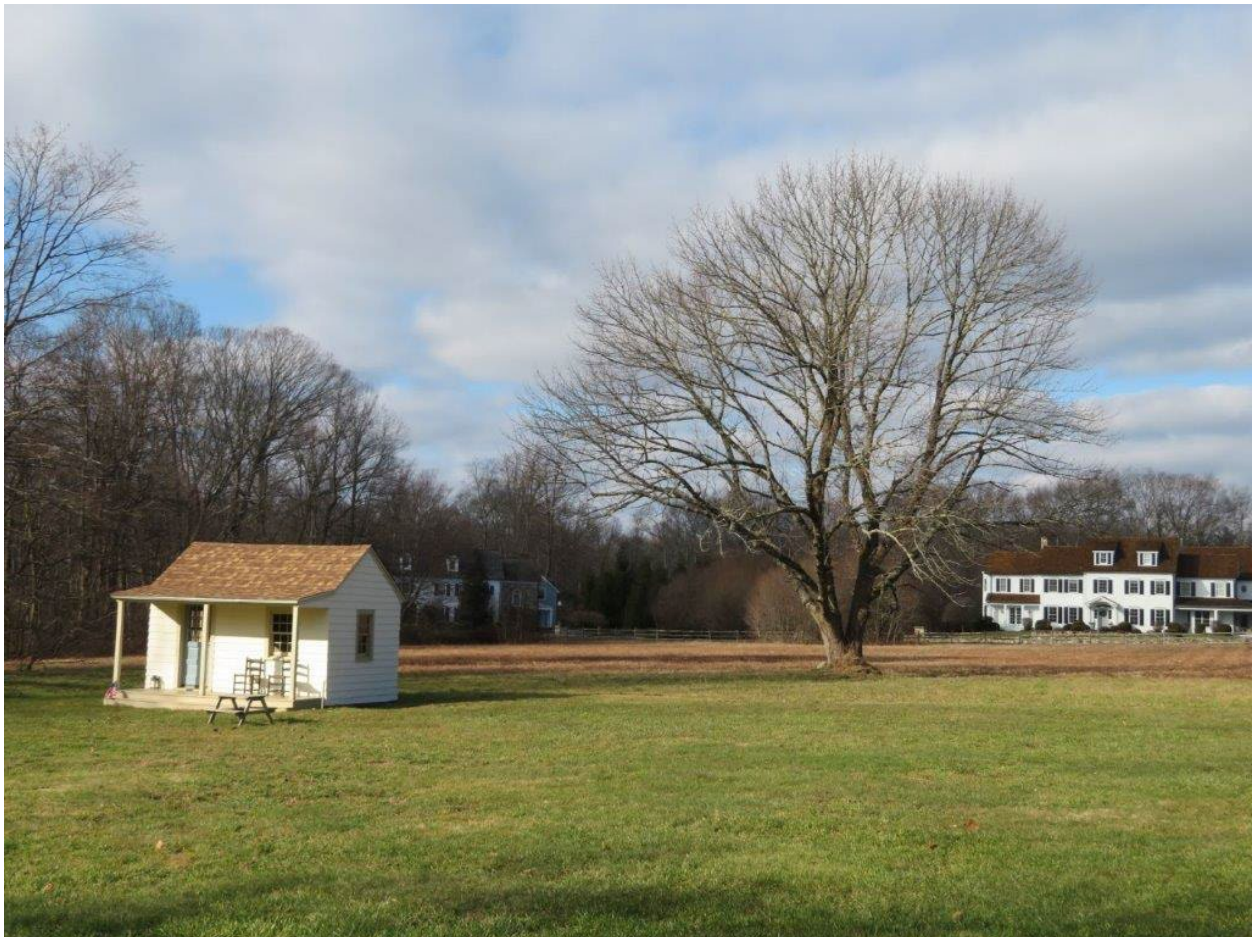
Figure 4.14c Repeat view in 2024 shows the twin ash tree north of the playhouse is retained. The northward view over the meadow is foreshortened by the neighboring house immediately north. A second residential property is visible to the northwest behind the playhouse. The foreground is open mown lawn. HL 2024.

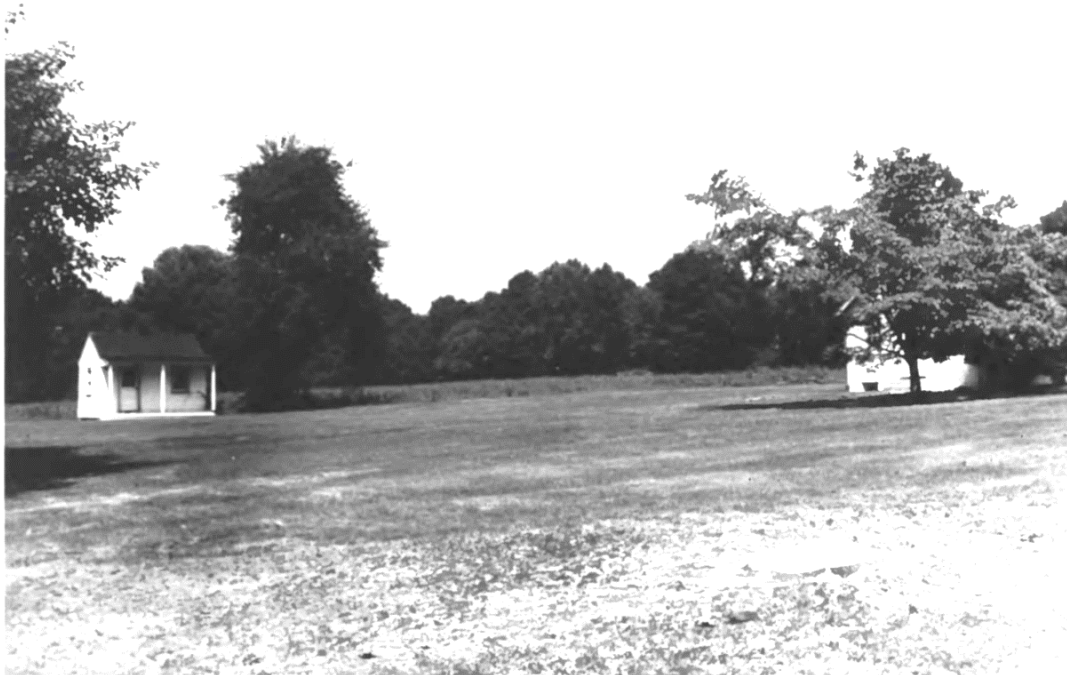
Figure 4.15a Circa 1963 photograph of the playhouse (left) and greenhouse (right). An open expanse of rough and patchy turf covers the foreground. Taller grass is seen in the background, to the north. Two trees are present, one near each of the respective structures. Courtesy MHF.

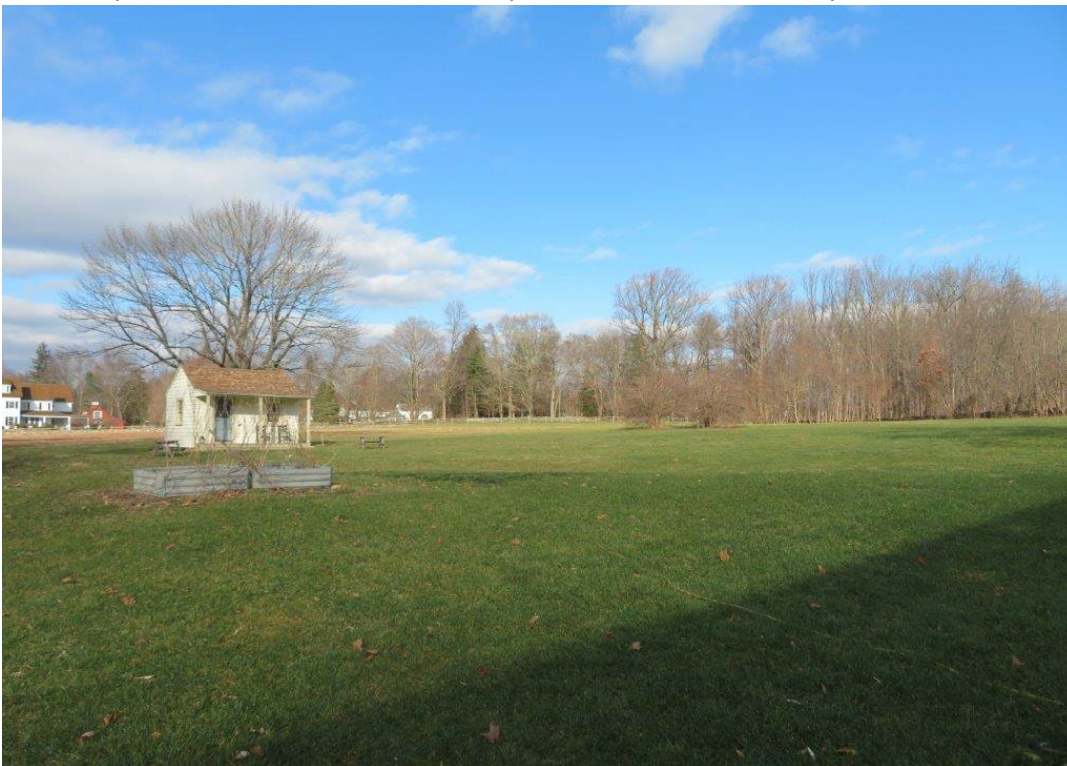
Figure 4.15b 2024 photograph captures a raised bed southwest of the playhouse and open lawn through the former location of the greenhouse in LCA 1. The ash tree north of the playhouse is still present, although no other trees are present in the area. HL 2024.

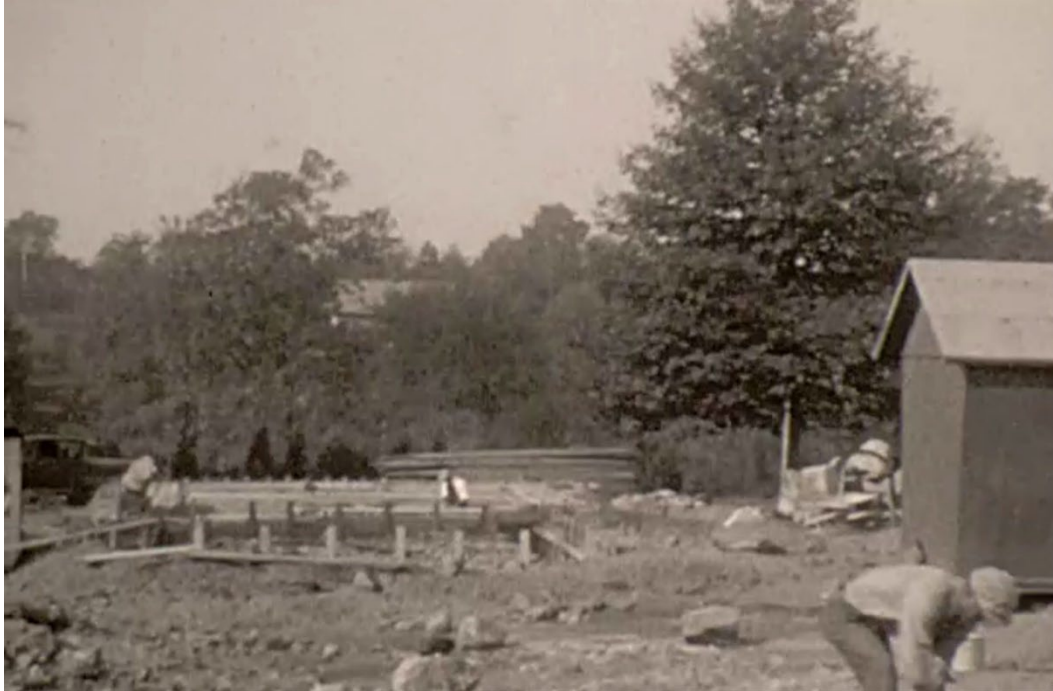
Figure 4.16a Circa 1929 still image capture from a Mather family home video. The newly constructed foundation of the barn appears in the midground of the image. A small outbuilding, apparently lifted from its foundation, is seen to the right. A vehicle on the left side of the image indicates the entry drive. Beyond the truck, a line of trees and shrubs marks the west edge of the drive. Courtesy McPherson-Nickerson family.

Views in LCA 2, both internal and external, have been altered by changes in vegetation since the Stephen Mather Era. In the past, the historically open pasture to the west allowed for expansive views over the Goodwives River. Today, however, dense woodland vegetation encloses the west side of the entry drive and parking area, restricting and foreshortening the once-open vista (**Figure 4.16a,b**).

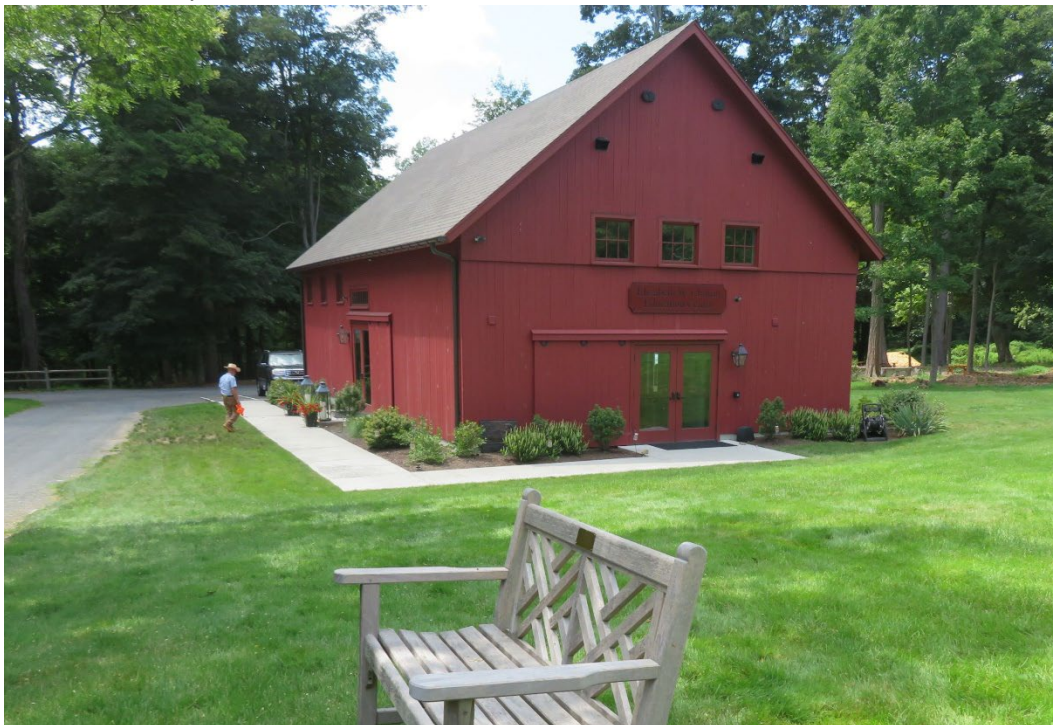
Figure 4.16b The west-facing view beyond the Education Center in 2023 is foreshortened by the dense vegetation on the west side of the parking area. The gravel drive entry from Stephen Mather Road is in approximately the same location as indicated in the historic image. HL 2023.

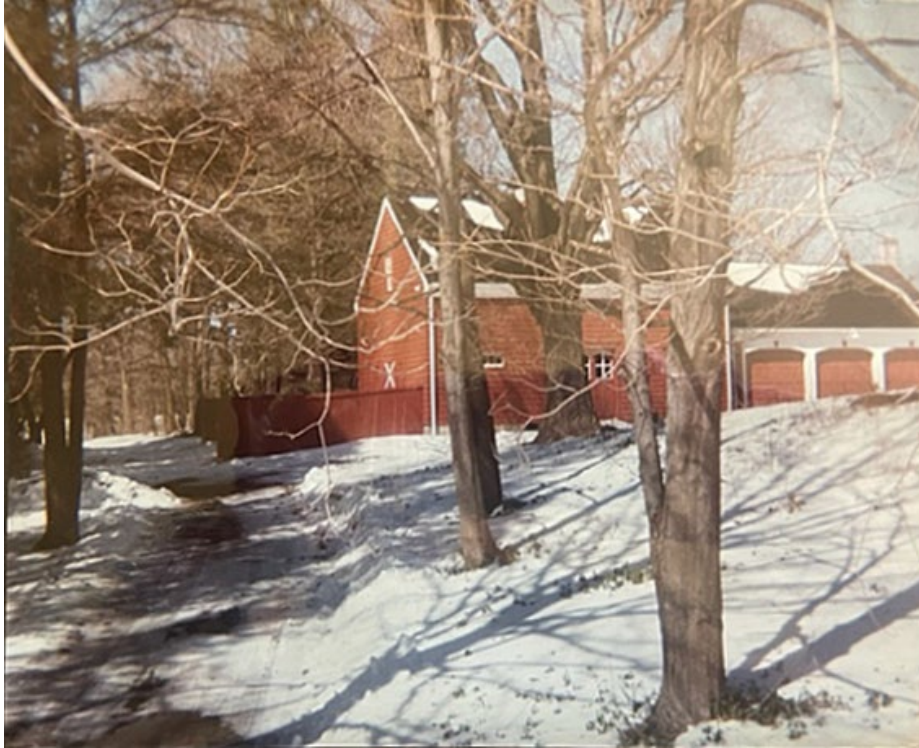
Figure 4.17a 1982 photograph of the barn built in 1929 as seen from the drive entrance on Stephen Mather Road. To the east, the topography rises to a natural knoll. The drive wraps around the north side of this knoll to arrive at the three-car garage attached to the barn. Another arm of the drive continues north. A wooden fence with vertical slats, painted red, encloses an area on the west side. Courtesy MHF.

In 2024, upon entering LCA 2, either from Stephen Mather Road or along the drive through LCA 1, visitors arrive at the Education Center and parking area (**Figure 4.17a,b**). The trajectory of the drive entry from Stephen Mather Road, which continues north along the west side of a rocky knoll before turning east to meet the portion of the drive entering from Brookside Road, aligns with the historic trajectory, although the direction of vehicular traffic may be reversed as the attached three-car garage was likely approached from the east. The service drive that historically continued along the west side of the barn and wrapped around the north façade is not present today (**Figure 4.18a,b**).

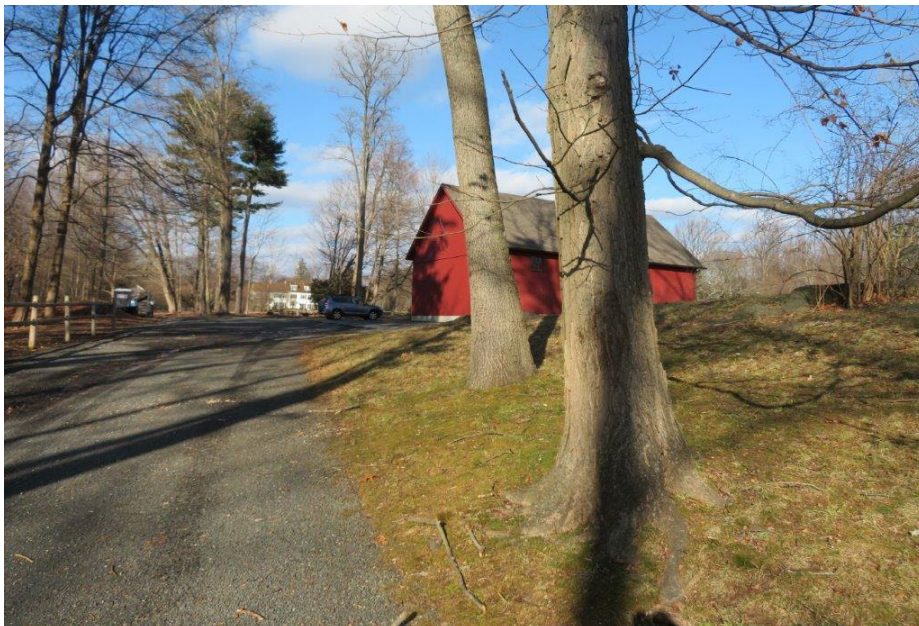
Figure 4.17b The location of the 2020 Education Center is shifted slightly eastward, compared with the historic 1929 barn, to accommodate parking on the west side. Deciduous trees line the east side of the drive on the sloping grade that ascends to the knoll in LCA 1. Several pine trees appear to the north, indicating the location of the historic evergreen allée. A wooden split-rail fence lines the west side of the drive. HL 2023.

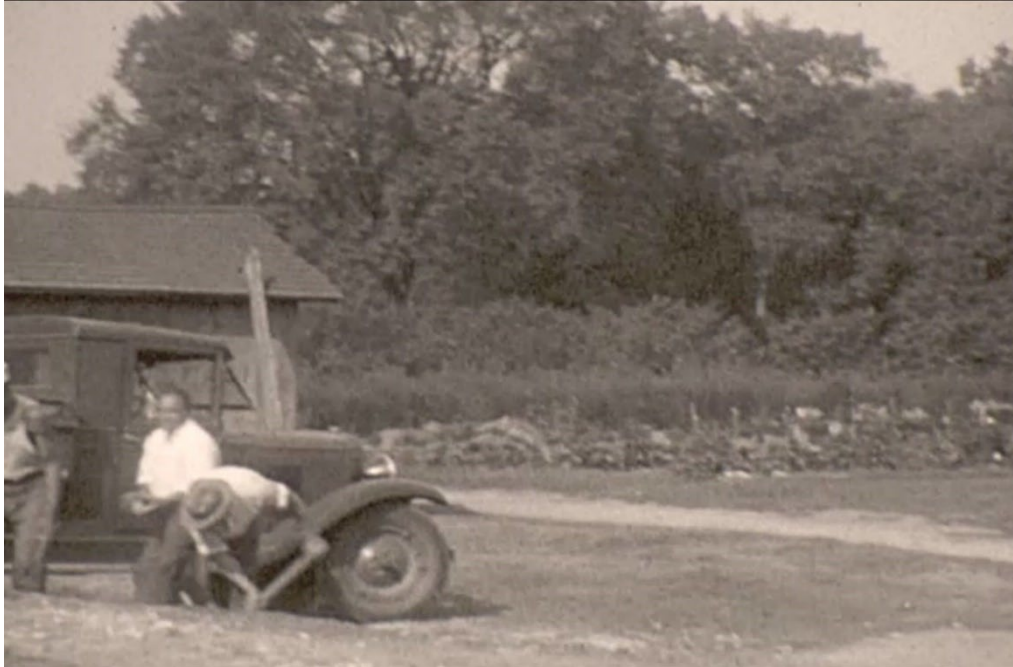
Figure 4.18a This circa 1929 still image capture shows the northwest view from the same vantage as the previous figure. A service drive divides the vicinity of the barn from the cultivated vegetable beds and row crops to the north (right). The same outbuilding seen in the previous figure appears at the left side of the image. Further west, beyond the cultivated area, a dense shrub edge and mature deciduous trees are present. Courtesy McPherson-Nickerson family.

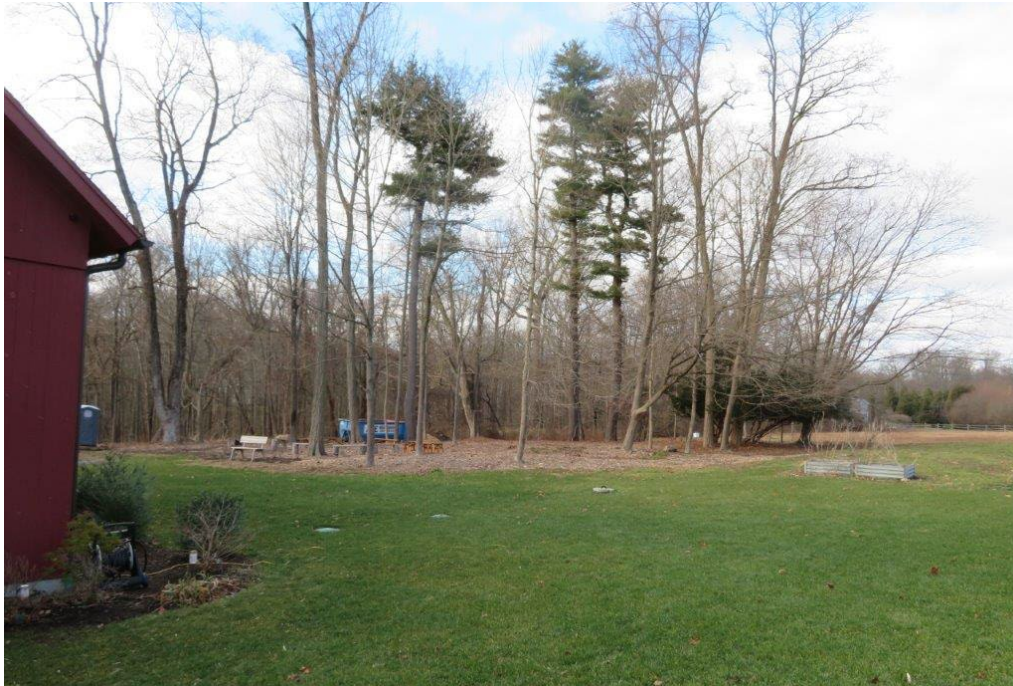
Figure 4.18b The landscape north and northwest of the Education Center in 2024 features a wooded area with a circular clearing for the outdoor classroom space. To the east (right), a raised bed is the only feature that indicates the historically productive land use. The drive along the north side of the barn, now the Education Center, is not present. HL 2024.

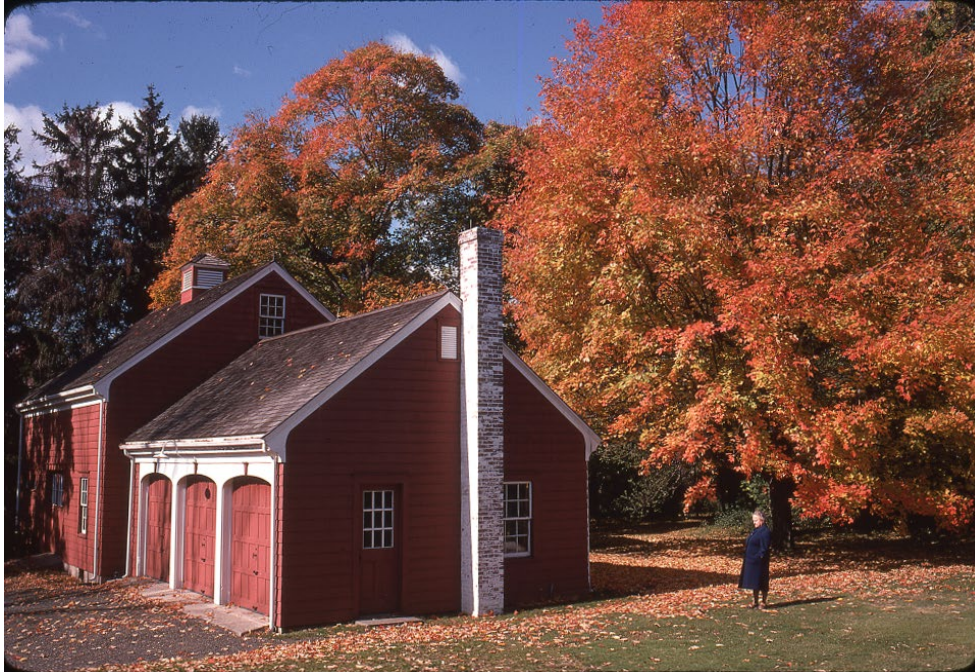
Figure 4.19a 1974 photograph of Bertha Mather McPherson standing beside the 1929 barn. The gravel drive is flush with the three-car garage. Two large maple trees are present on the north side of the barn. To the east, several spruce trees appear over the roofline of the barn. The foreground features mown turf. Courtesy MHF.

The primary building in LCA 2 is the Education Center, constructed in 2020. Situated in the approximate location of the 1929 barn built by Stephen Mather, the new building was shifted slightly eastward to allow for parking on the west side (**Figure 4.19a,b**). The Education Center was designed to resemble an eighteenth-century dairy barn, with a gable roof, sliding barn doors, and red siding. In contrast to the historic barn and garage, which included a fenced yard on its west side, the new Education Center does not have any adjacent enclosed spaces.
