MATHER HOMESTEAD CULTURAL LANDSCAPE REPORT

Mather Homestead Foundation
Draft for Review
January 2024

Heritage Landscapes LLC
Preservation Landscape Architects & Planners
Charlotte, Vermont & Norwalk, Connecticut

In 2023, the Mather Homestead Foundation commissioned Heritage Landscapes to prepare a thorough Mather Homestead Cultural Landscape Report (CLR) for this historically significant site. The CLR research findings indicate that originating as a productive, subsistence-based landscape, the Mather Homestead steadily evolved from its conception in 1778 to the present day. The property was designated as a National Historic Landmark in 1963 and inscribed on the National Register of Historic Places in 1966, with a boundary amendment in 1978.¹ The 1963 nomination notes its significance for its association

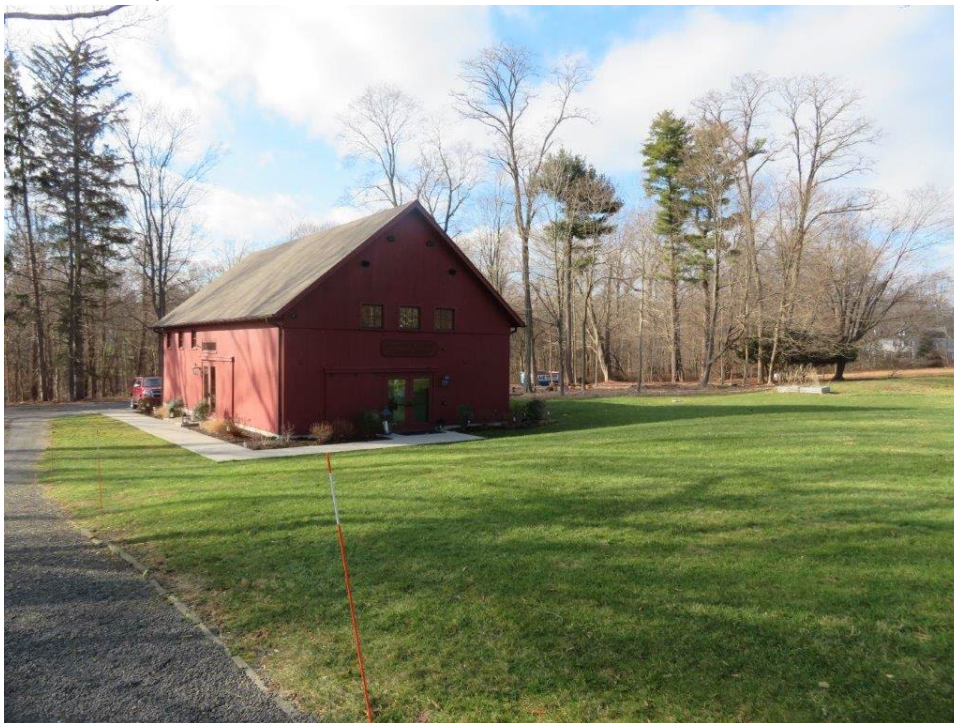
Figure 4.19b In 2024, the Education Center is present in the approximate location of the 1929 barn. The gravel drive does not extend up to the foundation of the structure; a concrete walk wraps around the perimeter, providing access to the east façade entry. The maple trees north of the historic barn are not present. Mown lawn extends north alongside a wooded area to the northwest. HL 2024.

The primary building in LCA 2 is the Education Center, constructed in 2020. Situated in the approximate location of the 1929 barn built by Stephen Mather, the new building was shifted slightly eastward to allow for parking on the west side (**Figure 4.19a,b**). The Education Center was designed to resemble an eighteenth-century dairy barn, with a gable roof, sliding barn doors, and red siding. In contrast to the historic barn and garage, which included a fenced yard on its west side, the new Education Center does not have any adjacent enclosed spaces.

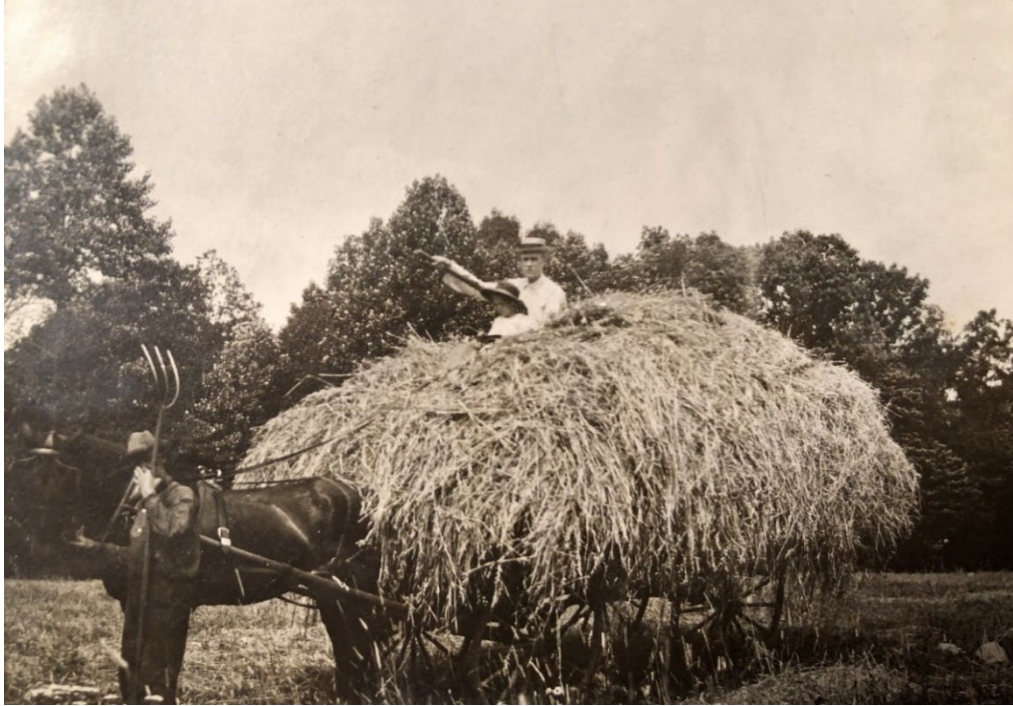
Figure 4.20a Undated circa 1910 photograph of Stephen T. Mather and young Bertha Mather, sitting atop a hay wagon. Another man, likely the caretaker, stands beside the horse pulling the wagon. The hayfields extend into the background to a dense woodland edge. Courtesy McPherson-Nickerson family.

During the Stephen T. Mather era, from 1906 to 1930, land use in LCA 3 was related to large-scale crop production, including hay and possibly other crops such as flax. The western portion of LCA 3 was left as woodland (**Figure 4.20a,b**). In the decades following the property's transfer to Bertha Mather McPherson, productive land use persisted in LCA 3 (**Figure 4.21a,b**). Family photographs from the late 1970s show that these northern fields were still planted with hay during this period.

Northward views from LCA 3 are foreshortened by neighboring residential properties and by the shared private driveway to the northeast. Despite this constraint, the northwest views over tall grasses to a dense woodland edge within LCA 3 are closely aligned with the historic condition (**Figure 4.20a,b**).

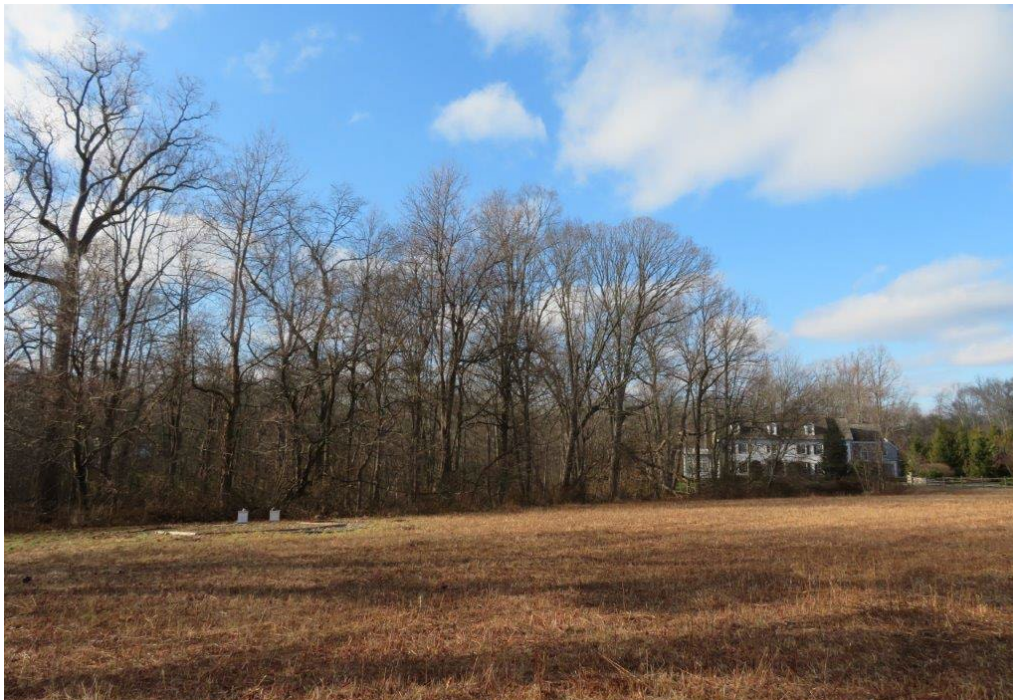
Figure 4.20b This 2024 photograph of the meadow area in the northwest corner of the property, a parcel owned and managed by the Darien Land Trust, shows the remaining portion of the landscape that reflects the historic character of LCA 3. The view over the mown meadow is foreshortened by the residential property to the northwest, visible beyond the tree line. Two beehives are situated near the wildflower garden (left). HL 2024.

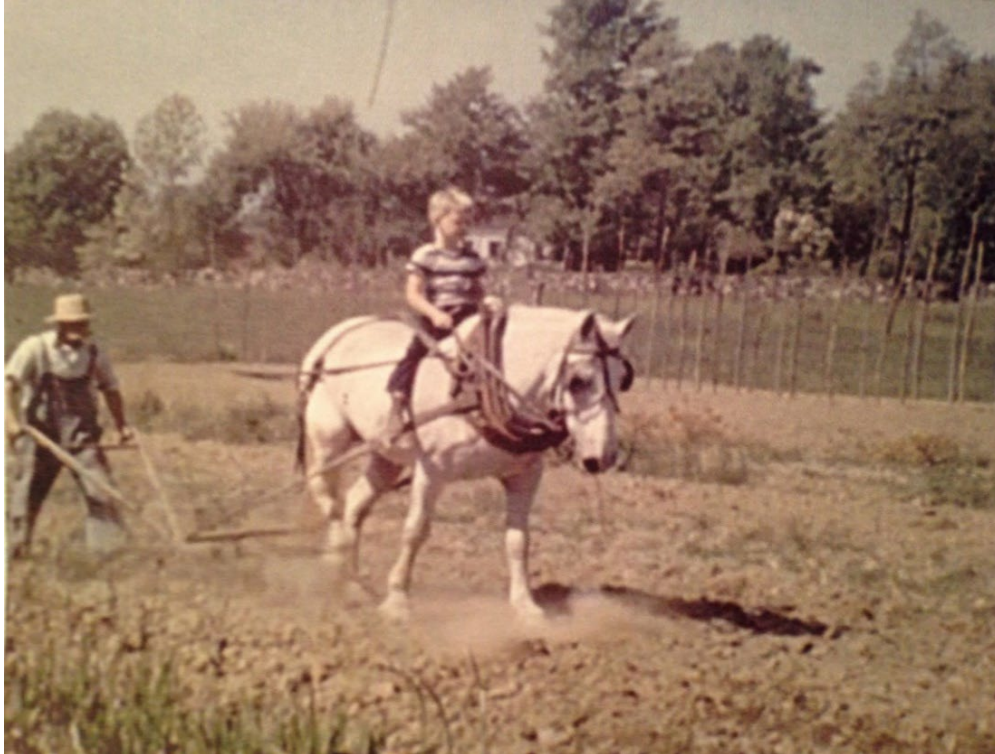
Figure 4.21a Circa 1944-45 photograph of Stephen Mather McPherson riding a horse that is pulling a plow. A man follows behind and steers the plow. Near the far edge of the cultivated plot, a line of branches stuck in the ground indicates the growing of beans or other legumes. In the background, the cultivated land gives way to lawn bordered by a stone wall. Courtesy McPherson-Nickerson family.

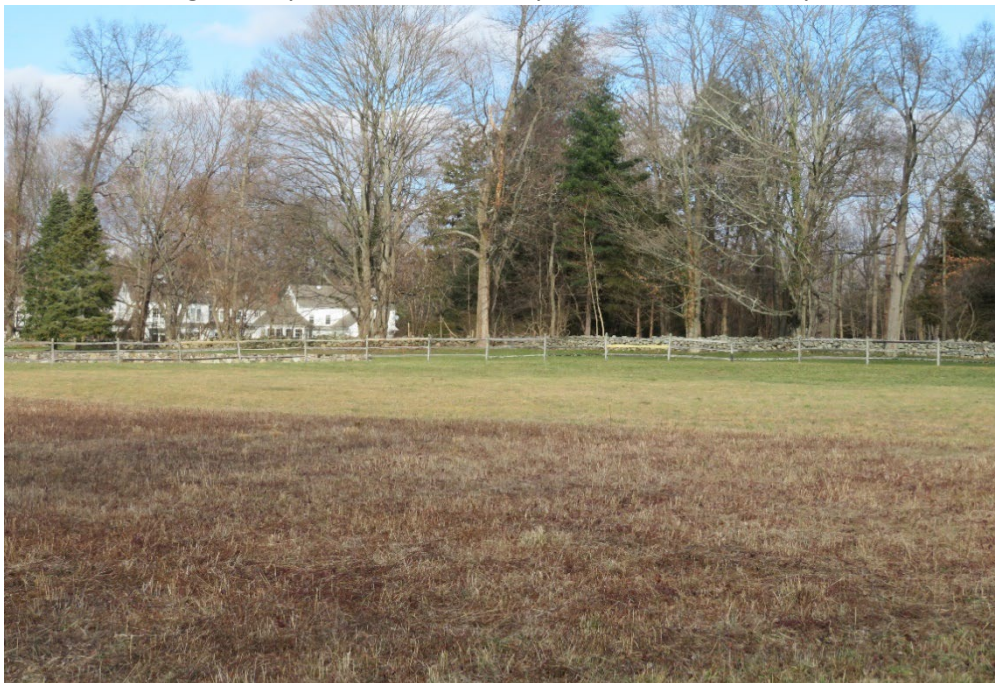
Figure 4.21b Repeat view in 2024 shows the meadow parcel in the foreground, giving way to mown turf lawn that extends northeast to the current property line. A wooden split rail fence lines the south side of the private shared driveway. HL 2024.

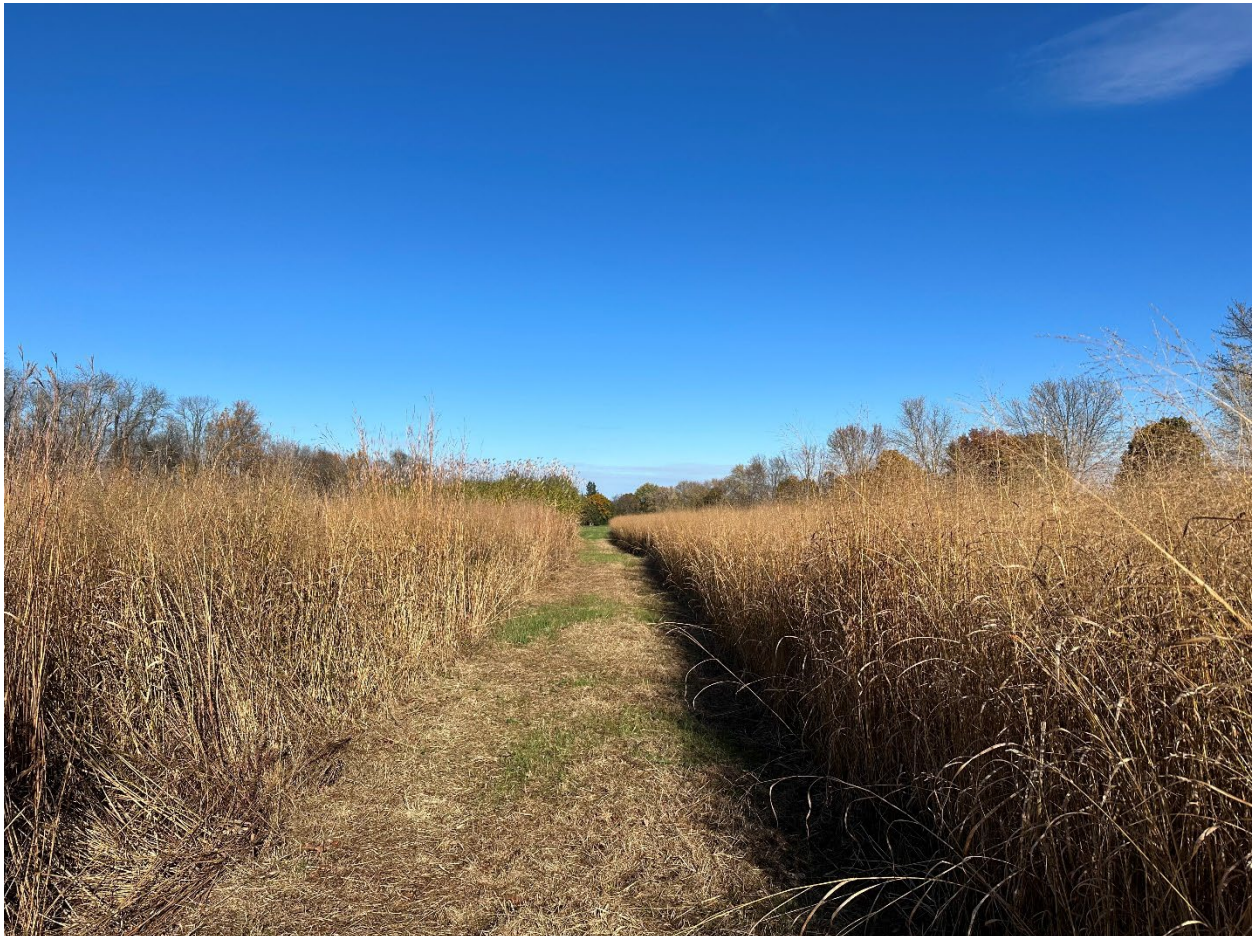
Figure 5.1 This image shows an example of native grasses with a mown path. A field of native grasses could be developed as insect and bird habitat. A simple path or varied paths cut for exploration would invite visitors. HL 2024.

On the conservation lands north of the Playhouse, a wildflower meadow, a milkweed colony, or native grasses could be established. If grasses are chosen, a maze could be cut for an engaging exploration event late in the growing season (Figure 5.1).
