MATHER HOMESTEAD DARIEN, CT

CONDITIONS ASSESSMENT REPORT

P22-028

JULY 6, 2022

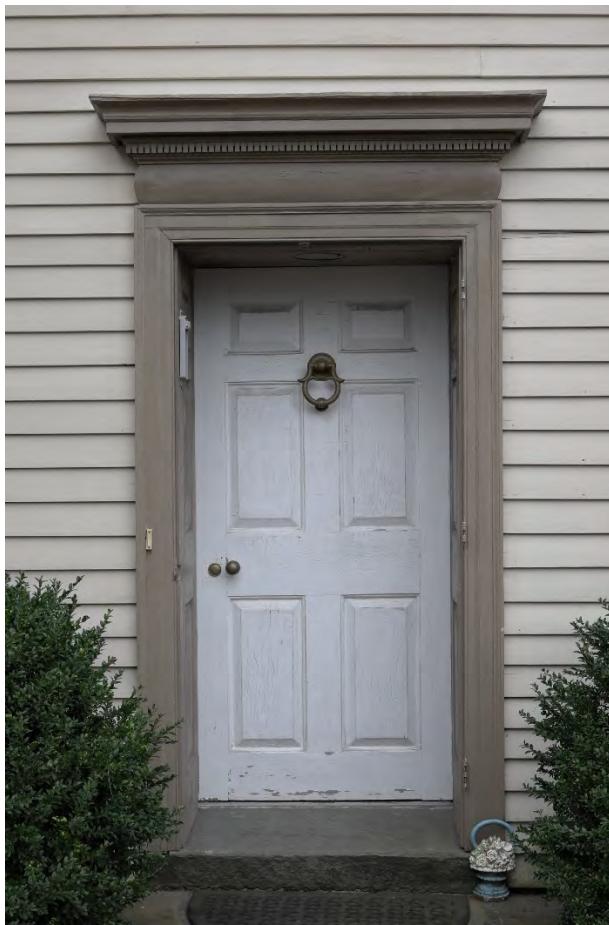
Mather Homestead – Mather Home - Exterior Details

North Elevation – Entrance Doorway

Peeling Paint

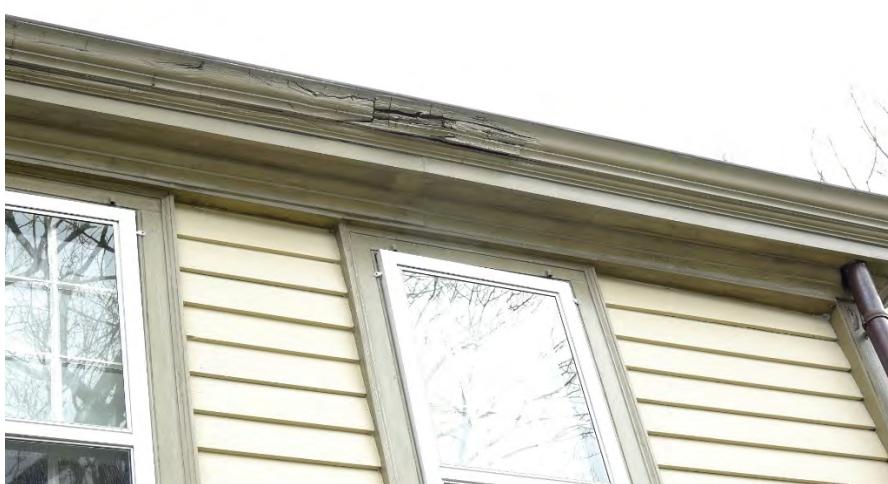
Mather Homestead – Mather Home - Exterior Details

South Elevation – Wood Cornice/Built-in Gutter Trim

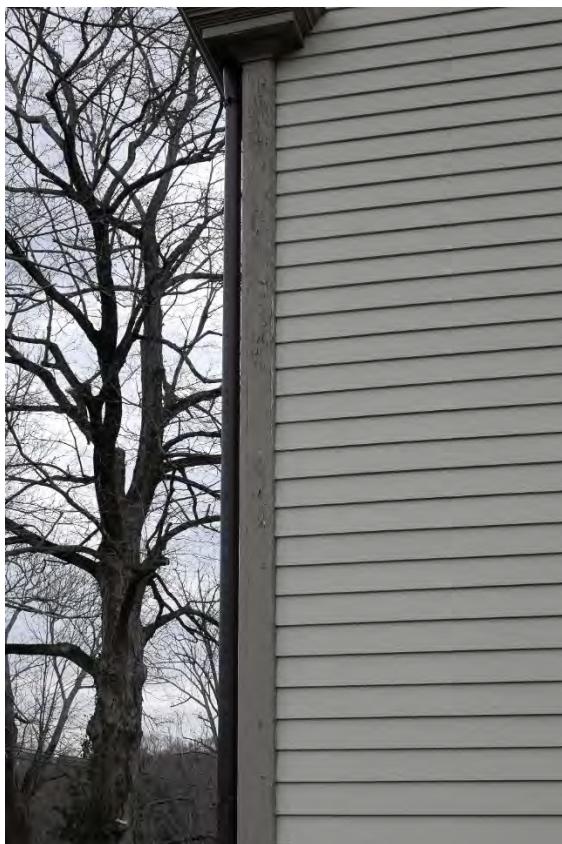
Mather Homestead – Mather Home - Exterior Details
East Elevation
Peeling Paint at Trim

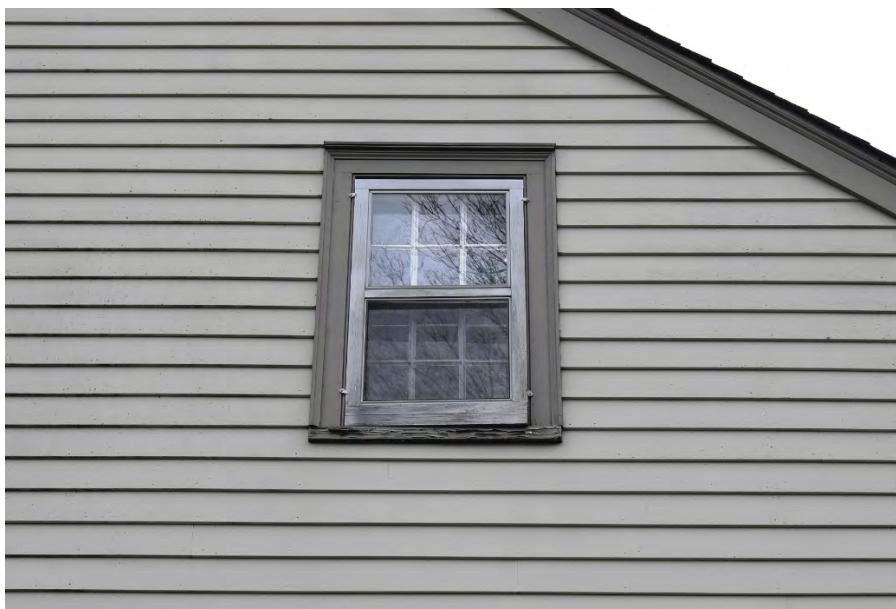
Mather Homestead – Mather Home - Exterior Details
East Elevation
Peeling Paint, Rotting Wood at Window, Windowsill, and Storm Window

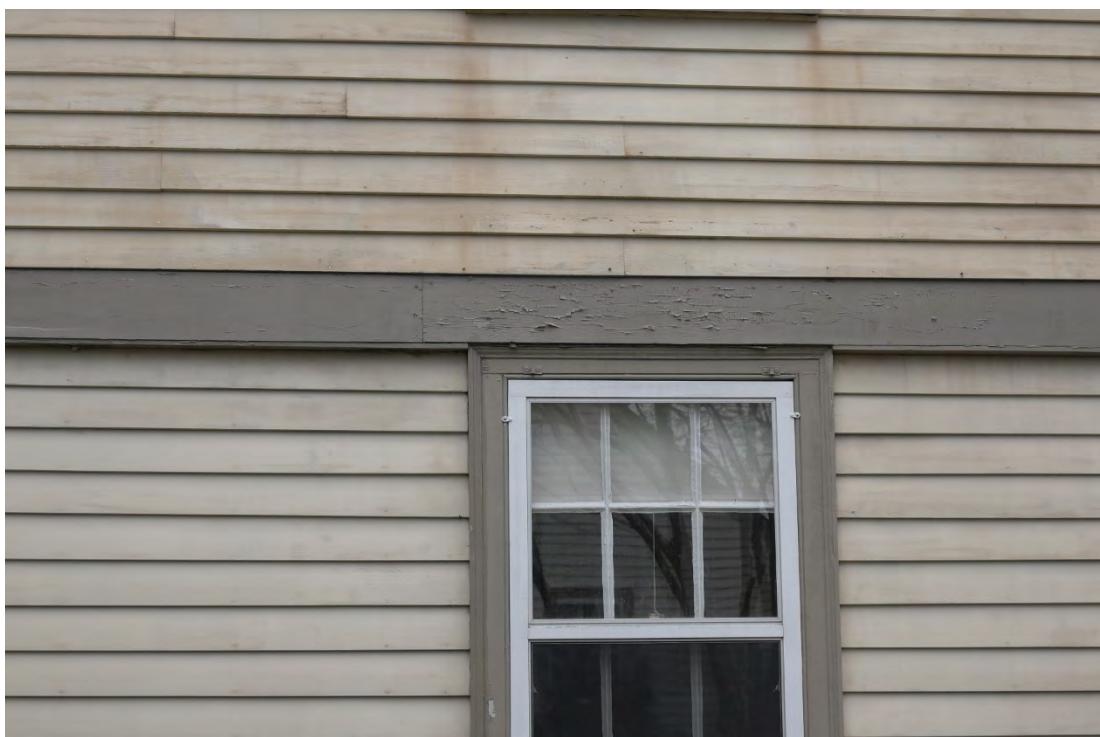
West Elevation of Ell

Peeling Paint on Trim; Staining on Painted Wood Clapboard Wall from Window Screen Above

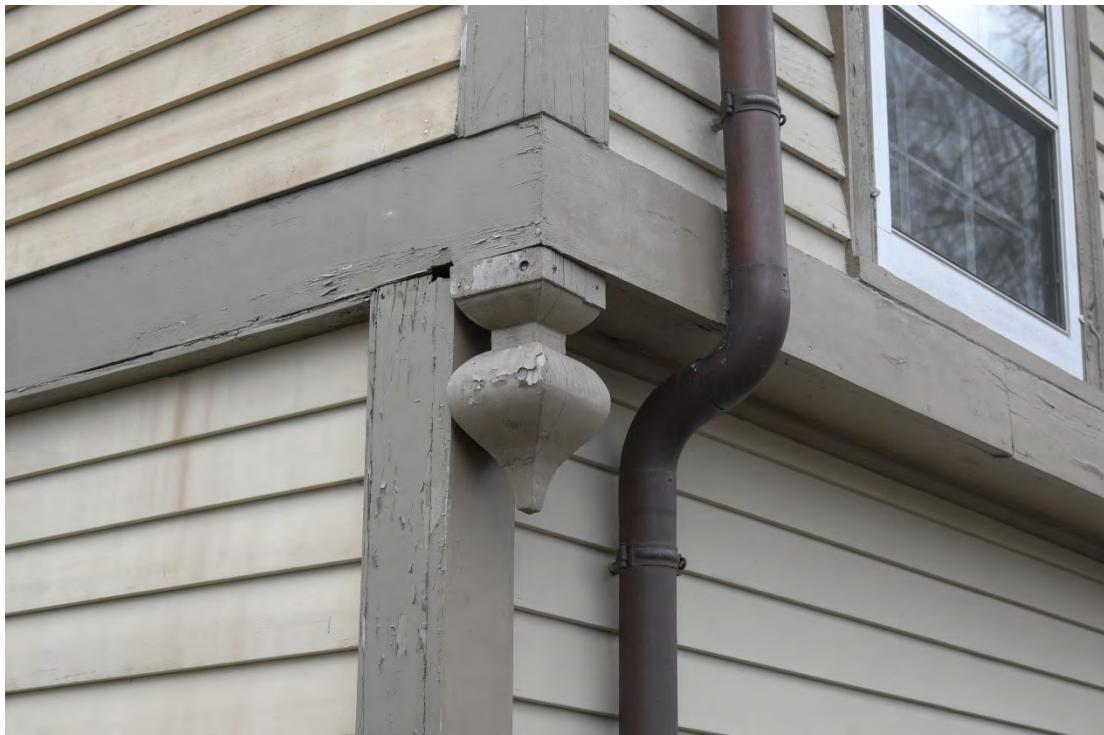
Northwest Corner at Ell

Peeling Paint at Trim

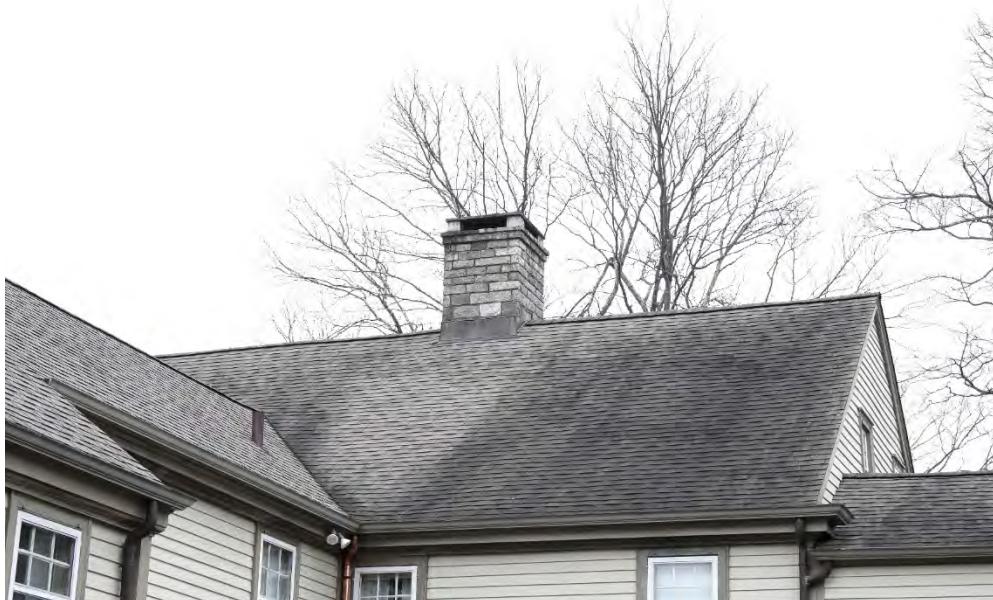
Mather Homestead – Mather Home - Exterior Details
Chimney on Original Core
Overall in Good Condition; Minimal Open Joints

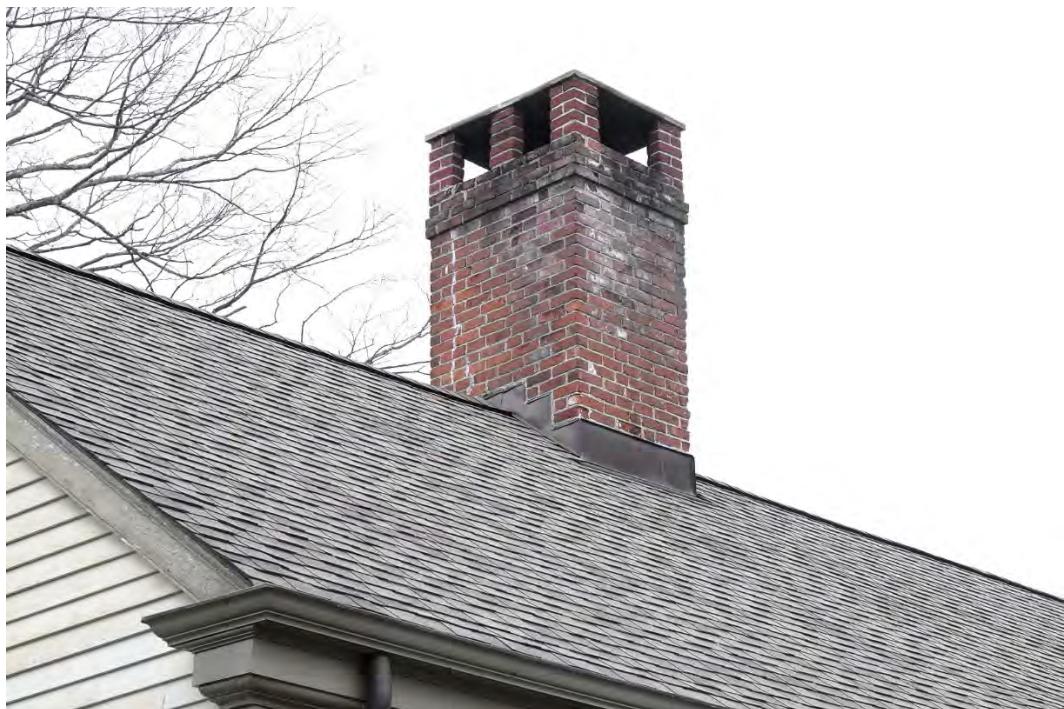
Mather Homestead – Mather Home - Exterior Details
Chimney at Ell
Open Joints; Spalling Brickface; Crack Through Brickwork; Stained/Discolored Brick

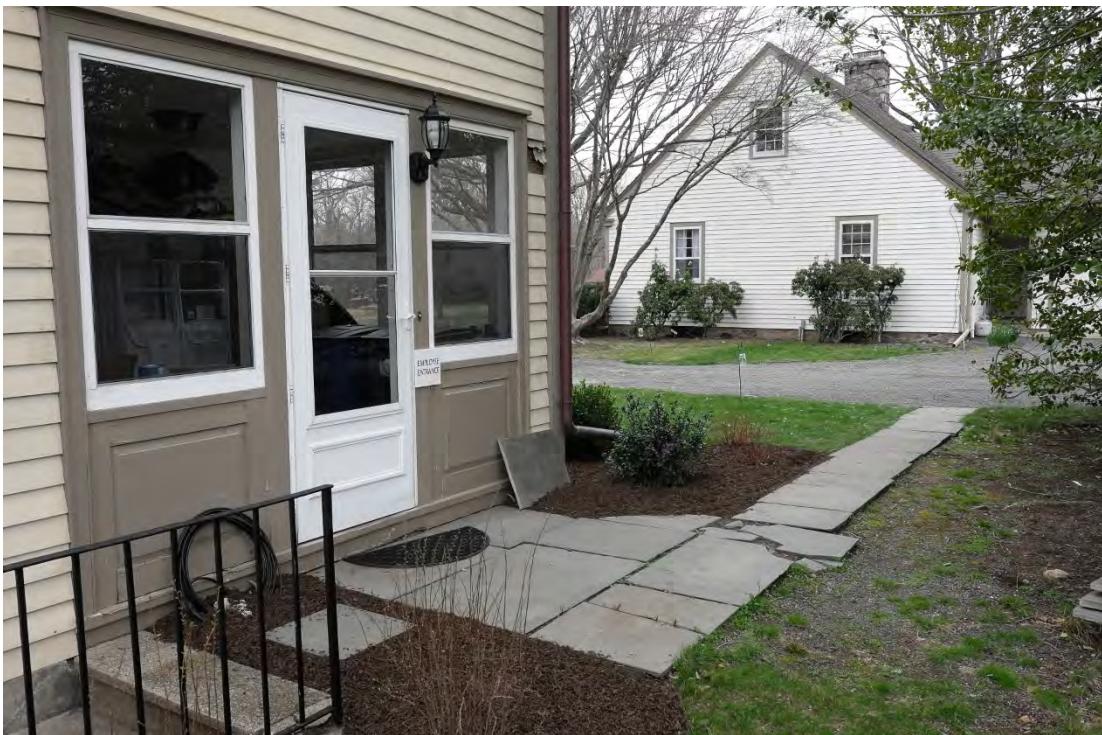
East Elevation – Rear, Porch Entrance

Broken Paving Stones at Pathway [This has been repaired since survey began]

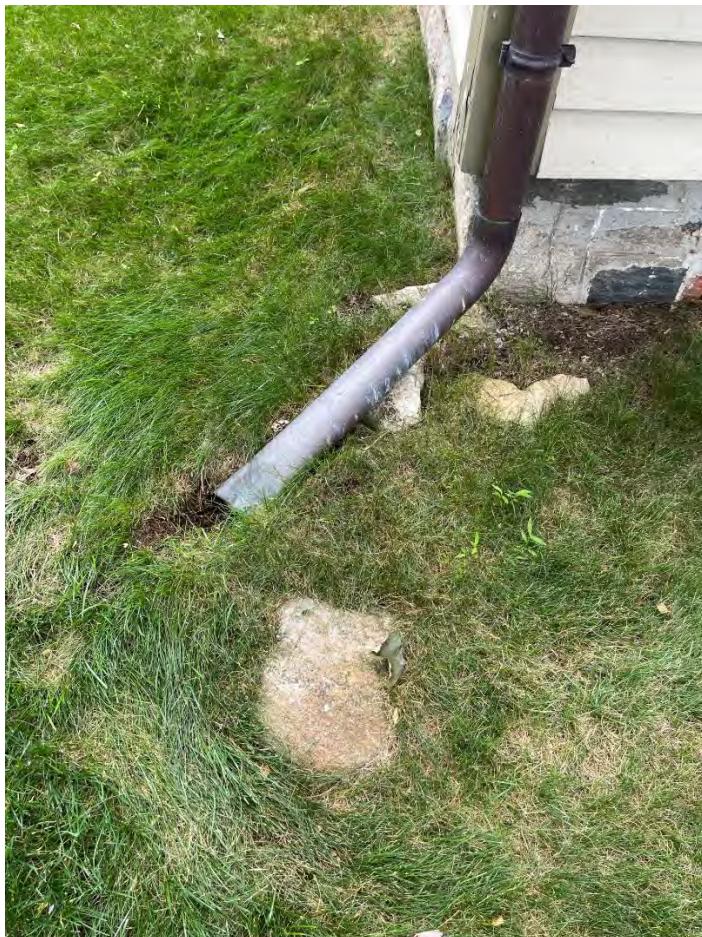
Mather Homestead – Mather Home - Exterior Details
Southwest Corner
No Splash Block at Leader

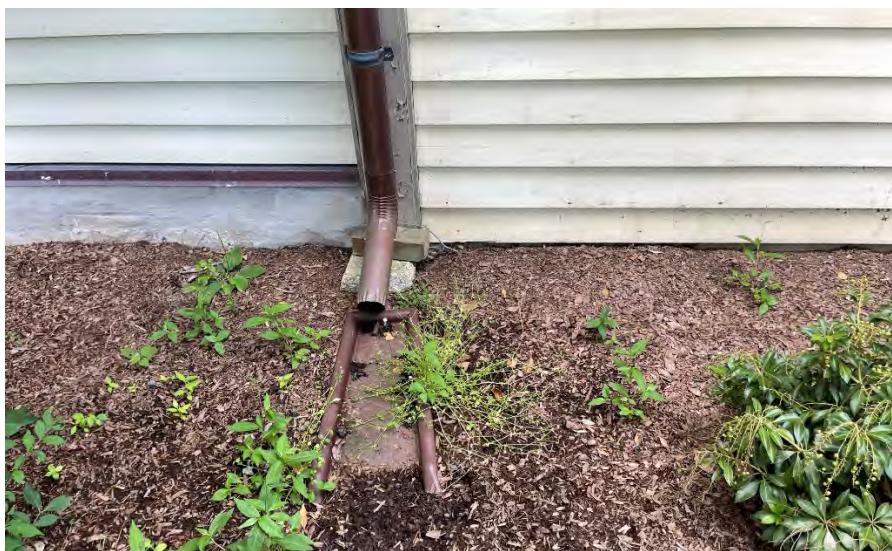
Mather Homestead – Mather Home - Exterior Details
East Elevation at Juncture of Original Block to Ell Connector
No Splash Block is Blocked by Mulch, Minimal Clearance of Grade to Siding

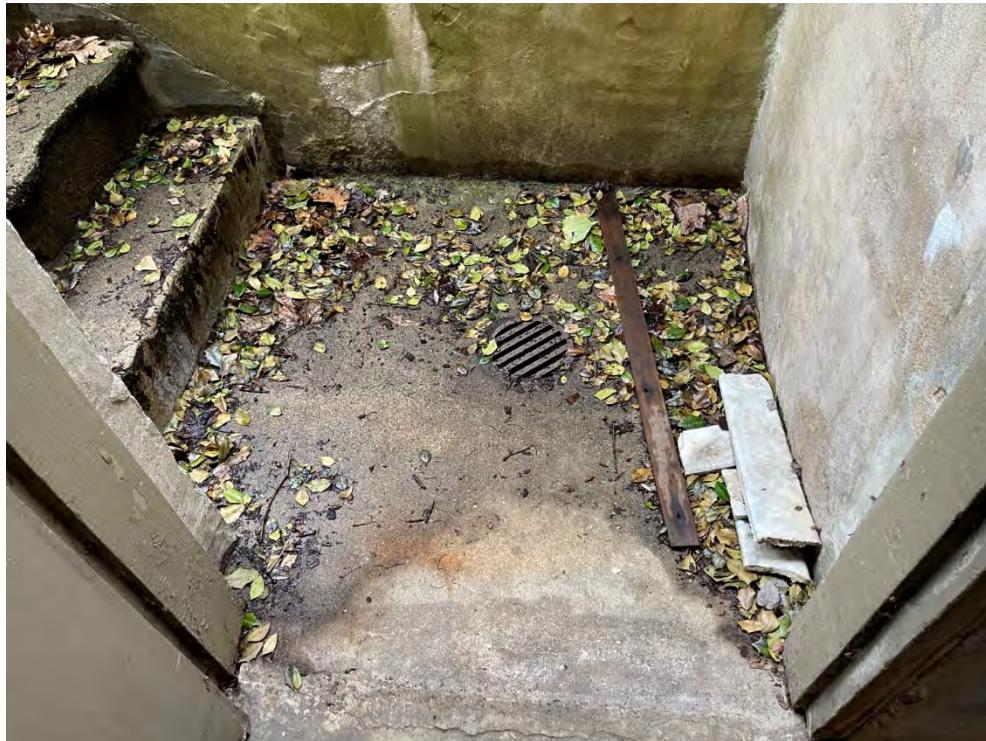
Mather Homestead – Mather Home – Ell Connector - Exterior Details
West Elevation – Exterior Basement Stair
Debris At Drain

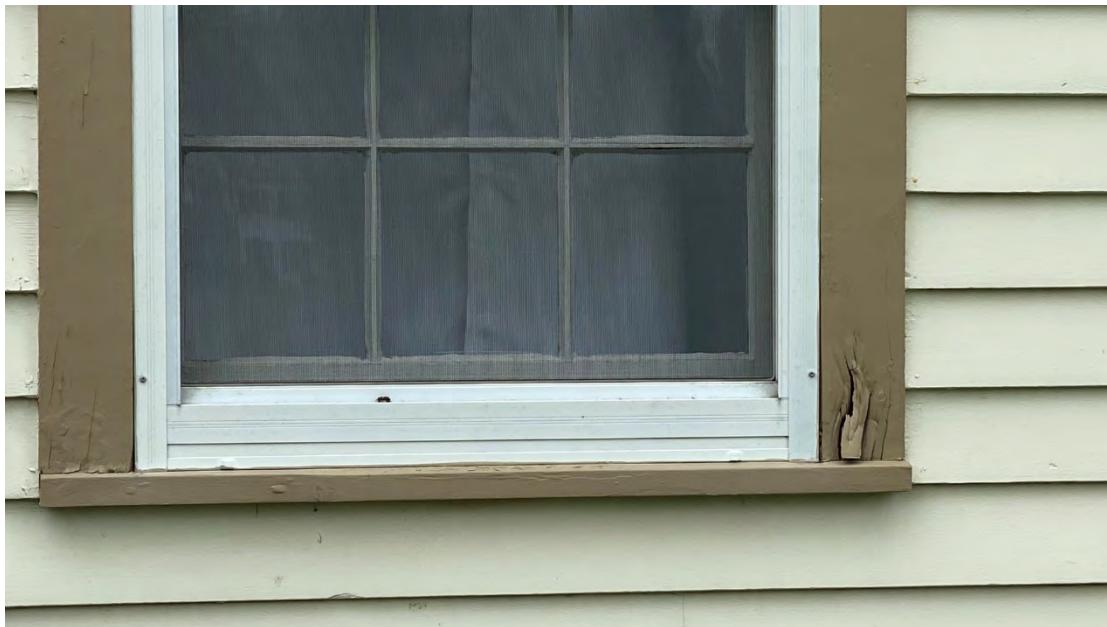
North Elevation – Deterioration of Wood Trim at Window

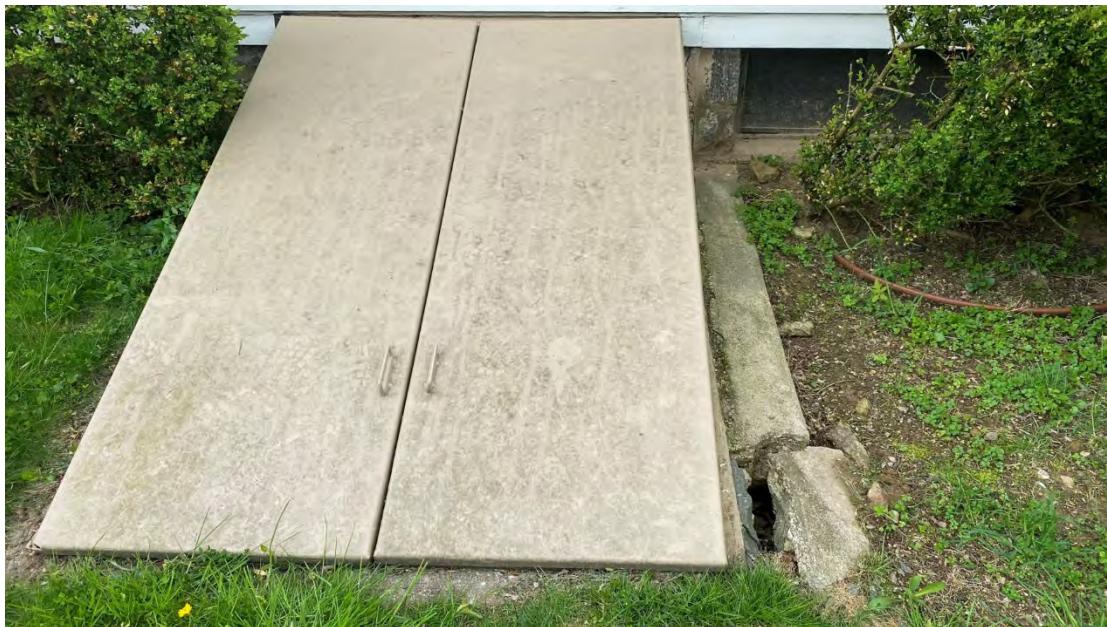
North Elevation – Broken and Displaced Masonry at Basement Hatch

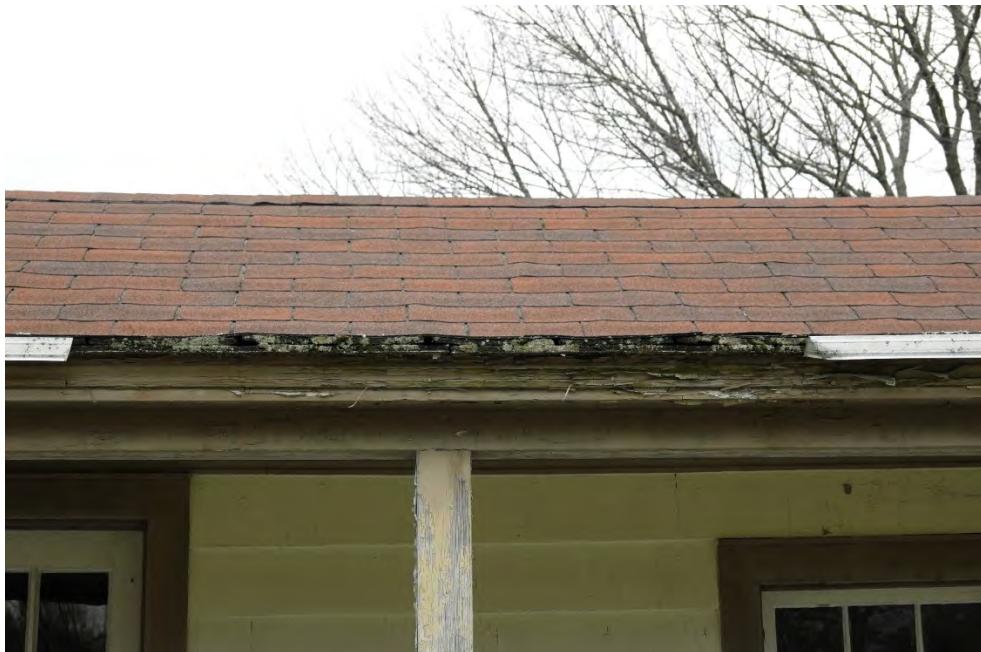
Mather Homestead – Playhouse - Exterior Details
South Elevation
Missing Flashing Exposing Original Wood Shingles; Peeling Paint; Deteriorated Wood

Replace damaged, deteriorated and missing wood shingles with new to match. Replace all damaged and deteriorated wood trim to match existing. Repair or replace all damaged, deteriorated or missing porch elements to match existing or original based upon research. Carefully remove all paint layers and paint with appropriate coatings.

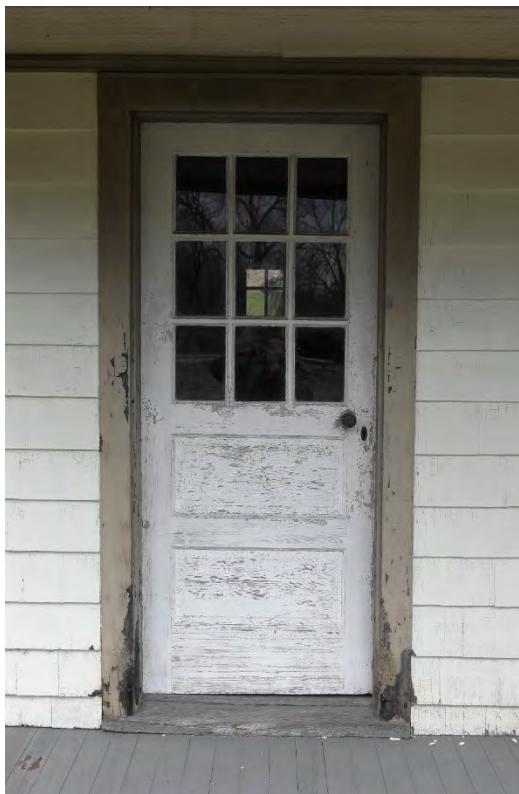
Mather Homestead – Playhouse - Exterior Details
South Elevation
Peeling Paint at Door, Trim; Porch Floor

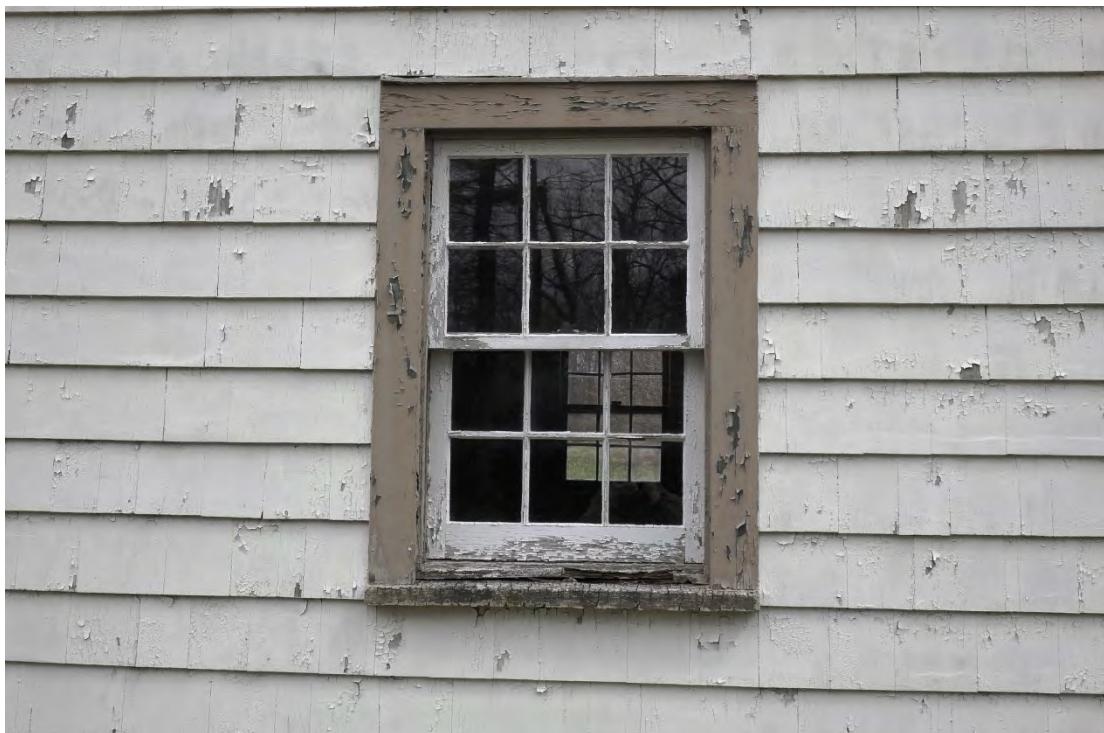
West Elevation

Peeling Paint on Siding and Trim; Deterioration of Wood on Windowsill

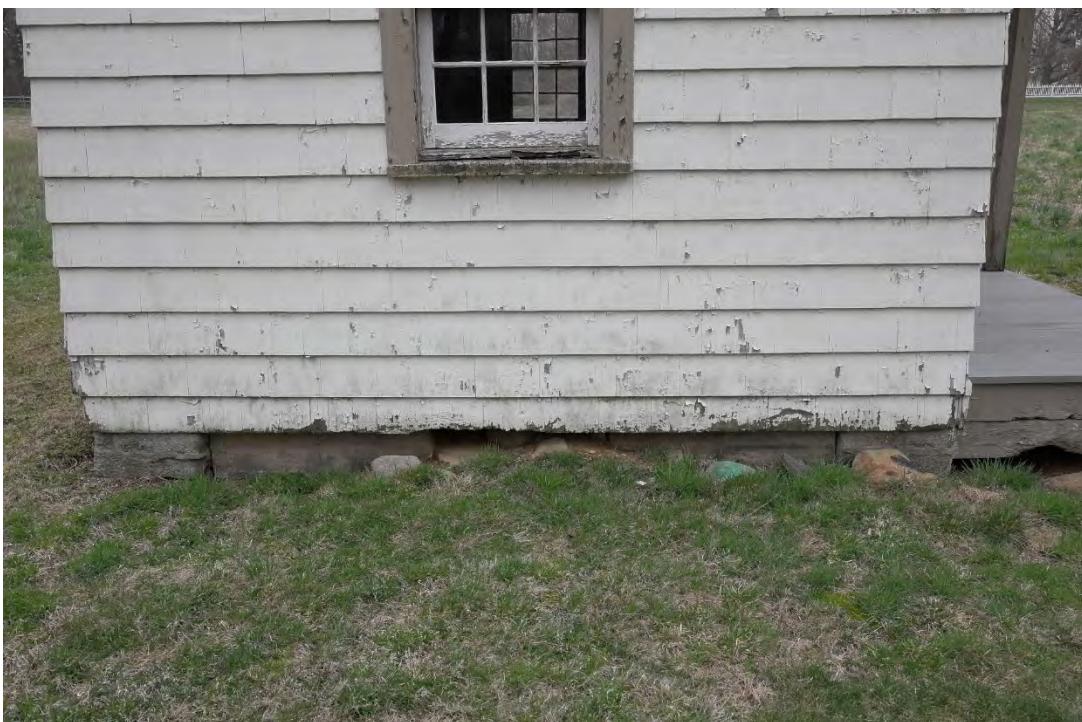
West Elevation

Peeling Paint on Siding and Trim; Deterioration of Wood on Windowsill; Base of Wood too Close to Grade; Missing Masonry Unit at Foundation

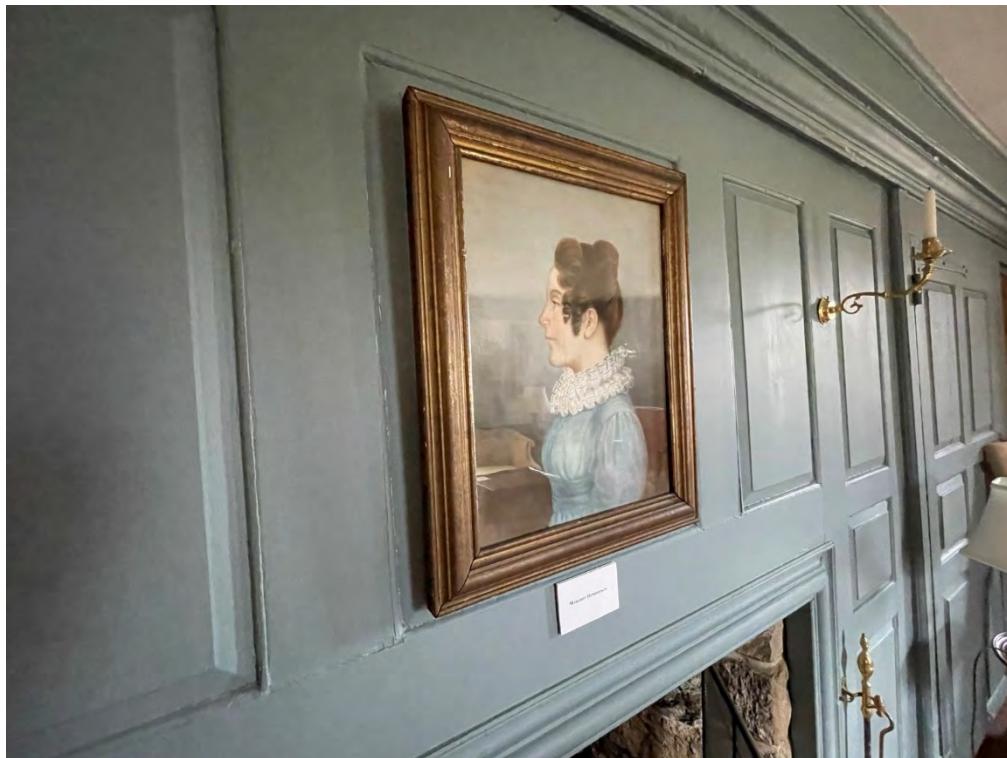
Mather Homestead – Mather House– Original Block - Interior Details
First Floor – Parlor – Peeling Paint

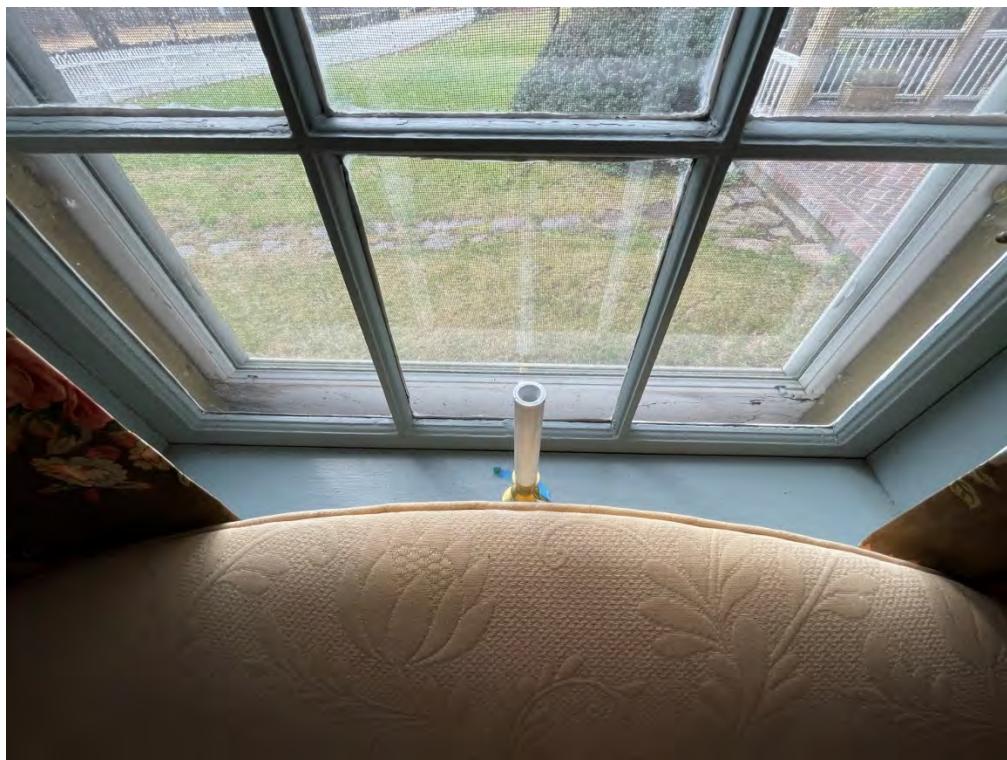
Mather Homestead – Mather House– Original Block - Interior Overalls
First Floor – Parlor – Damaged Storm Window

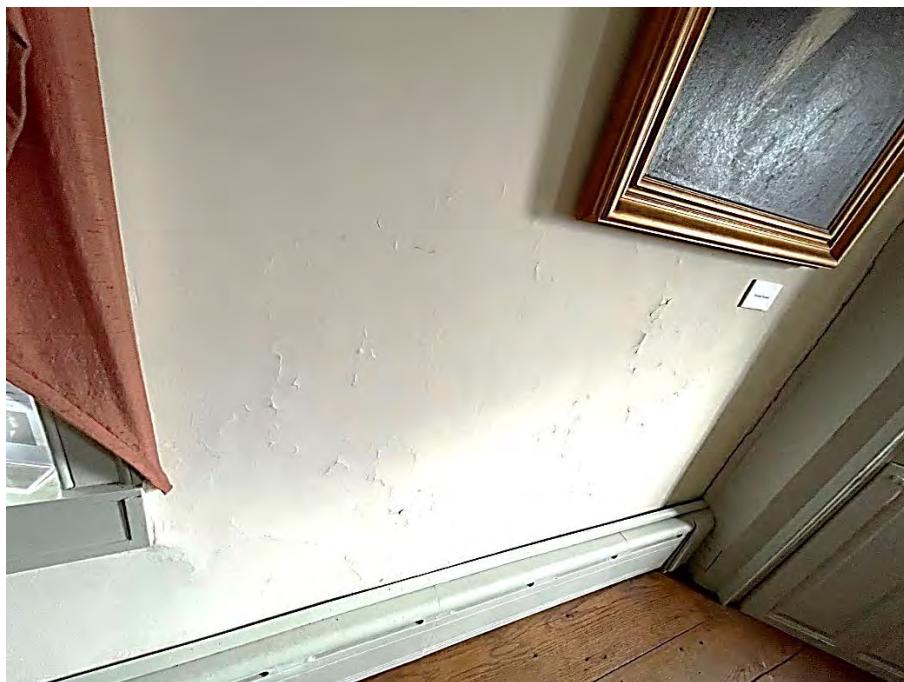
Mather Homestead – Mather House– Original Block - Interior Details
First Floor – Dining Room– Peeling Paint

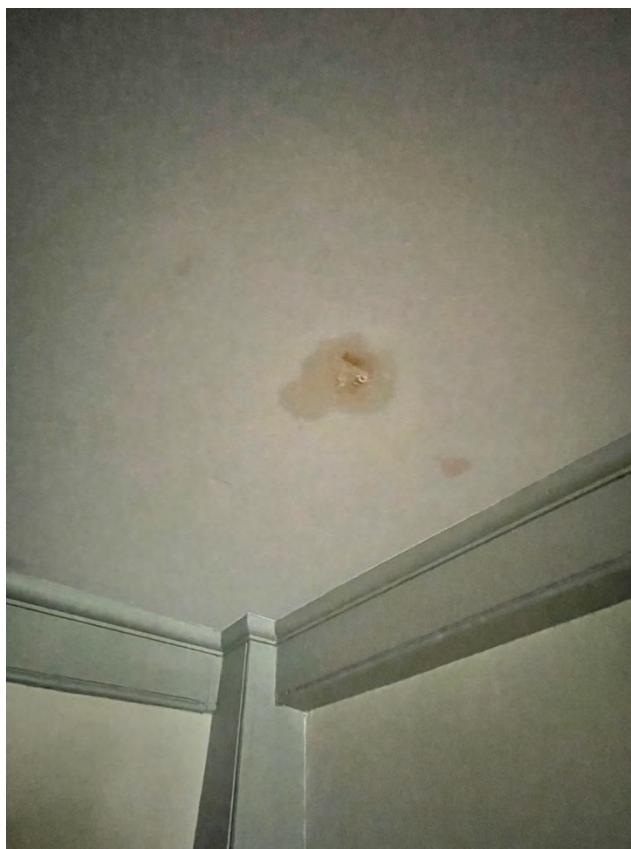
Mather Homestead – Mather House– Original Block - Interior Details
First Floor – Dining Room – Stain on Ceiling (from Leak?)

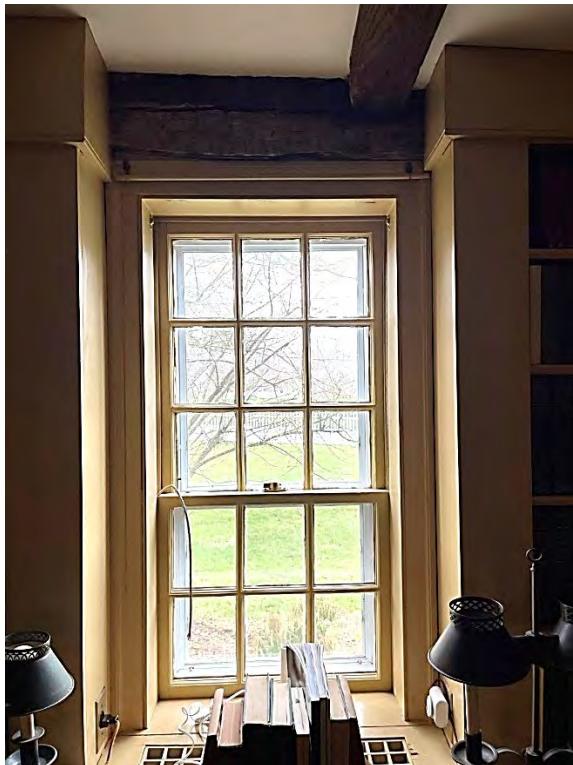
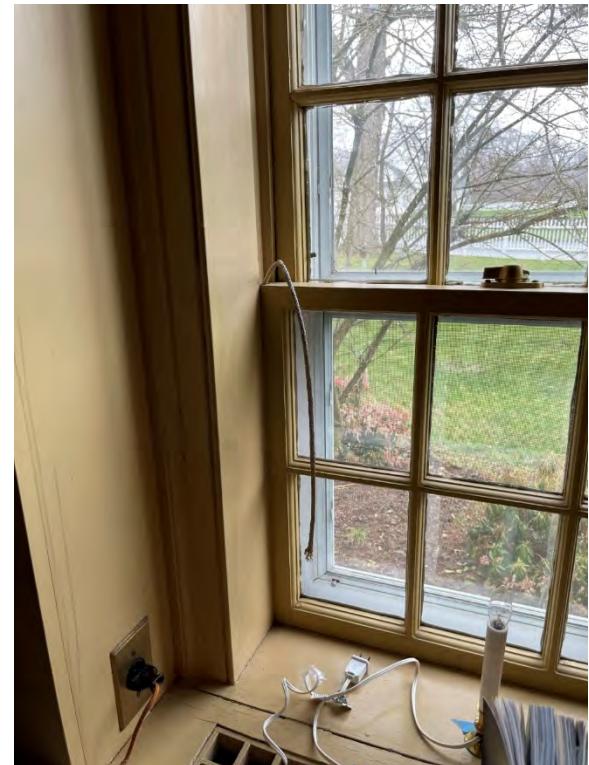
Mather Homestead – Mather House – Original Block - Interior Overalls
First Floor – Original “Buttery”/Now East End of Family Room – Broken Window Cord

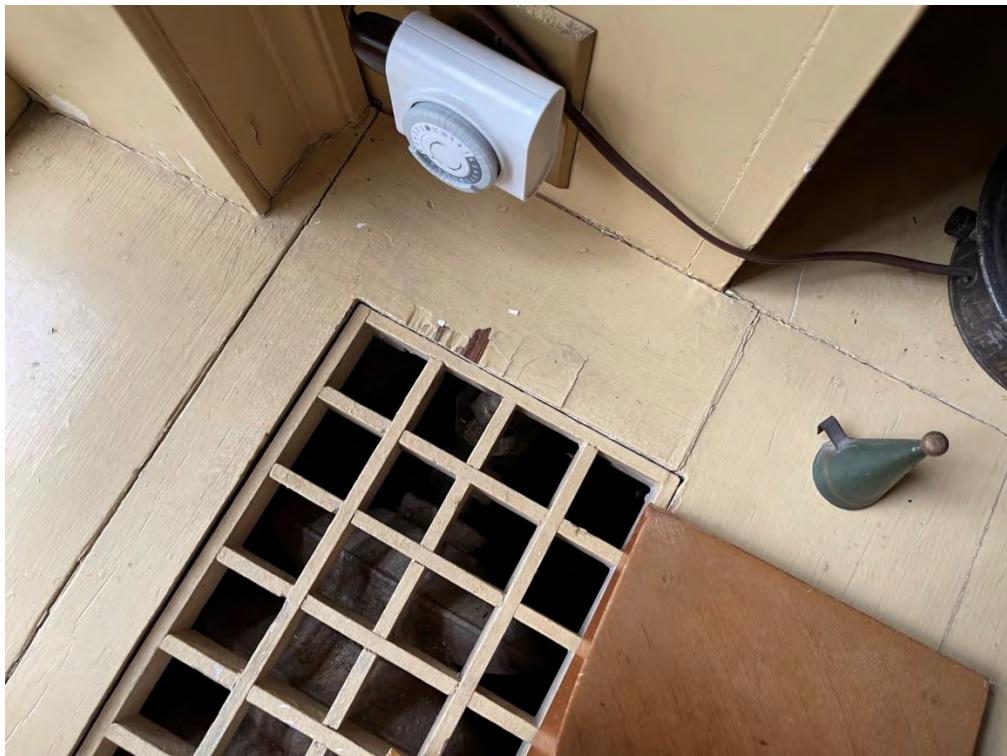
Mather Homestead – Mather House – Original Block - Interior Details
First Floor – Original “Buttery”/Now East End of Family Room – Chipped Wood Flooring

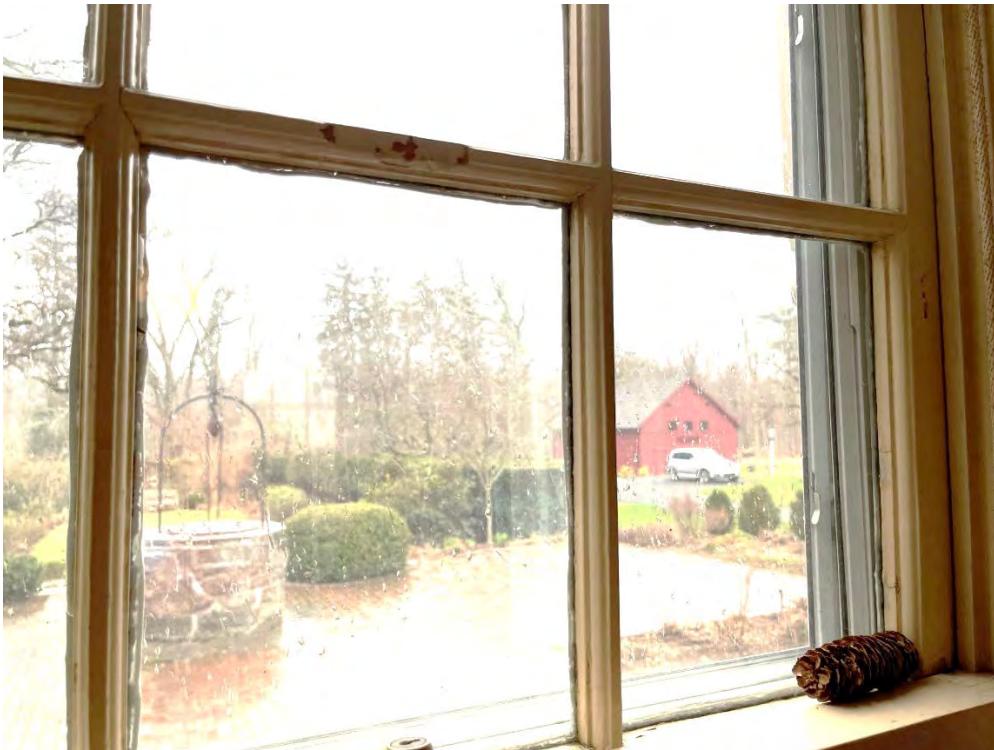
Mather Homestead – Mather House - Ell Connector - Interior Details
First Floor – Kitchen
Peeling Paint on Window

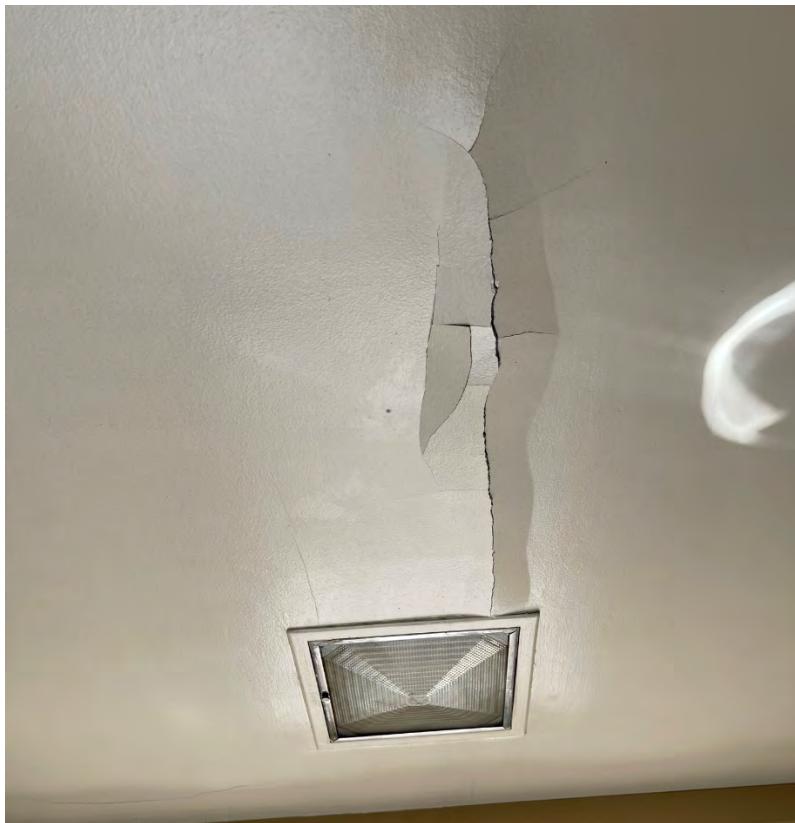
Mather Homestead – Mather House - Ell Connector - Interior Details
First Floor – Kitchen
Delaminating and Peeling Paint on Ceiling

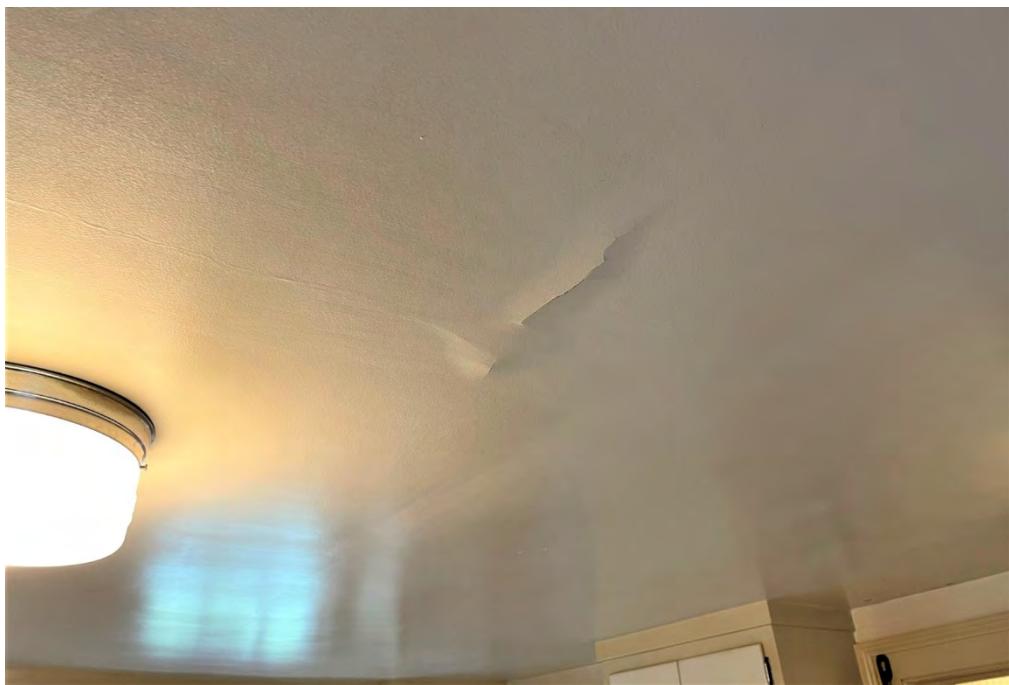
Mather Homestead – Mather House - Ell Connector - Interior Details
First Floor – Kitchen
Delaminating and Peeling Paint on Ceiling

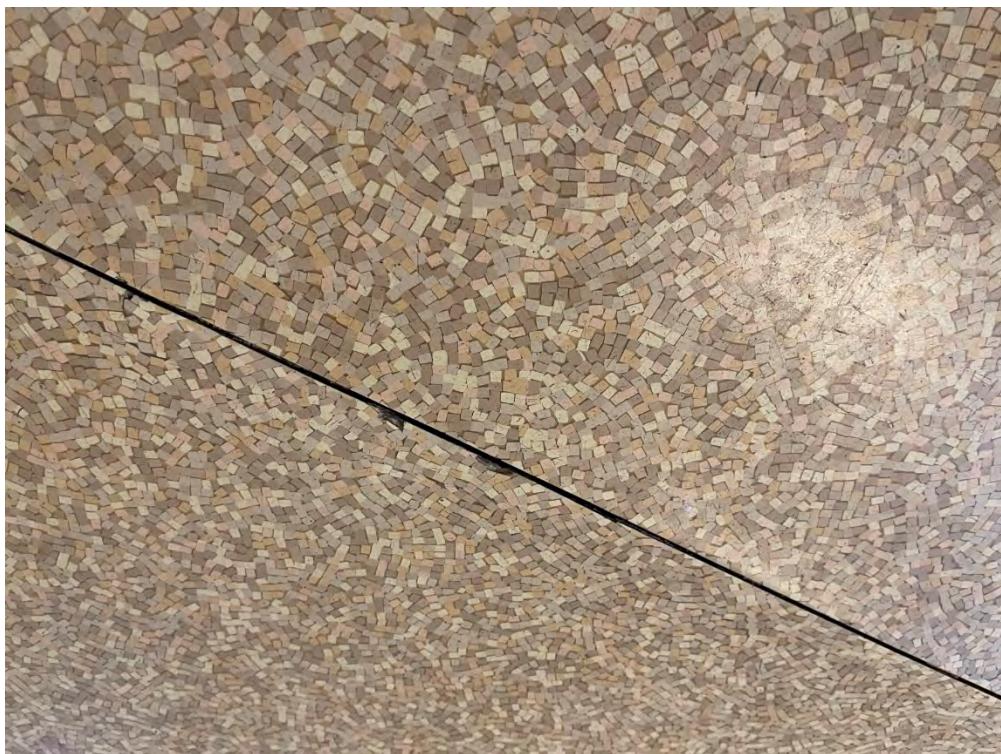
Mather Homestead – Mather - Ell Connector - Interior Details
First Floor – Kitchen
Lifting Resilient Flooring

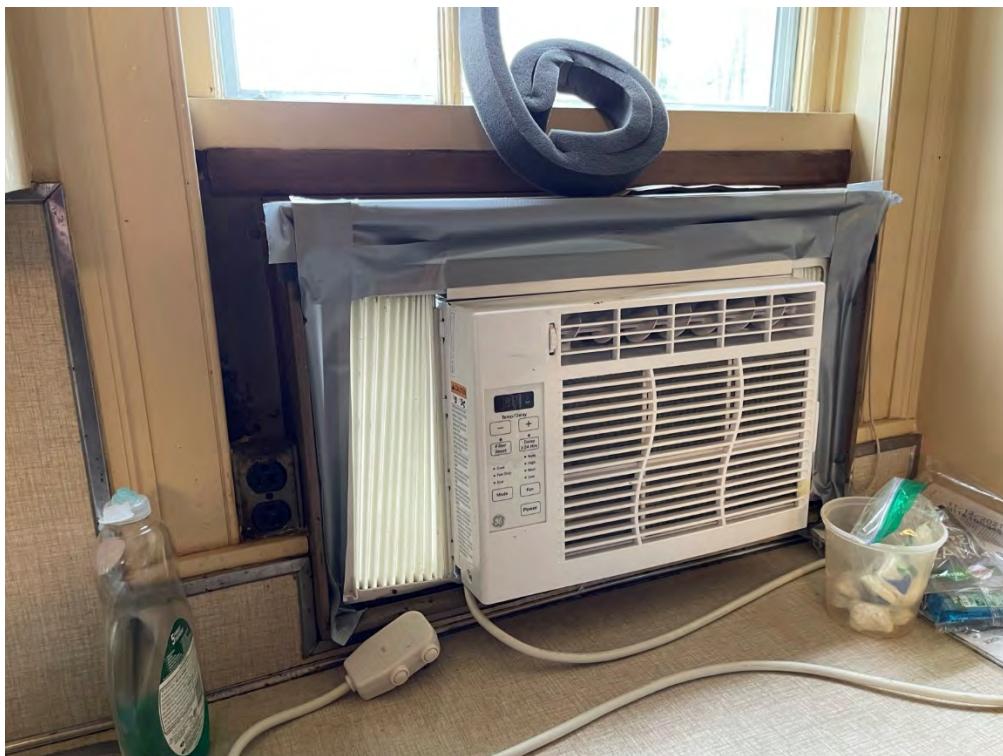
Window AC Unit Improperly Installed

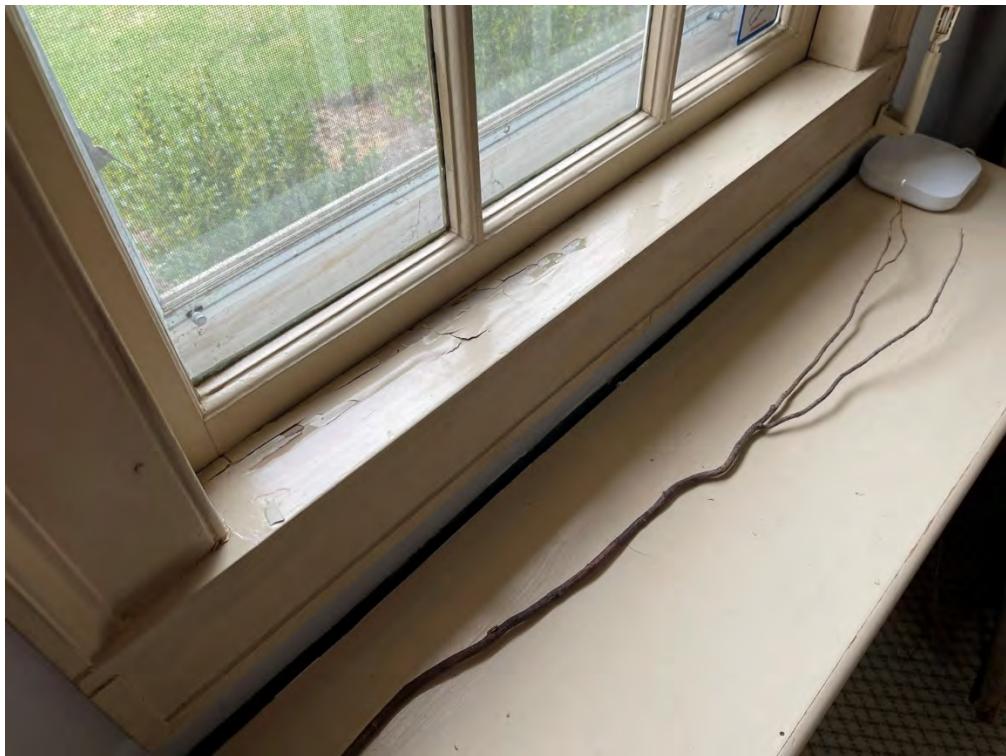
Peeling Paint on Windowsill

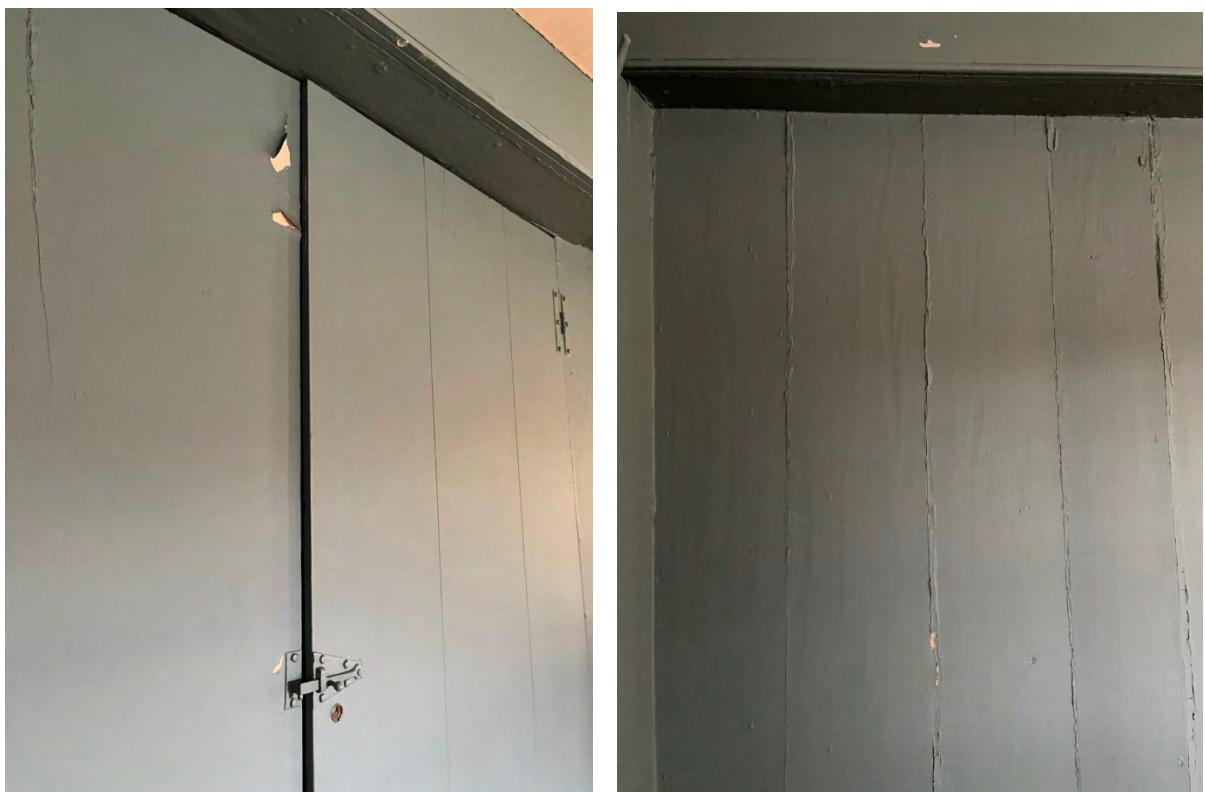
Peeling Paint

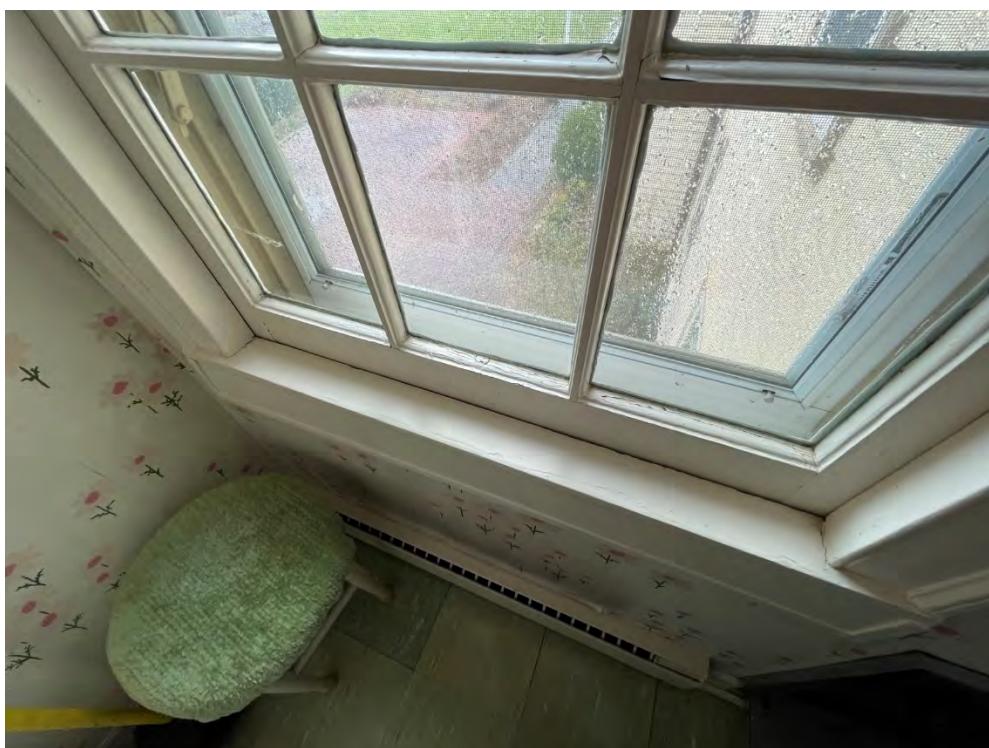
Mather Homestead – Mather House – Original Block - Interior Details
Second Floor – Bathroom
Peeling Paint on Window
