MATHER HOMESTEAD DARIEN, CT

CONDITIONS ASSESSMENT REPORT

P22-028

JULY 6, 2022

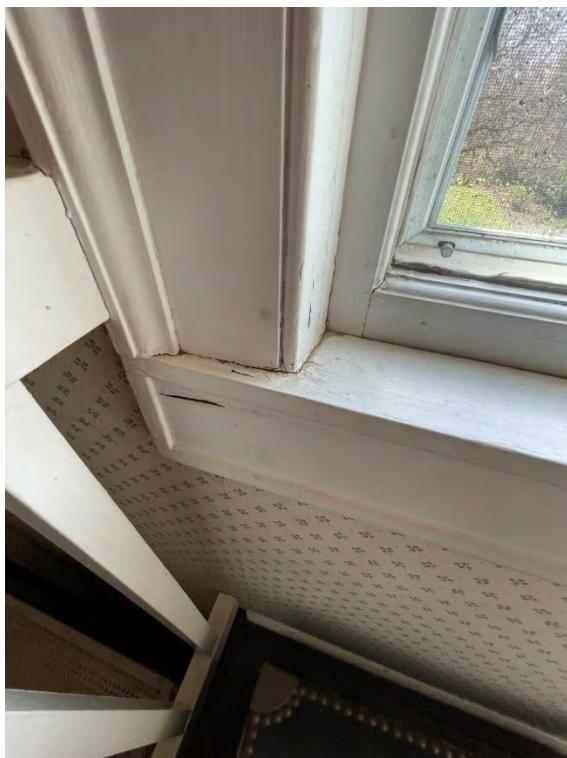
Mather Homestead – Mather - Ell Connector - Interior Details
Second Floor – North Vestibule/Hall – Damaged Finishes

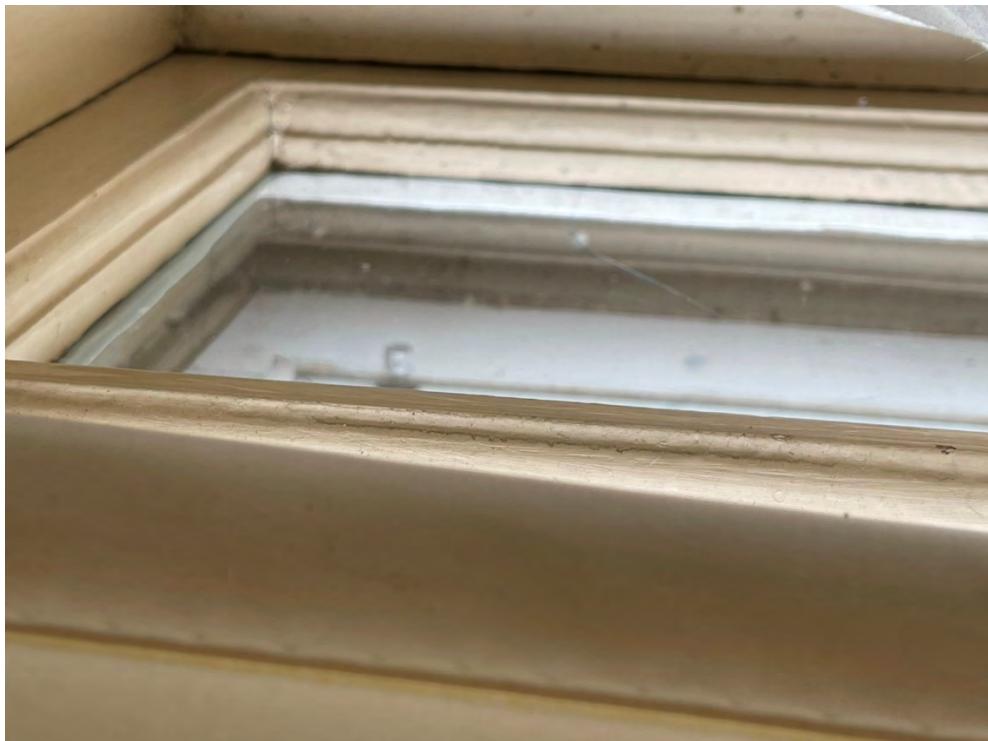
Second Floor – West Bedroom
Cracked Glass in Window

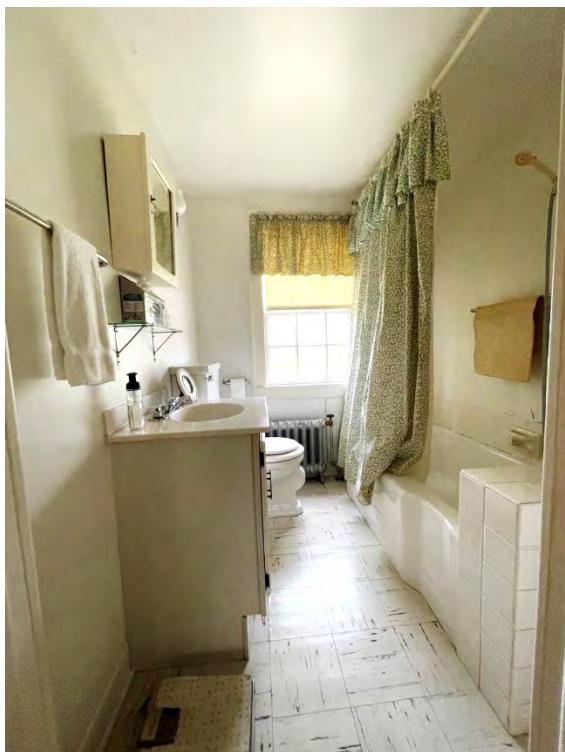
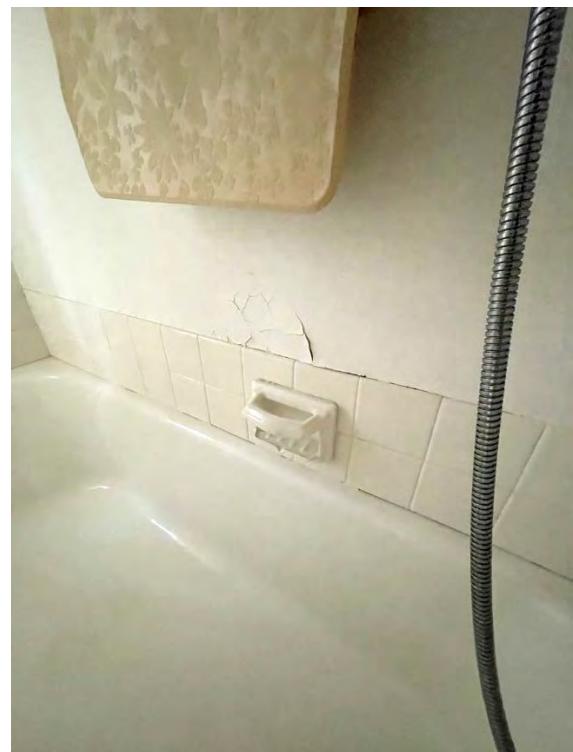
Mather Homestead – Mather House - Ell - Interior Overalls and Details
Second Floor – Left: Bathroom – Looking North; Right: Damage at Tub Wall

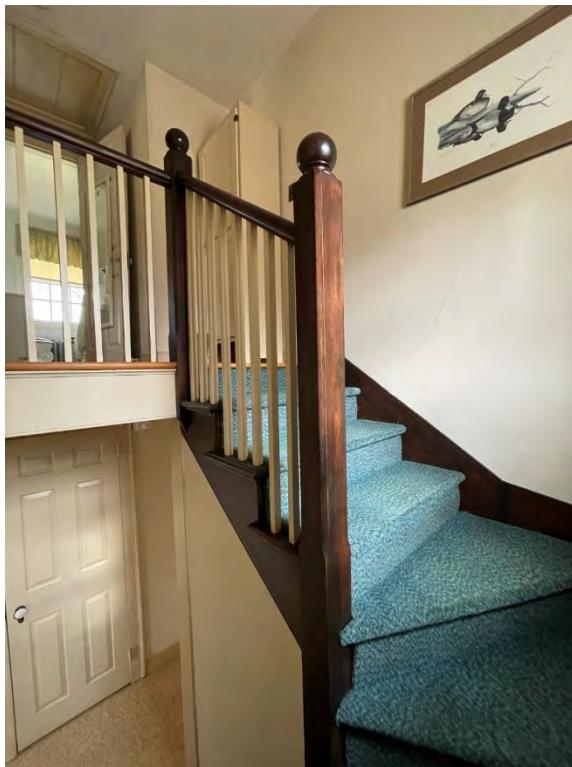
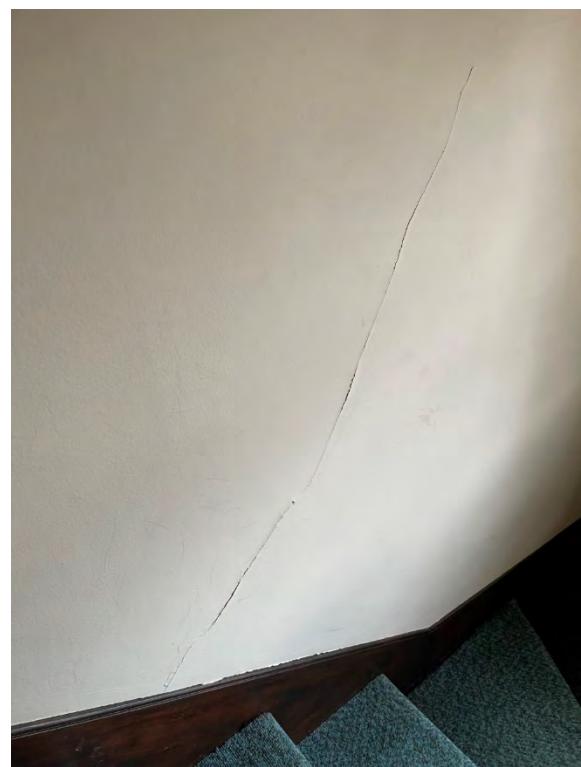
Mather Homestead – Mather House - Ell - Interior Overalls and Details
Second Floor – Stair
Left: Overall; Right: Crack in Plaster

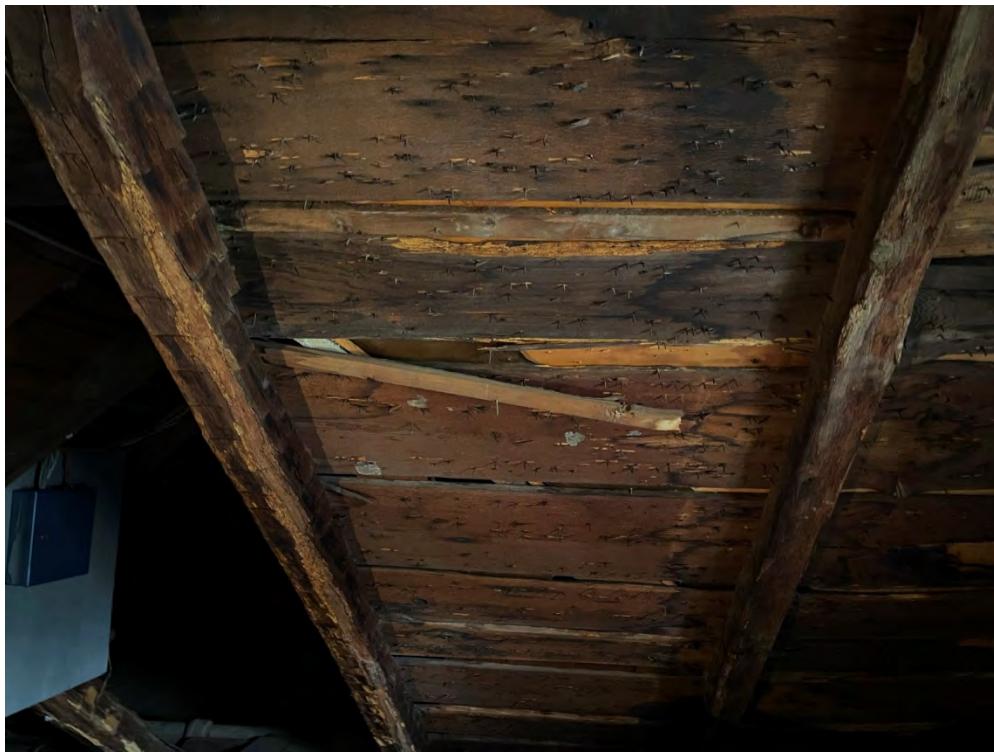
Mather Homestead – Mather House – Original Block - Interior Details
Attic – Displaced Wood Sheathing

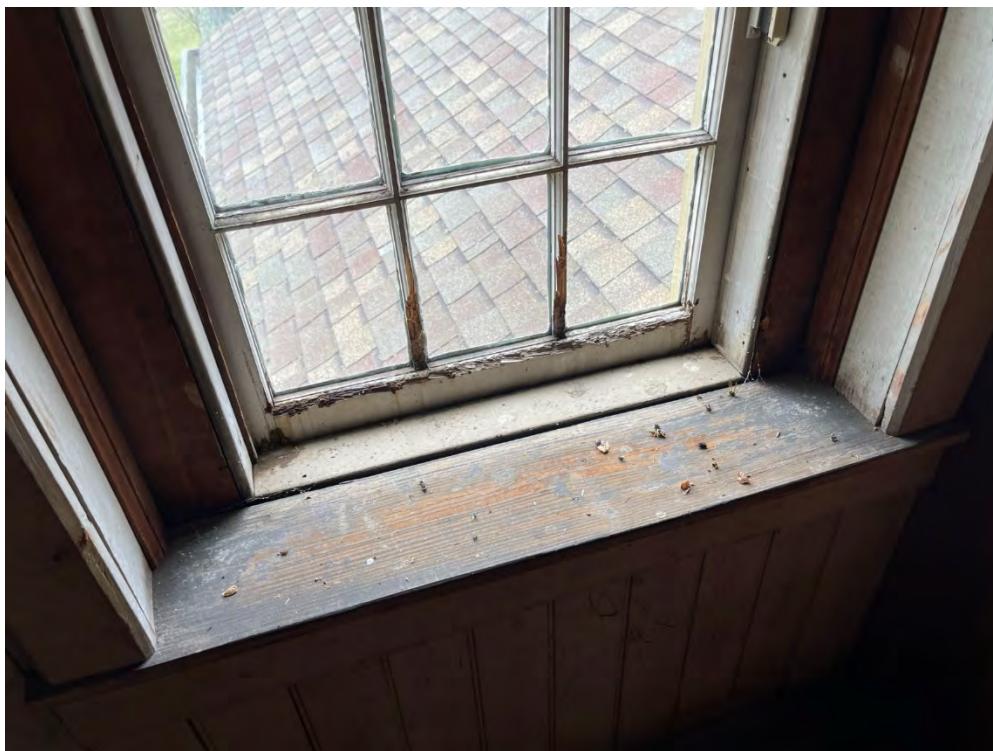
Mather Homestead – Mather House – Original Block - Interior Details

West Attic Room
Worn Wood on Window

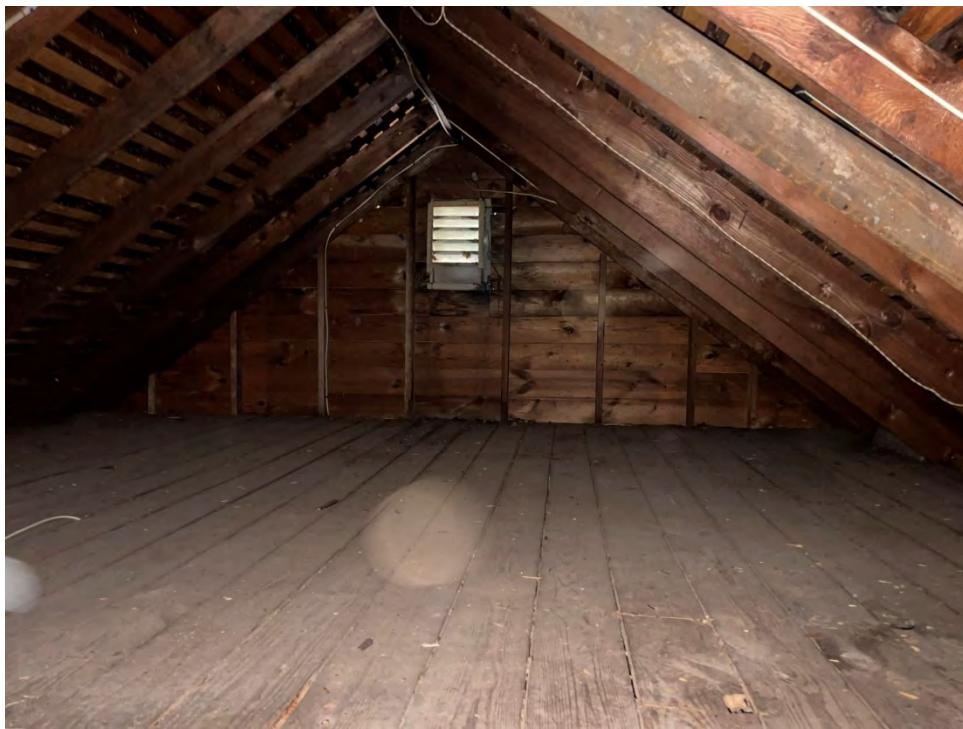
Mather Homestead – Mather House - Ell - Interior Overalls
Attic – North Wall
Staining From Previous Leaks

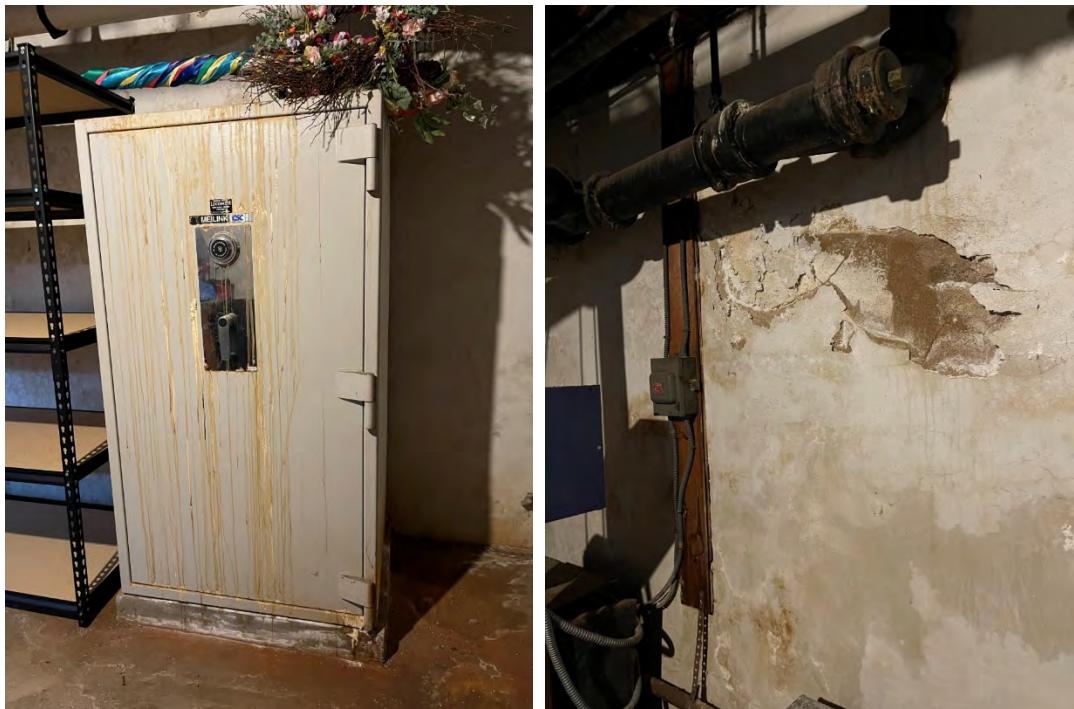
Mather Homestead – Mather House – Ell Connector - Interior Details

Basement – Staining and Moisture Damage from Previous Leak

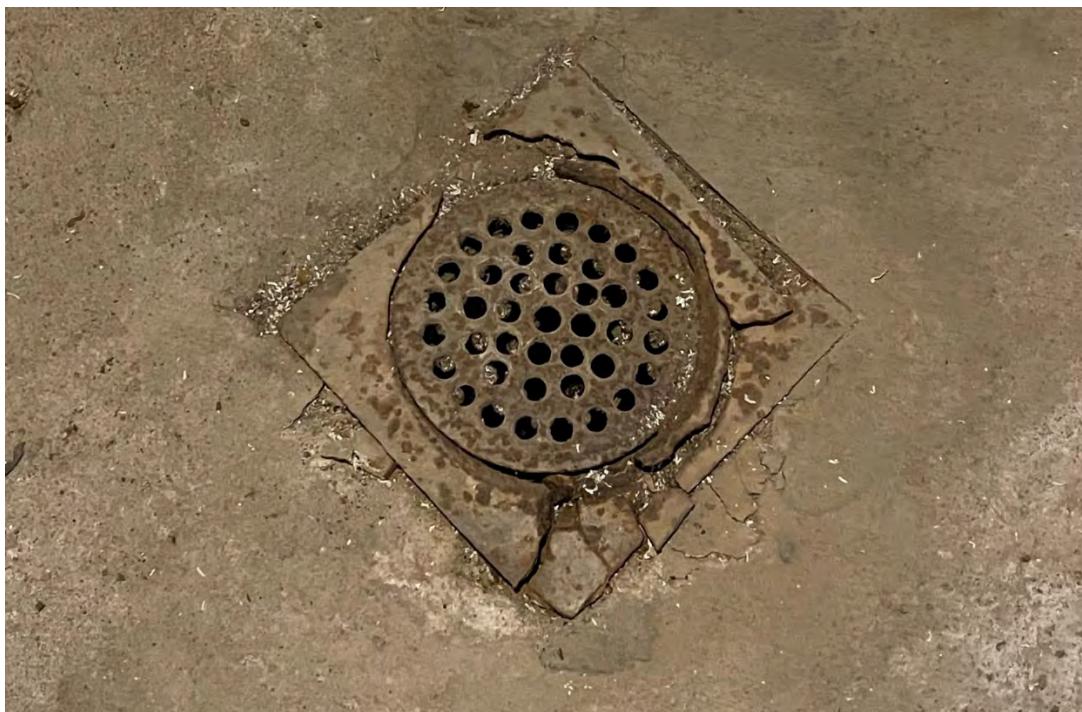
Mather Homestead – Mather House – Ell Connector - Interior Details

Basement – Cracked and Damaged Drain Surround

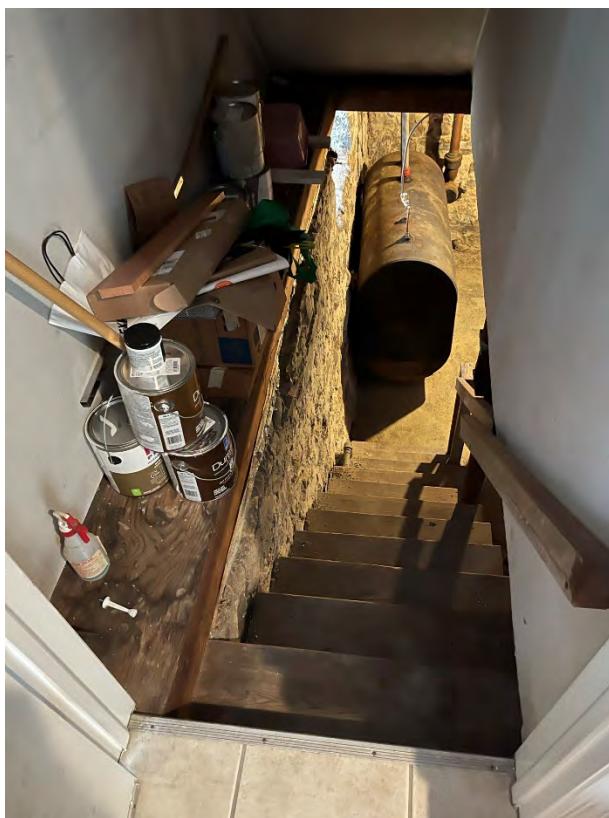
Mather Homestead – Caretaker's Cottage - Interior Details
First Floor – Steps to Basement – Storage Issues

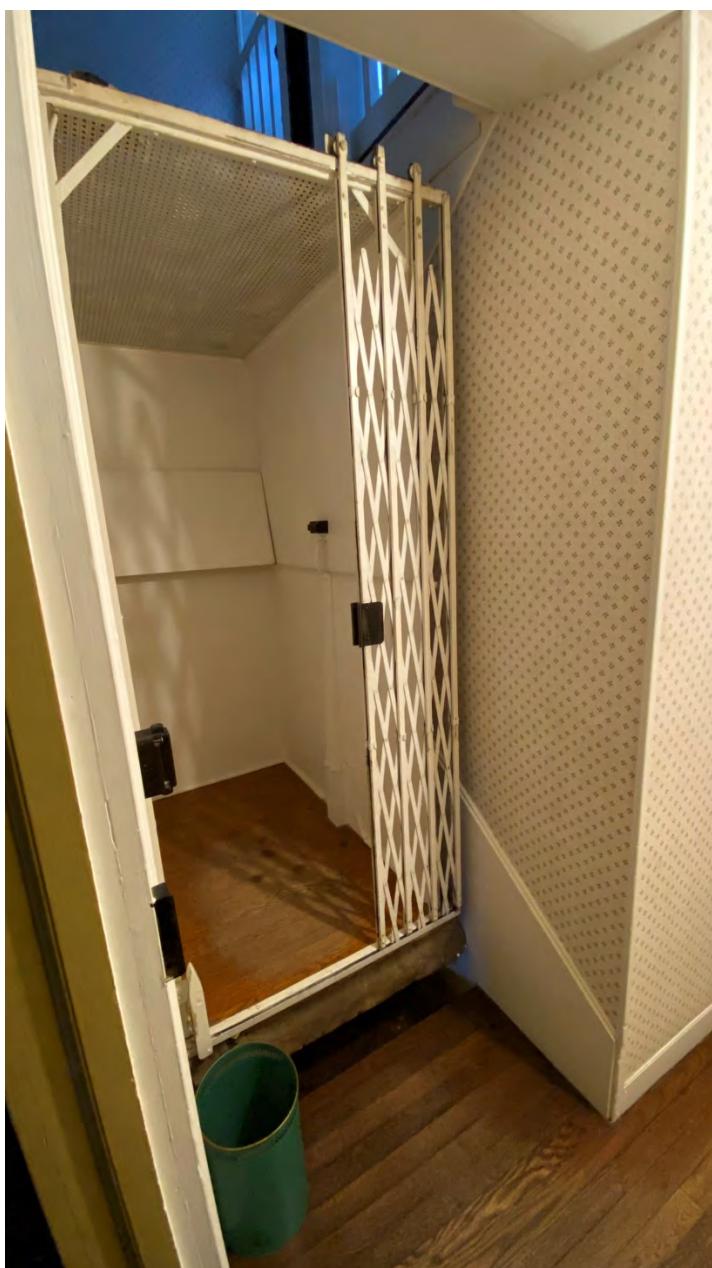
Mather Homestead – Mather House – ADA and General Access Review
First Floor – Ell Connector Vestibule – Existing Elevator

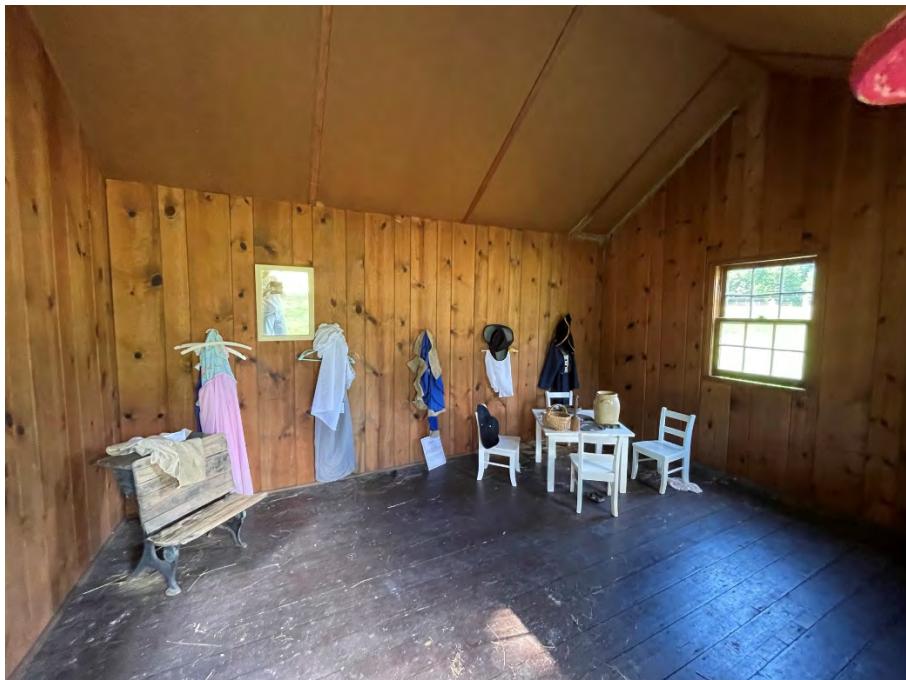
Mather Homestead – Playhouse – Interior Overalls
Overall View Looking Northeast

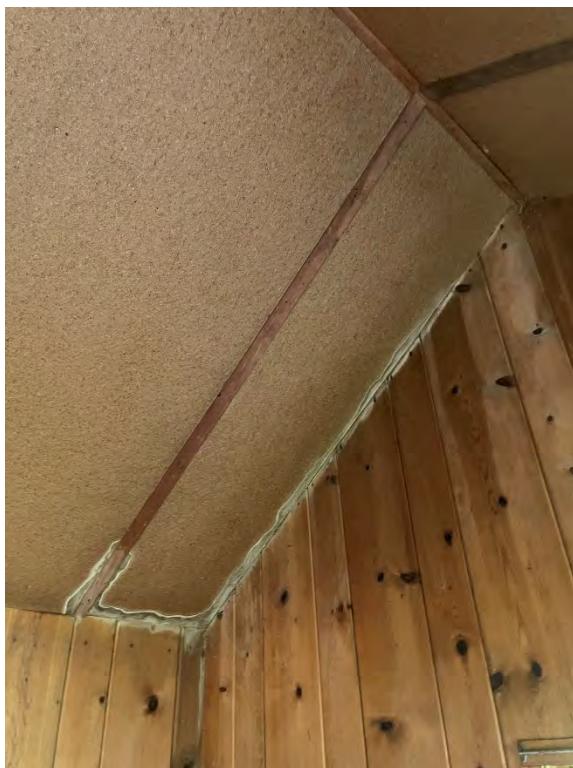
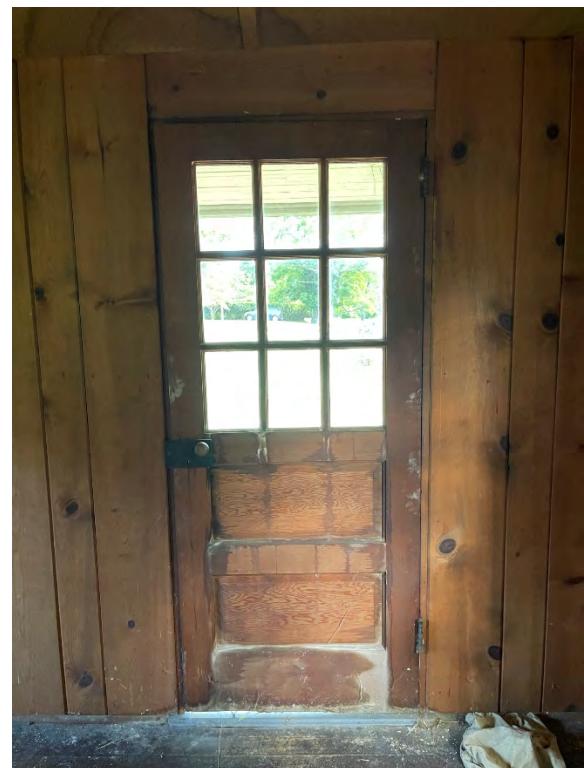
Mather Homestead – Playhouse – Interior Details
Left: Northeast Corner - Damage from Leak; Right: Damage from Moisture Infiltration

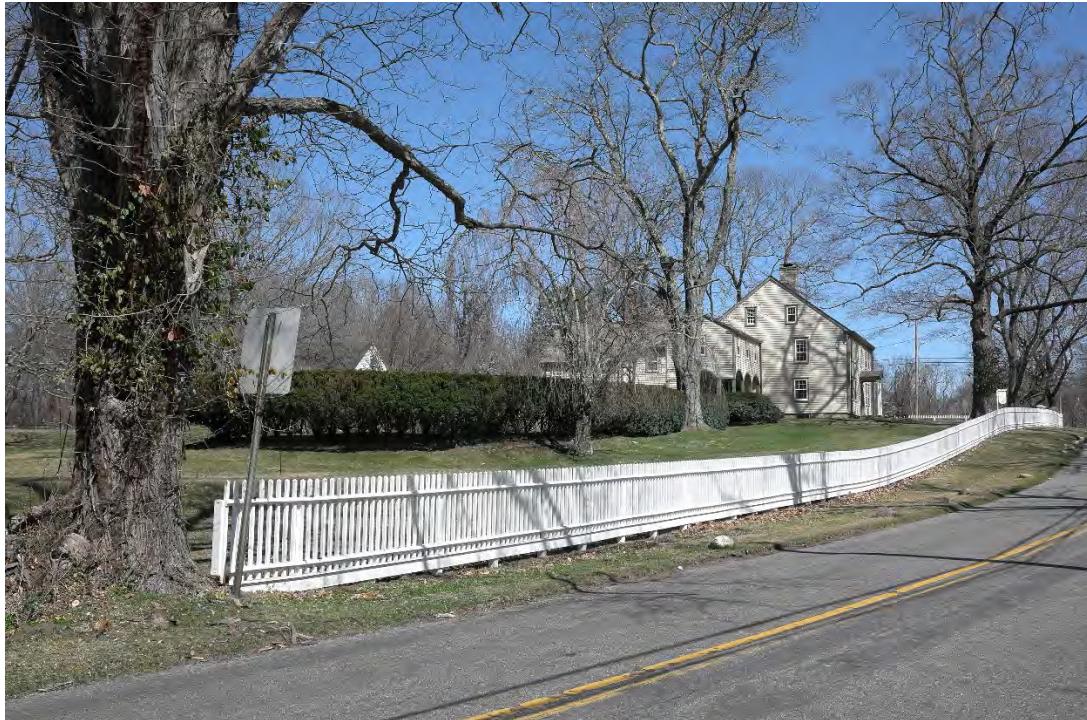
Mather Homestead – Site – Critical Site Elements
Early Perimeter Picket Fence along Stephen Mather Road

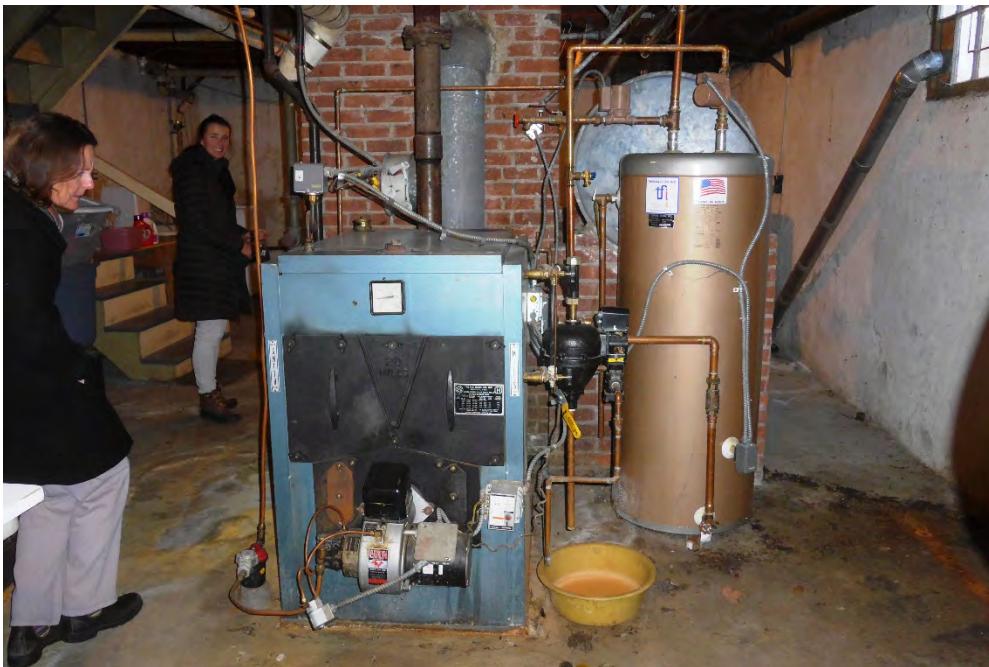
Mather Homestead – Mather House – Mechanical, Electrical, Plumbing
Oil Fired Gravity Fed Steam Heat Boiler and Hot Water Heater in Basement

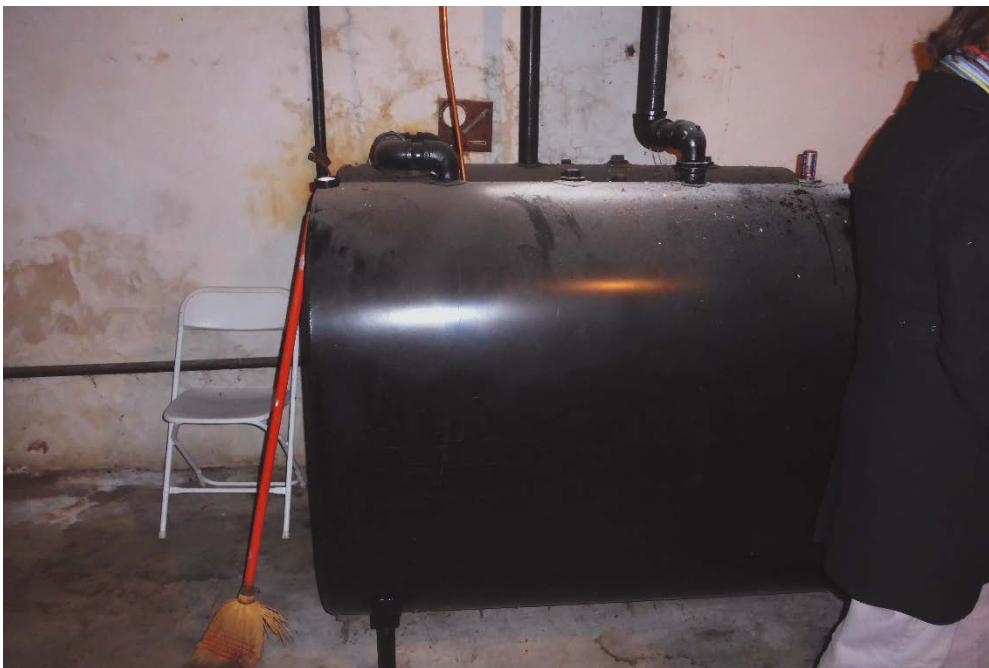
Mather Homestead – Mather House – Mechanical, Electrical, Plumbing
One of Two Oil Tanks in Basement

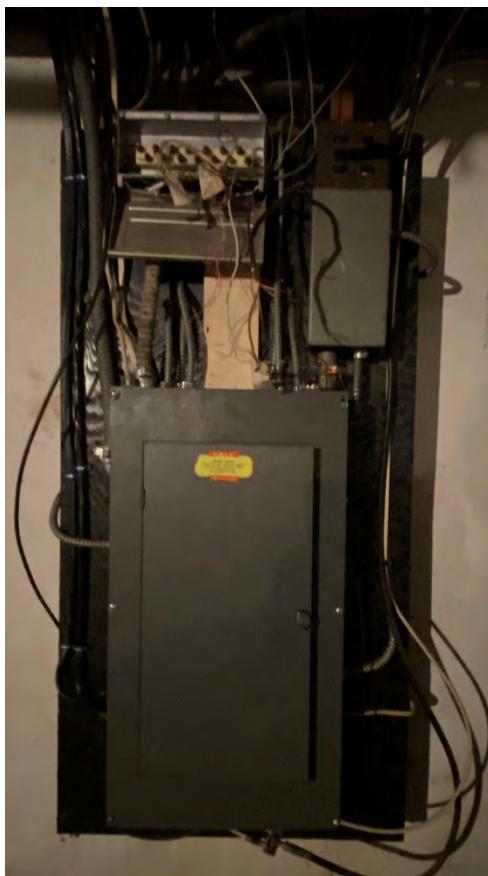
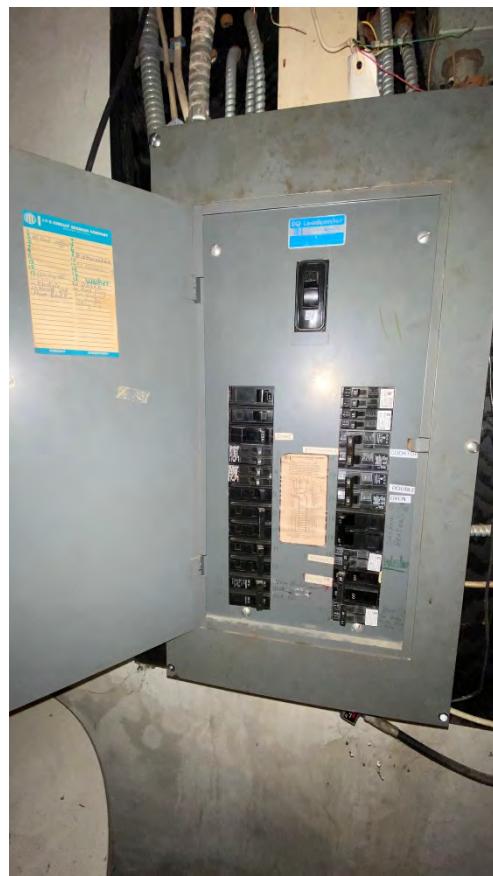
Mather Homestead – Mather House – Mechanical, Electrical, Plumbing
Main Electric Service Panel and Circuit Breaker Panel in Basement

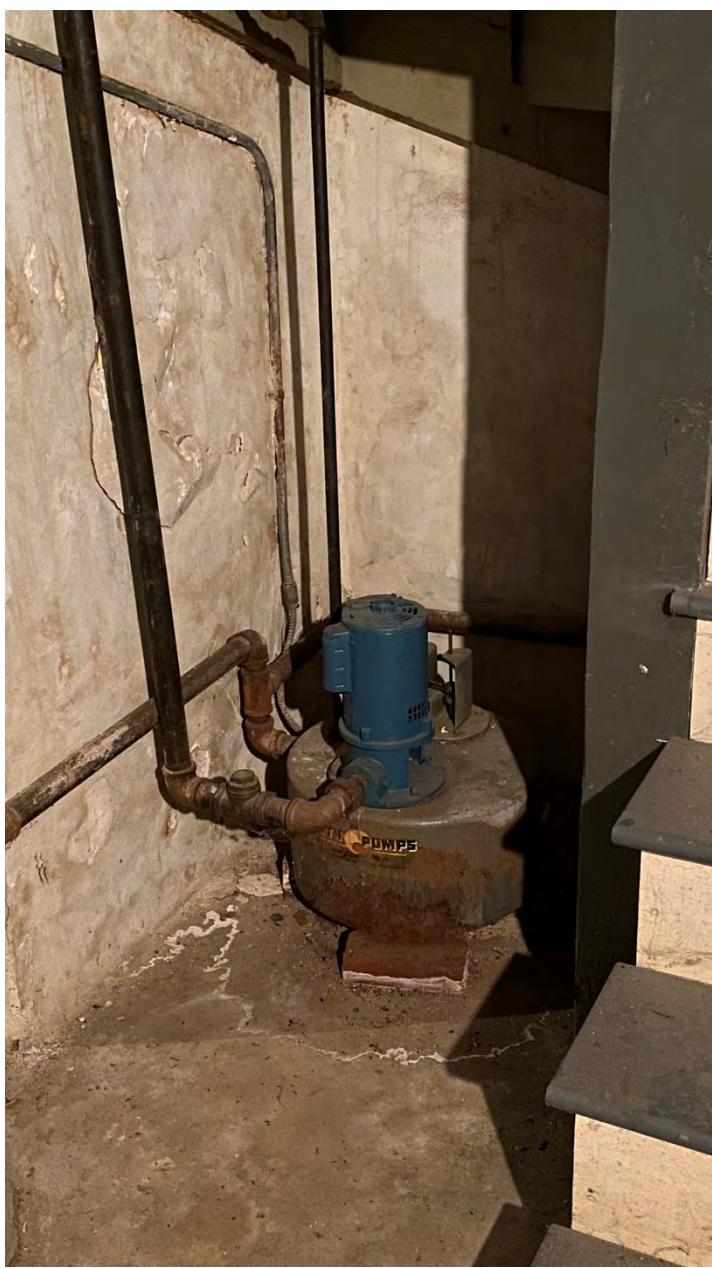
Mather Homestead – Mather House – Mechanical, Electrical, Plumbing
Steam Gravity Return Pump

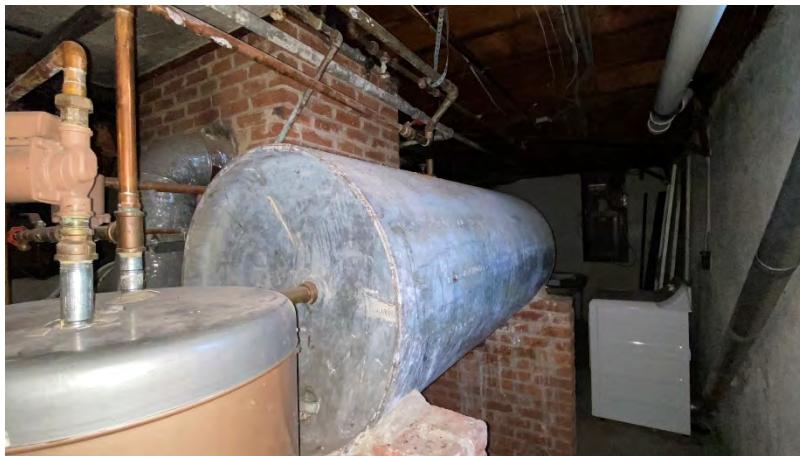
Mather Homestead – Mather House – Mechanical, Electrical, Plumbing
Obsolete Water Holding Tank in Basement

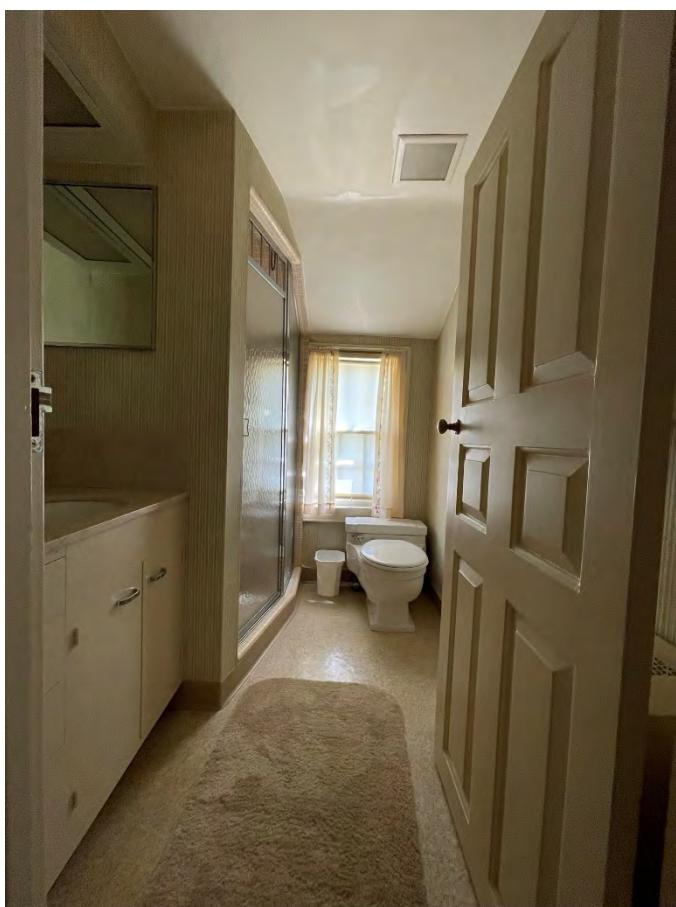
Mather Homestead – Mather House – Mechanical, Electrical, Plumbing
Second Floor – Bathroom above West Porch
Consideration Should be Given to Terminating all Second Floor Plumbing Lines
